EVALUATION OF THE SEISMIC PERFORMANCE OF AN OLD MASONRY BUILDING IN LISBON

M.S. LOPES

Instituto Superior Técnico, Departamento de Engenharia Civil, Av. Rovisco Pais 1, 1000 Lisboa, Portugal

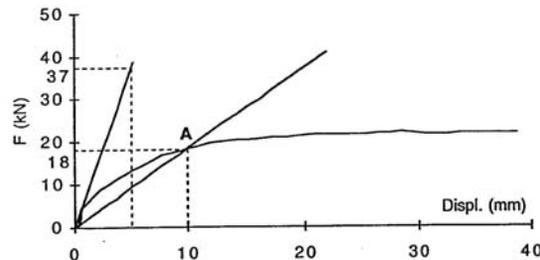
Fig. 6 Test of the facade. Relationship force versus average of top displacements

$$K = \frac{F_A}{\text{Displ}_A} = \frac{18\text{kN}}{10\text{mm}} = 1.8\text{kN} / \text{mm}$$

This value is more than 4 times less than the initial stiffness which is approximately:

$$K_{\text{initial}} = \frac{37\text{kN}}{5\text{mm}} = 7.4\text{kN} / \text{mm}$$

To assess the seismic performance of the building under earthquake loading the value of the acting forces in the elements of the facade tested must be compared with the respective strength. The measured strength of the part of the facade tested can be taken from fig. 6 and is $V_{rd} = 22 \text{ kN}$. The acting shear force on this elements is

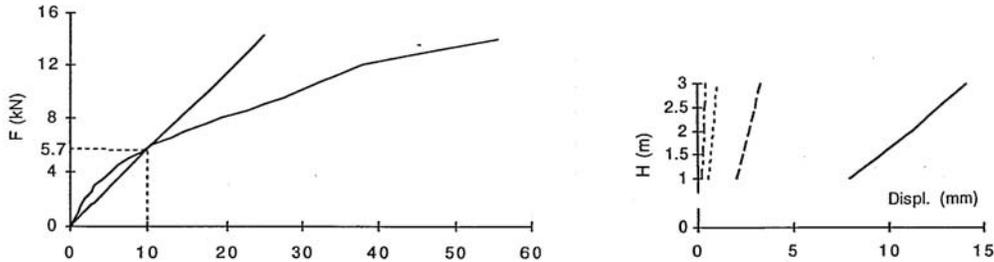
Fig. 8 Test 3 on the interior wood bearing wall.

The mechanical properties of the interior wood bearing walls and the staircase were calibrated by the same method as for the facade. From test 2, performed on a interior bearing wall the experimental stiffness of $K = 570 \text{ kN/m}$ can be obtained (fig. 8). Figure 8 also shows the deformation of this wall along the height, for several load levels.

Relationship force versus displacement 1. Deformed shape along the height for several load levels

The fig. indicates that the predominant deformation mode is a shear or a rigid body rotation around the base. In either case the overall behaviour can be simulated by a cantilever with shear deformation only. For a shear cantilever with the dimensions of the element tested (shown in fig. 3) to have the experimentally measured stiffness its shear modulus should be $G=8860\text{kN/m}^2$. However, the tested panel was free at the top what would not be the real situation. This means that if the predominant deformation mode was the rotation at the top and bottom connections, the stiffness could be higher. Therefore, a value of G for the wood panels 4 times higher was also considered and both cases were analysed. The staircase was also considered to have only shear deformation. The experimentally measured stiffness was $K = 300 \text{ kN/m}$, as shown in fig. 9. The corresponding analytical value for G is 4300 kN/m^2 .
