OVERALL IMPACT OF JULY, 9 EARTHQUAKE. TEN YEARS LATER

M.A. Ferreira & C.S. Oliveira

SUMMARY

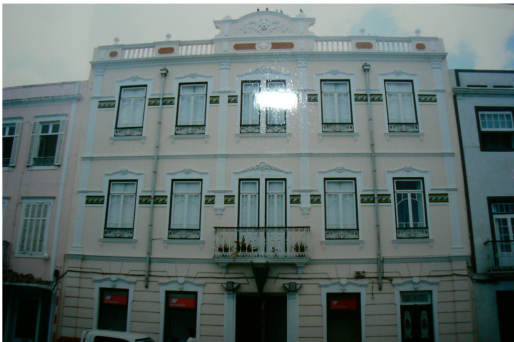
<p>Slight damage – cracks of width ≤ 1 mm.</p>

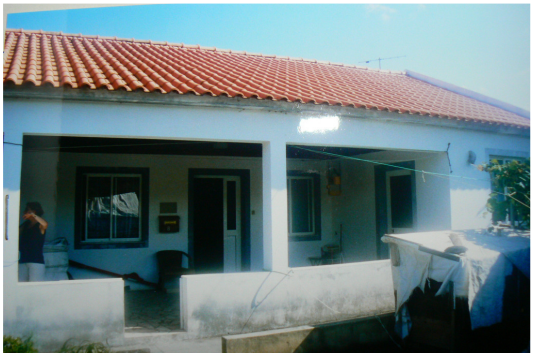
<p>Slight damage – Slight cracks (≤ 2 mm).</p>

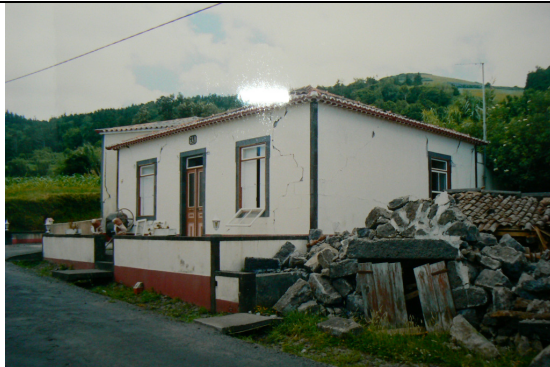
Slight structural damage. Fallen of plaster.

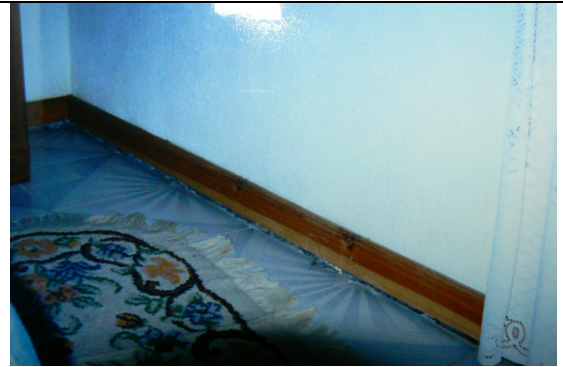
Separation between floor and wall.

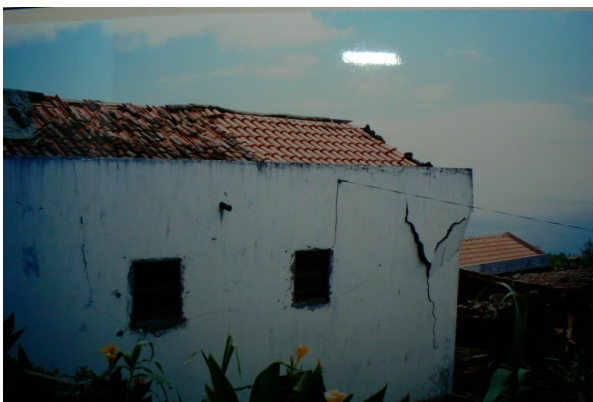
Falling of tiles. Large and extensive cracks in the exterior walls.

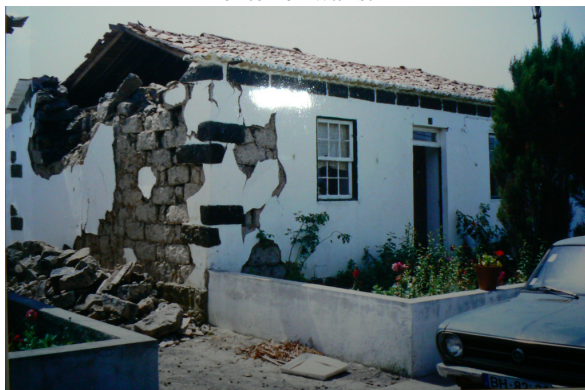
Partial failure of wall.

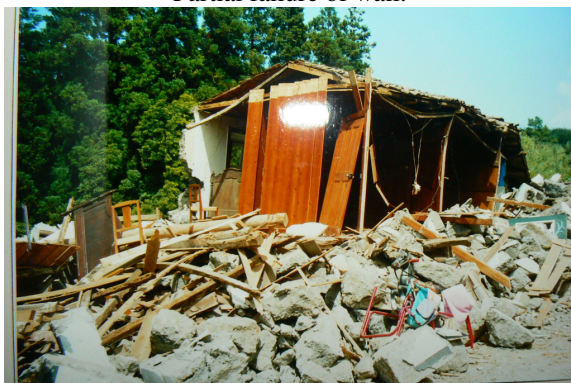
Collapse of masonry walls.
