## VULNERABILITY ASSESSMENT IN EDUCATIONAL BUILDINGS – INFERENCE OF EARTHQUAKE RISK. A METHODOLOGY BASED ON SCHOOL DAMAGE IN THE JULY 9, 1998, FAIAL EARTHQUAKE IN THE AZORES

M.A. Ferreira<sup>1</sup>, J.M. Proença<sup>2</sup> and C.S. Oliveira<sup>3</sup>

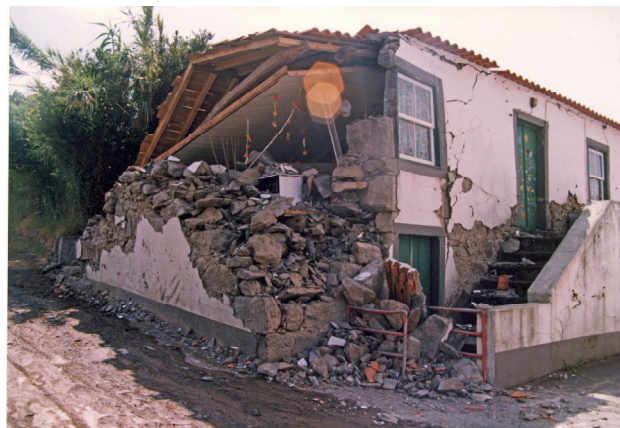
In the aftermath of the quake, a team from Instituto Superior Técnico (IST) have visited all the 21 school buildings of Faial and a quick and correct building evaluation was made for the retrieval of normal living conditions. The report (Azevedo *et al.*, 1998) shows little damage was detected in all schools, apart from the collapse of an exterior wall in a kindergarten (Figure 1) and two schools considered potentially dangerous were demolished (Espalhafatos and Ribeira Funda).

Figure 1 Salão kindergarten partial collapse. Azorean traditional construction type.
