Developing a Maintenance Plan for the Stone Sculptures and Decorative Elements in the Gardens of the National Palace of Queluz, Portugal.

A. E. Charola¹, M. Vale Anjos², J. Delgado Rodrigues² and A. Barreiro³

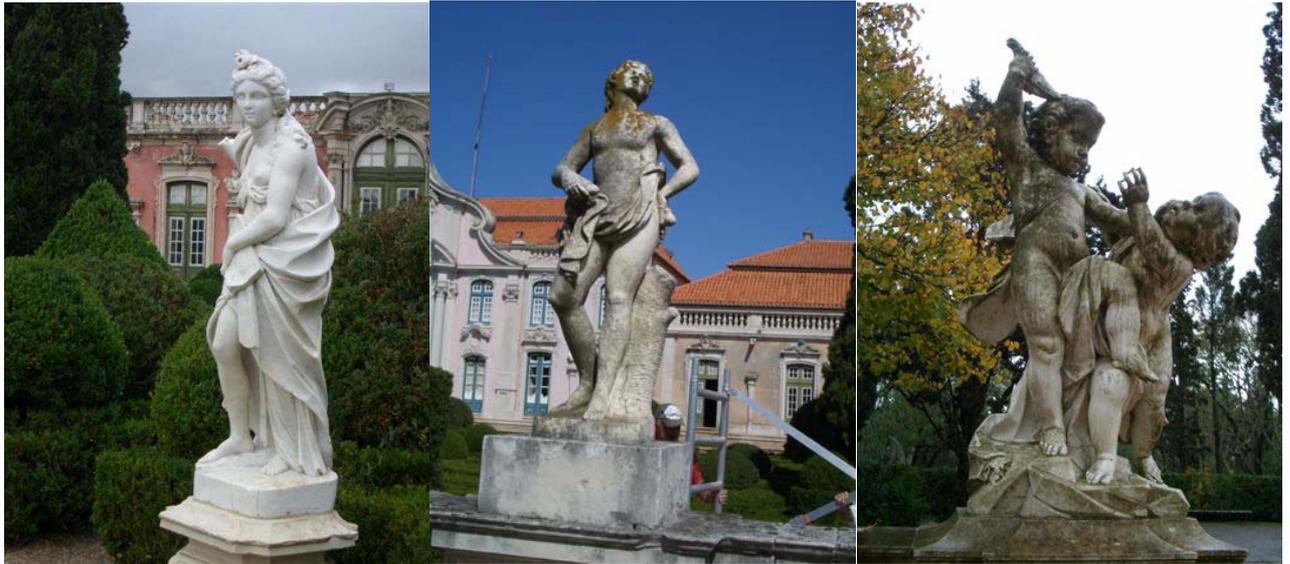
Figure 1: Three sculptures in the Garden of Malta. Left: cleaned in 2003; center: cleaned in 1999; and, right: cleaned in 1997

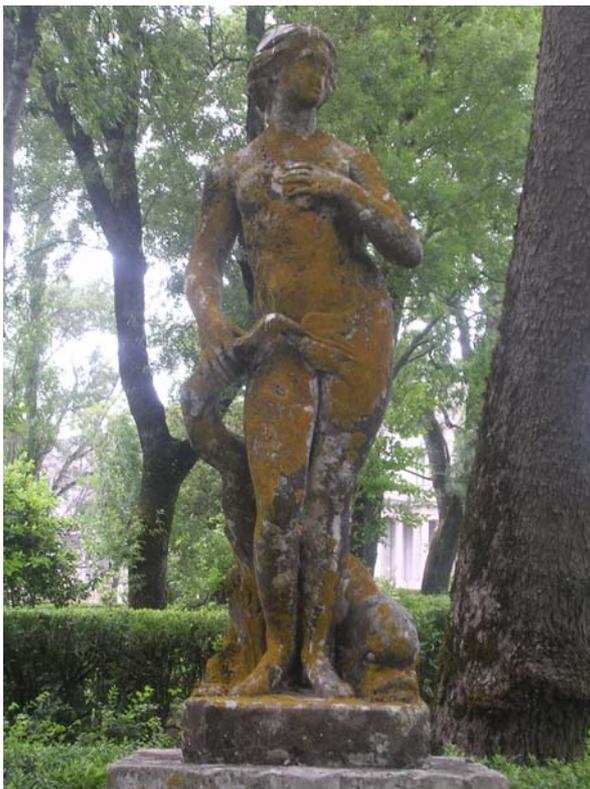
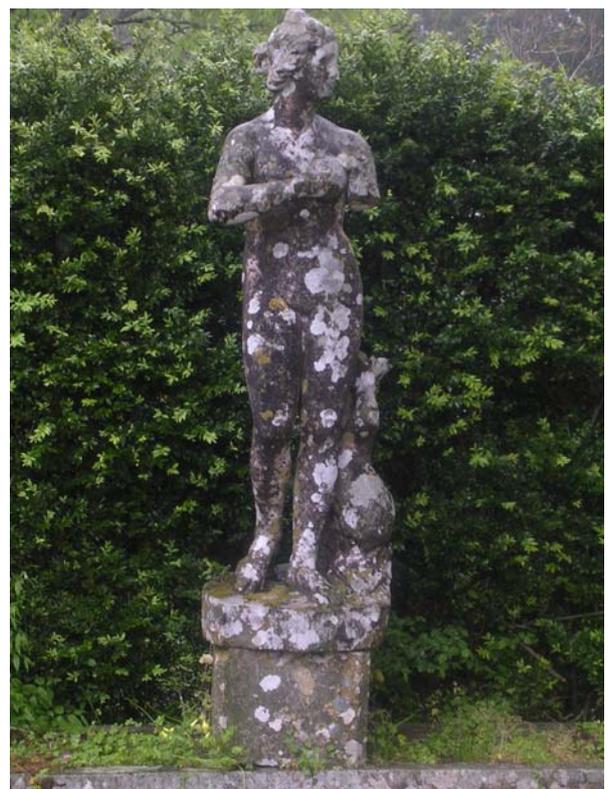
Figure 2: Two statues in the park area of the garden. Note the heavy lichen colonization that cover them totally.

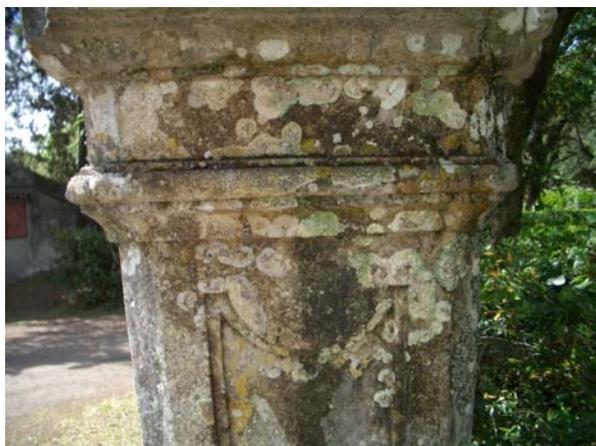
Figure 4: Detail of the area of the pedestal where the left half was treated with a 2 % Preventol solution and the right half with the 2 % zinc chloride solution. Only one application was used. The stone has been wetted for the measurements and this highlights the active biocolonization which tends to look greener when wet.

Figure 4 shows the results obtained during test applications to some pedestals in the park area of the garden.

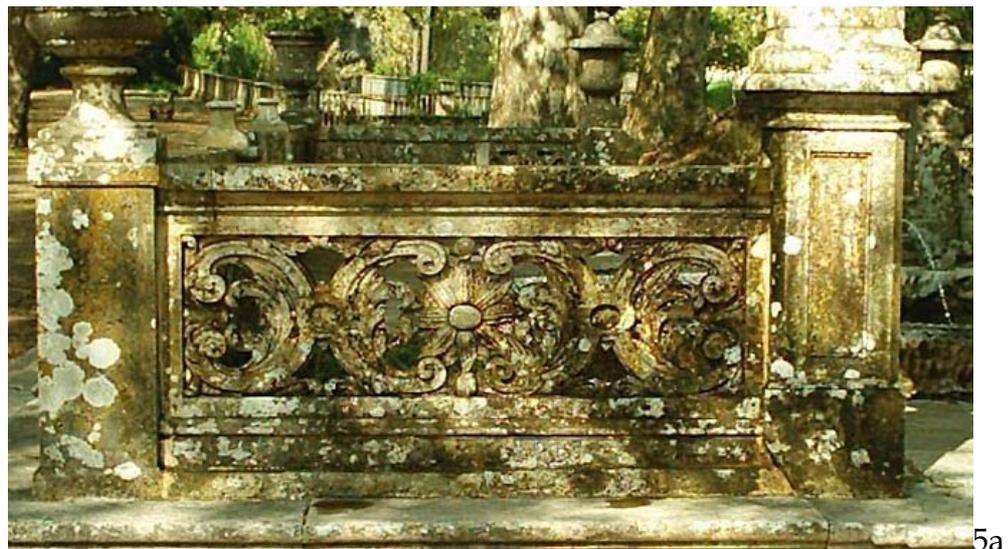
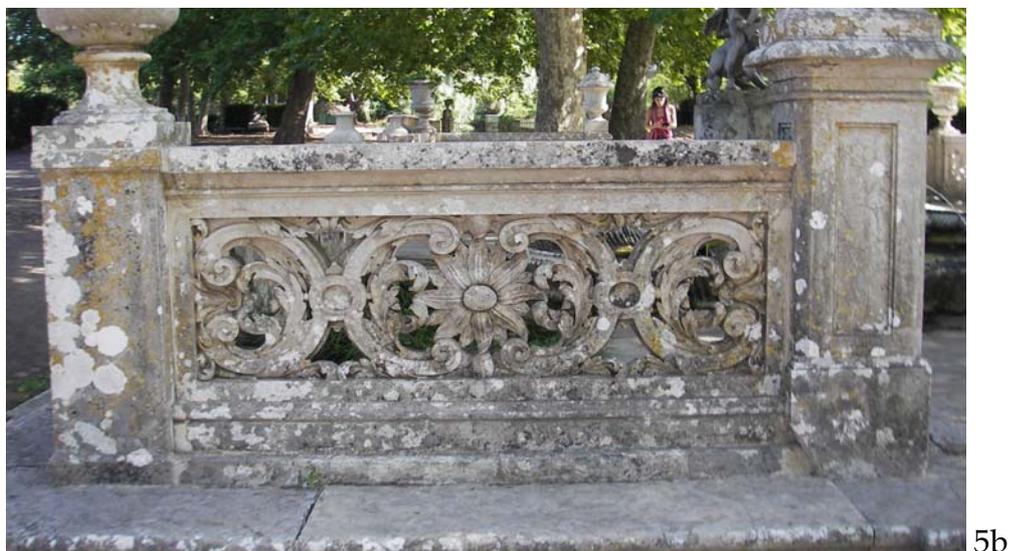
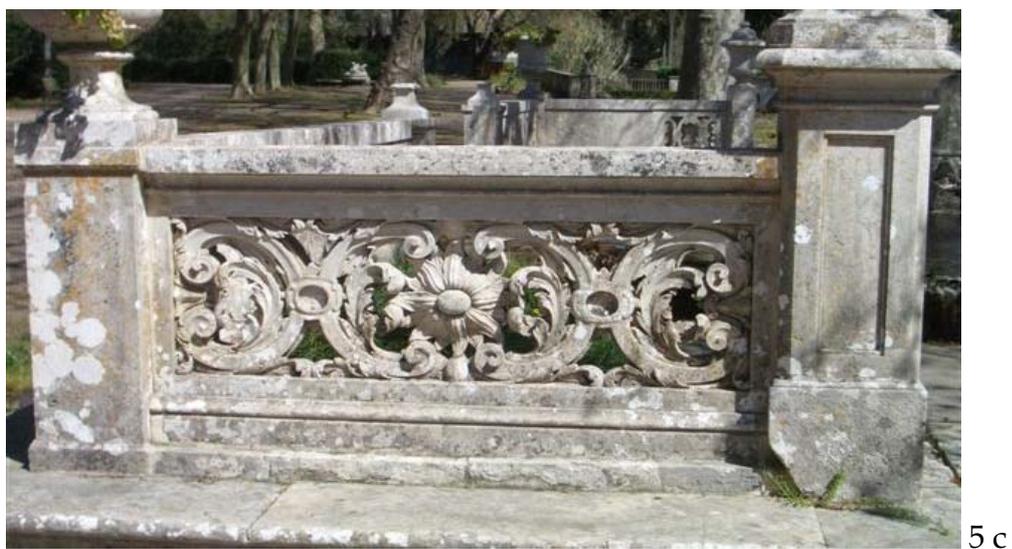
Figure 5: Section of the balustrade exemplifying the results of the applied treatments. (a) Before (spring 2006); (b) Fall 2006, five months after application of Preventol 3 % solution; (c) March 2007, six months after application of the zinc acetate solution (1 % Zn).

The results have been very promising, with no recolonization occurring to date. Even elements located in a very shady and damp areas, such as a balustrade, composed of 4 L-shaped sections, which encloses a small fountain and a lead sculpture on a pedestal, has as yet not recolonized after one year, in spite of the very rainy spring (in 2007).

This balustrade was one of the elements that was most heavily colonized by various kinds of lichens, as shown for one of its sections in Figure 5a. Hence, it was decided that rather than using the 1.5 % concentration solution of the biocide, for this special case a 3 % solution was applied in April 2006. By September 2006, when the zinc solution at the 1 % elemental zinc concentration was applied, most of the biocolonization had disappeared as shown in Figure 5b. This decreased even more in the following months as shown Figure 5c.

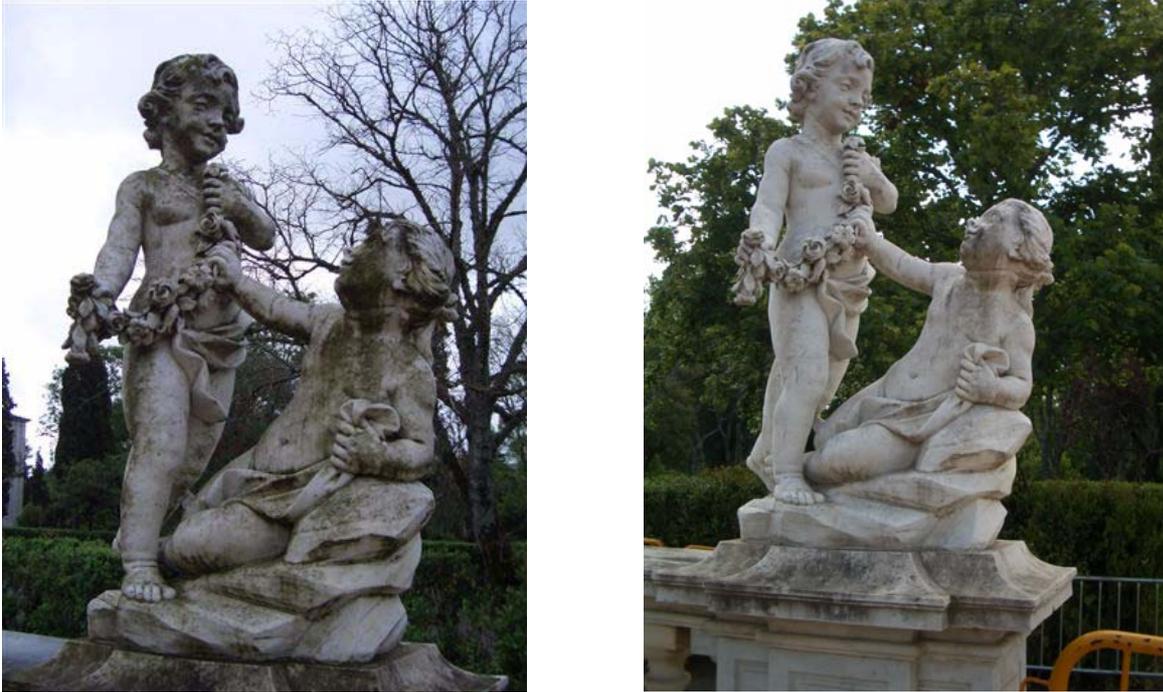
Figure 6: The putti group on the left—photographed in April 2006—was treated with the biocide in September 2006 and is shown on the right in May 2007.

Similar results were obtained for other objects. Figure 6 shows the before and after of another pair of putti. Figure 7 shows one of the balustrades where half had been treated with the biocide. At this point the second half has already been treated.

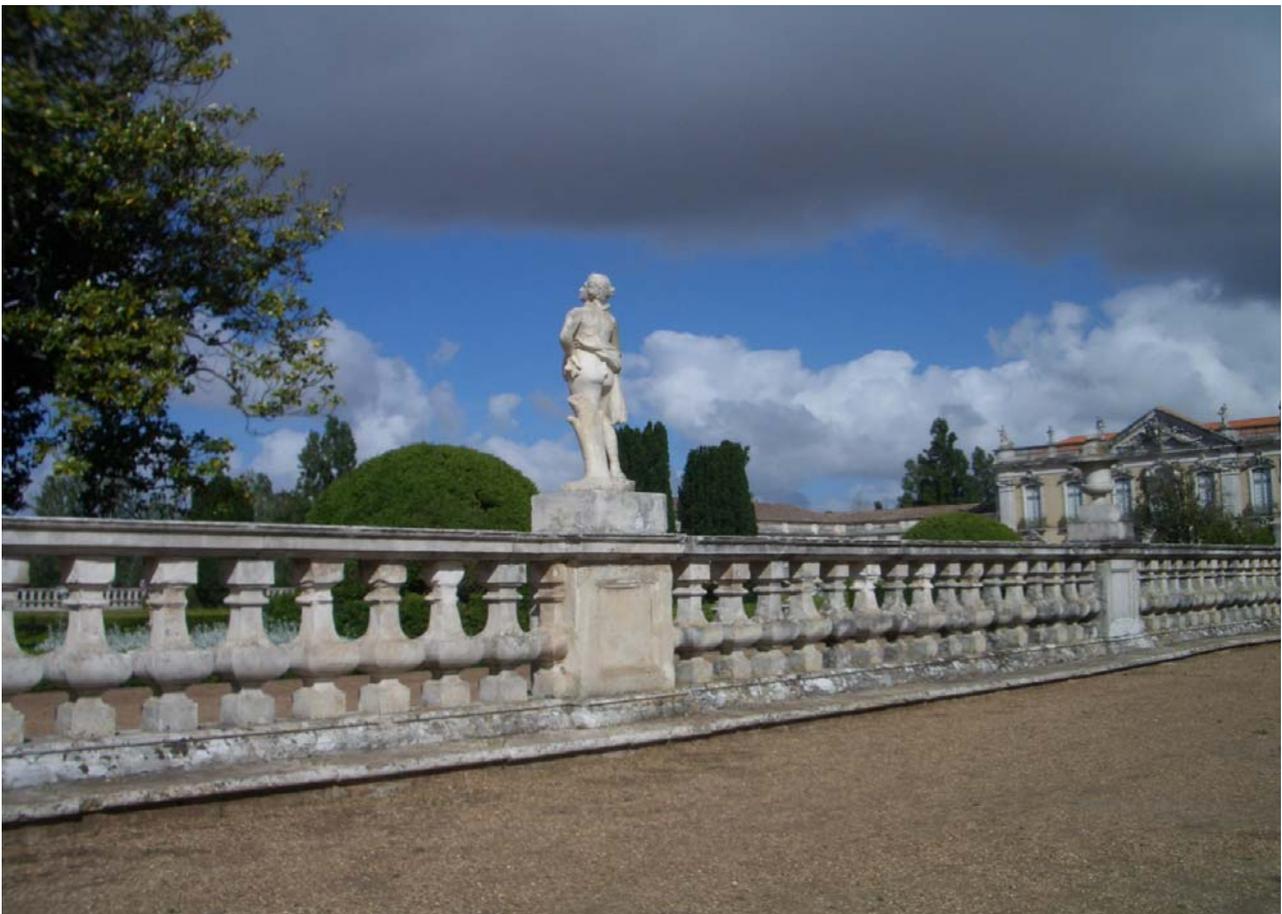
Figure 7: View of one of the balustrades in May 2007. The left side was treated in fall 2006. The cleaner appearance of the balusters on the left side is clearly noticeable in comparison to those on the right.
