Strengthening of Old Masonry Walls for out-of-Plane Seismic Loading with a CFRP Reinforced Render

J. Guerreiro¹ · J. G. Ferreira¹ · J. Proença¹ · A. Gago¹

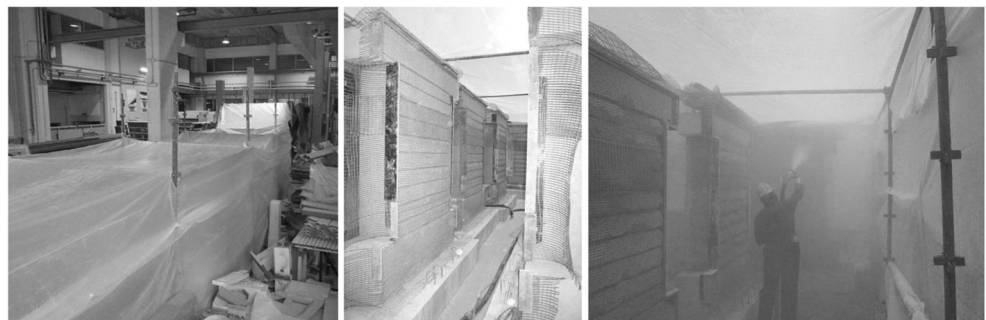
Fig. 2 Render mortar shotcrete operation

The reinforcing render can be described as a bi-component material, composed by a hydraulic but non-cementitious coating mortar and a carbon fibre reinforced polymer (CFRP) mesh. The coating mortar's function is to bond the reinforcement layer to the masonry wall, as it retains chemical, physical and mechanical compatibility with the ancient masonry. On the other hand, the CFRP mesh will provide to the reinforcement layer with the needed tensile strength. The main advantages [20] of using CFRP mesh instead of traditional steel meshes comes from its higher tensile strength, durability, ease of application, and thinner mortar layer (unlike steel meshes, CFRP mesh does not require a mortar cover to protect it from the environment).

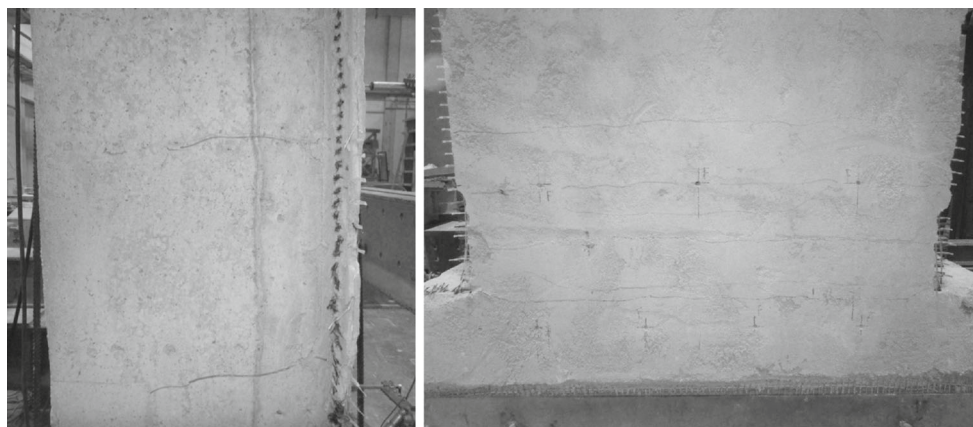
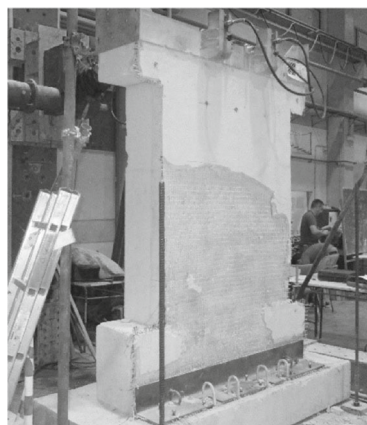
Fig. 10 Damage patterns for the tests with low axial load (100 kN)

For EPF_01 and EPF_02 strengthened specimens the collapse was caused by the ripping of the reinforced render CFRP mesh, leading to a significant decrease in the specimens bearing capacity. The damage found on the pseudo-masonry was mainly due to the bending out-of-plane mechanism, associated to the formation of several horizontal bending cracks (Fig. 10a). The lower crack (in the transition section between the wall pier and its bottom spandrel) crossed the entire width of the specimen for

For EPF_05 and EPF_06 specimens (without confinement devices) the collapse mode (damage patterns) involved the debonding between the CFRP reinforced render and the masonry. This led to the absence of some of the flexural distributed cracks, as the detachment of the reinforced render layer occurred before these cracks could develop and before the CFRP mesh rupture. Notwithstanding the separation between masonry substrate and the reinforced render layer (Fig. 10b), the reinforcement continued to provide significant bending capacity to the wall, leading to only slightly lower maximum horizontal loads and similar deformation capacity, when compared to those obtained in the specimens with confinement devices (Table 4, Fig. 11).

(a) Crack pattern (EPF_01 specimen)

(b) CFRP reinforced render detachment (EPF_06 specimen)

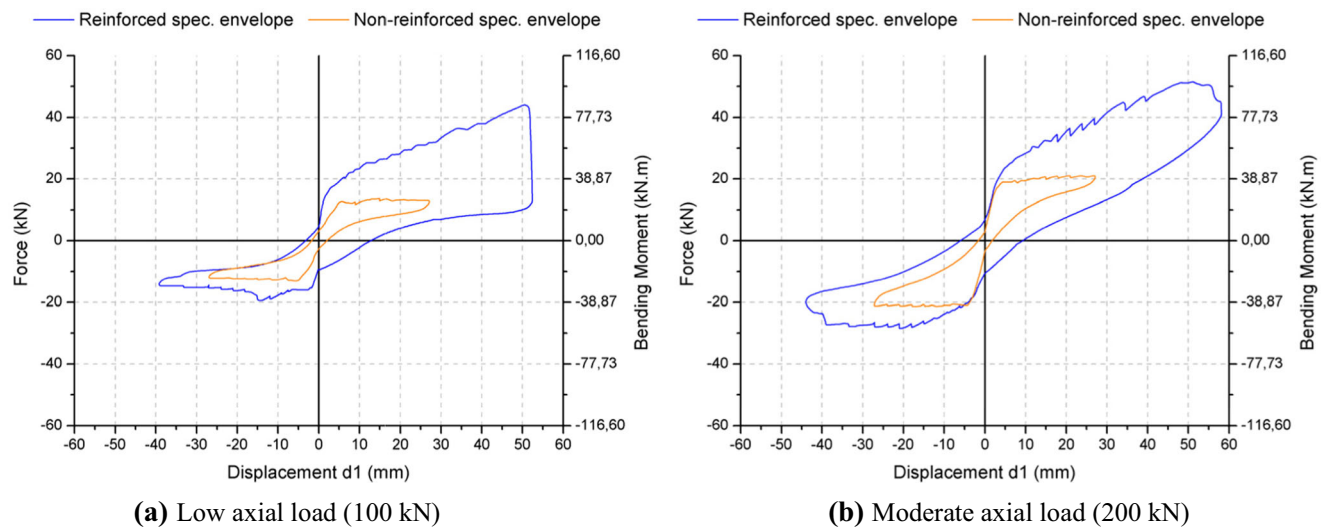
Fig. 14 Load-displacement curves envelopes

induced by the reinforcement CFRP mesh. The load-displacement diagrams enveloped by the strengthened specimens tests show wider hysteretic cycles than those

of the non-strengthened specimens (Fig. 14), especially in the later imposed displacements that these specimens could not achieve.

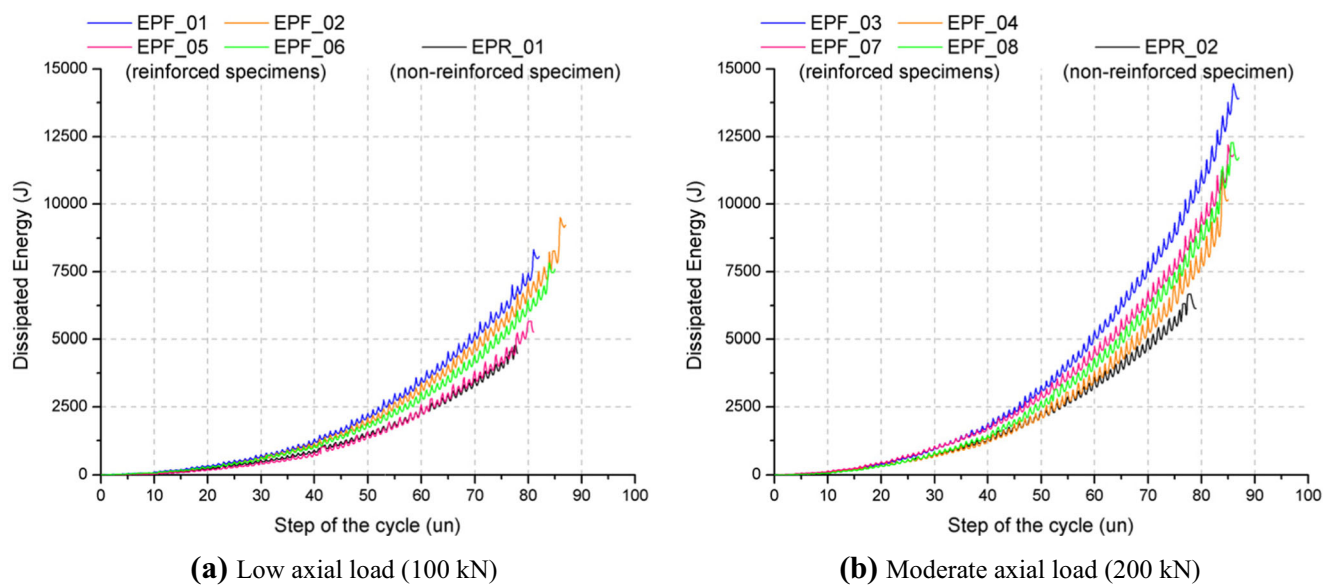
Fig. 15 Experimental dissipated energy results

Regarding the energy dissipation capacity, an important increase was also observed in the strengthened walls (Fig. 15), provided by the distributed cracking
