Strengthening of masonry wall load bearing structures with reinforced plastering mortar solution

This paper presents on the results of a sequence of experimental testing stages devised to determine the strengthening effects and to identify the most effective detailing procedures for this solution. The initial testing stage was focused on the behaviour of composite mortar-mesh specimens, subjected to tensile tests. In a later stage, a group of eight nearly full scale masonry wall models, unreinforced and reinforced with steel or fibreglass meshes, were subjected to in-plane and out-of-plane imposed displacements. The details of the implementation of this strengthening solution in a school in the Algarve are also reviewed.

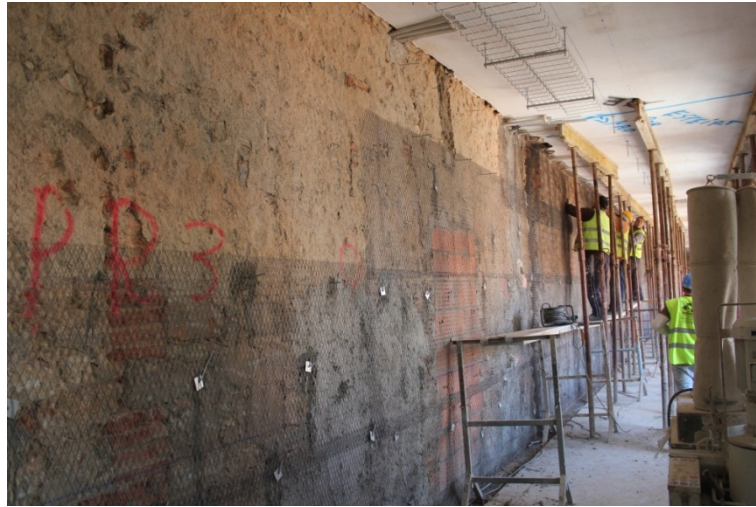
Figure 10. Steel mesh application on the site (interior leafs)

The meshes are nailed (clamped) onto existing walls by means of 6mm steel rebars and donut-shaped steel plates, arranged in quincunx pattern, and anchored with grout within these walls. The rebars are anchored with a 20° inclination or crossing through the wall in case of rubble stone masonry or brick masonry respectively. The donut-shaped steel plates were devised to ease the construction stages, particularly when tying the meshes close to the support.

A cement-based structural mortar was considered with a nominal compression strength over 10MPa, similar to the one used in the manufacture of the specimens. Figures 10 to 11 depict different stages of the strengthening works.

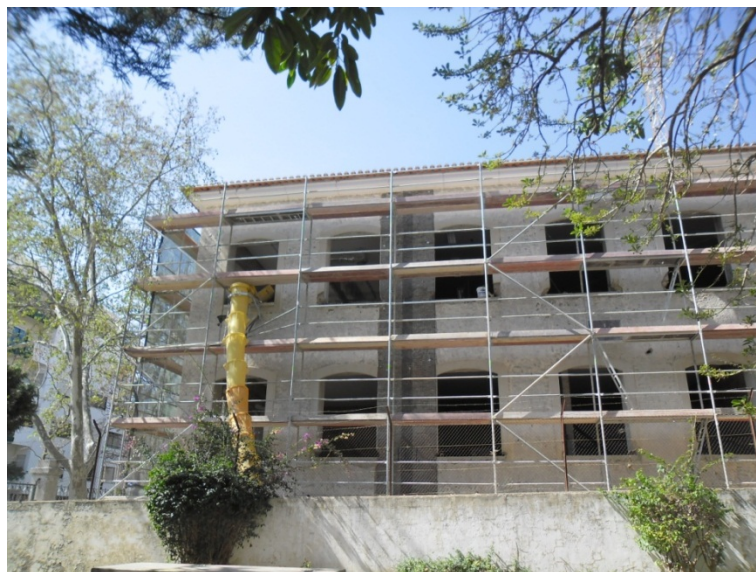
Figure 11. Fibreglass mesh application on the site (exterior leafs) – South elevation

Durability and conservation concerns dictated that fibreglass meshes (alkali-resistant) were applied in the exterior leaves (simulated in the tests by specimen GRMW), whereas galvanised expanded steel wire meshes were used on the interior leaves (replicated by specimens SRMW).
