Seismic strengthening of masonry buildings with reinforced concrete floor slabs: the schools D. João de Castro and Sá da Bandeira - Portugal

António Sousa Gago & Jorge Miguel Proença

Technical University of Lisbon - Instituto Superior Técnico (Portugal)

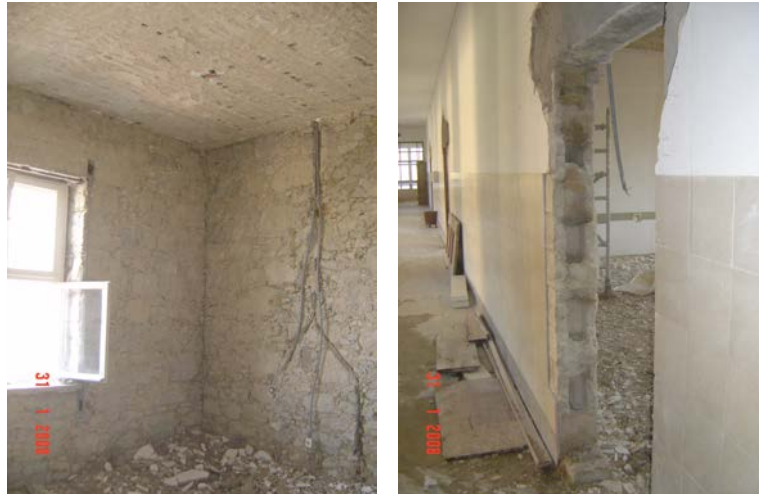
Figure 1.1 Secondary School of D. João de Castro, in Lisbon. Left: rubble stone masonry walls; Right: concrete block masonry walls

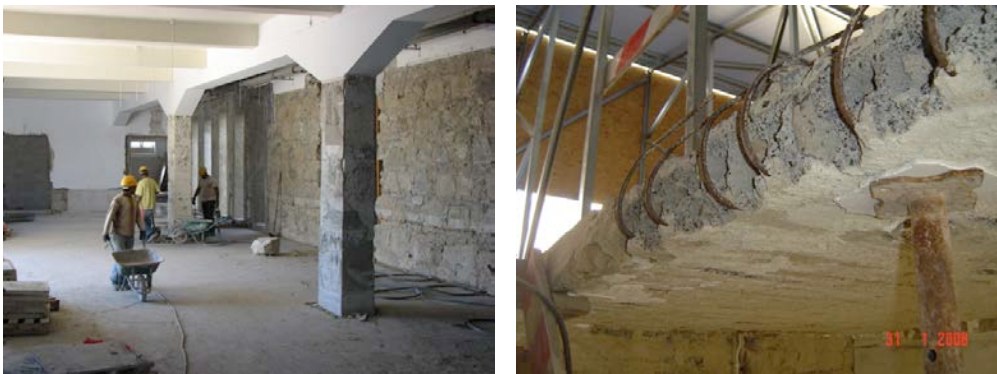
Figure 1.2 Secondary School of D. João de Castro, in Lisbon. Left: reinforced concrete column and beams; Right: Reinforced concrete slab

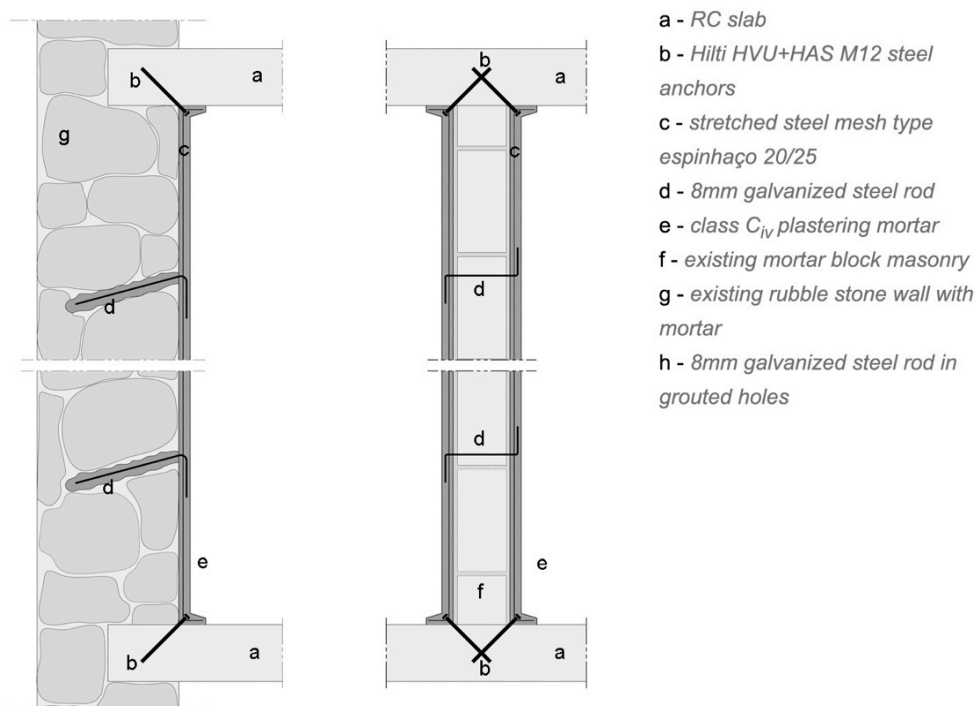
Figure 2.1 Strengthening solution for concrete block masonry walls (right) and rubble stone masonry walls (left)

The proposed strengthening solution for rubble stone and concrete block load bearing masonry walls consists of a reinforced plaster based on a mortar of controlled composition (pre-dosed), incorporating a stretched galvanised steel mesh. In the study here reported the efficiency of this traditional strengthening solution for masonry walls was greatly improved by anchoring the reinforcement steel mesh to the concrete slabs of the upper and lower floors. This solution is suitable for seismic strengthening of the buildings built at the end of the first half of the twentieth century, with a structure

based on masonry walls (rubble stone or concrete block masonry) supporting horizontal reinforced concrete elements (slabs and beams). The variant of the reinforced plaster solution herein described was developed, tested and applied in two case studies with structural characteristics representative of the buildings built at the end of the first half of the twentieth century. In those buildings the bearing structure (designed to withstand vertical loads) is composed of outer thick masonry walls on rubble stone (with thicknesses greater than 60 cm), and inner masonry walls on concrete blocks, with smaller thickness (about 30 cm). The floors are made of reinforced concrete slabs, armed predominantly in one direction, which are supported by the masonry walls. The stability of these buildings depends almost entirely of the strength and ductility of the loadbearing masonry wall. Thus, special care should be given to those structural elements in any the seismic strengthening intervention. The development and characterization of the strengthening solution herein described was undertaken with that outlook. As mentioned, the strengthening is obtained by a reinforced plaster, which is placed at one or both sides of the wall, and is connected to the wall substrate by steel staples (inner walls), which pass through the entire wall thickness, or anchored by rods (thick outer walls). Moreover, the stretched steel mesh is attached to the top and bottom concrete slabs by inclined rod. The connection to the concrete slabs increases the walls shear resistance and also benefits the diaphragm effect of the slab. The details of the strengthening solution for inner (concrete blocks) and outer (rubble stone) masonry walls are shown in Fig. 2.1

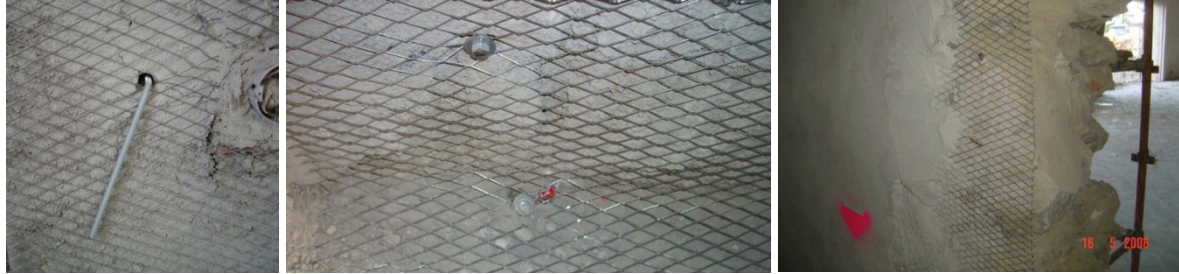
Figure 2.2 Strengthening solution – details of the mesh nailing and anchoring and of the mortar plaster

The procedure for the wall strengthening comprises the following steps: integral removing of the original rendering; placing of the galvanized stretched steel mesh; stapling and anchoring of the steel mesh to the slabs and walls; and, finally, the application of plaster mortar (in the present case it was used a pre-dosed mortar with a minimum compressive strength of 8 MPa). The different stages of the masonry walls strengthening procedure are illustrated in Figure 2.2.

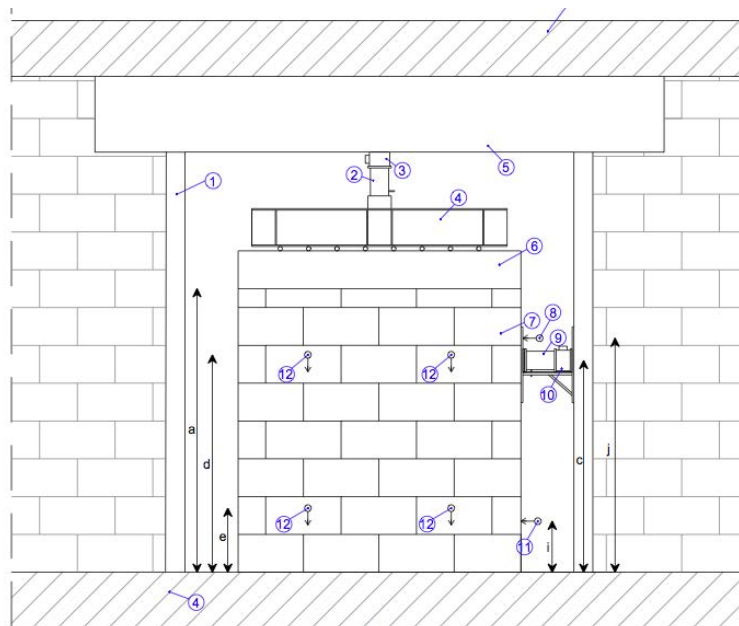
Figure 3.1 Test setup

of the walls that would be demolished in the functional rehabilitation of school buildings. The specimens were submitted to vertical and horizontal in-plane loads and were fully instrumented, with numerous displacement transducers and load cells. The corresponding experimental setup is shown in Fig. 3.1 and in Fig. 3.2. In each test was applied a vertical load corresponding to a vertical stress of 0.8 MPa, which was maintained constant during the complete test.

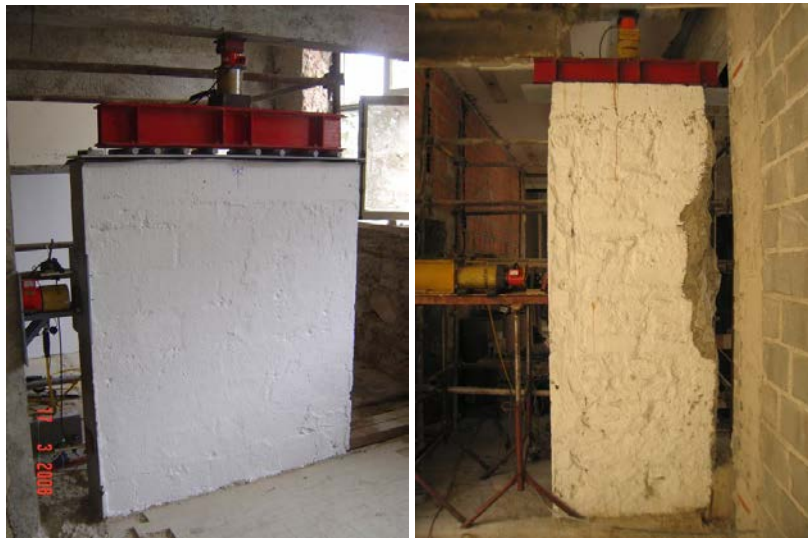
Figure 3.1 Test setup (left) and general view of a concrete block specimen (centre) and of a rubble stone specimen (right)

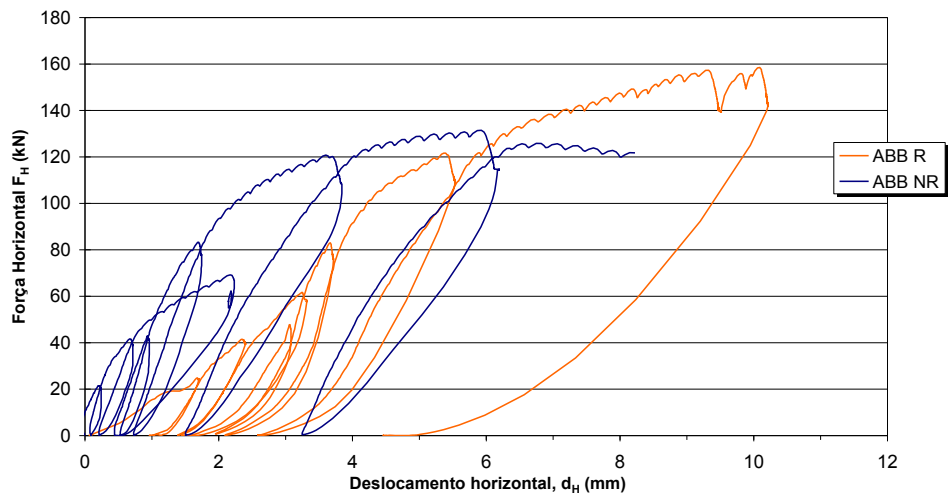
Figure 3.3 Force-Displacement diagrams for the concrete block masonry specimens – R: reinforced specimen; NR: non reinforced specimen

The applied vertical stress simulated the mean compressive stress of the masonry walls in this type of buildings. After reached the desired vertical stress level, a horizontal in-plane load was applied to the specimen. The horizontal loading was performed repeatedly, with loading and unloading branches, till the maximum strength of the specimens was reached. Table 3.1 presents the obtained values for the young modulus E in compression, as well as, the values of the maximum applied forces. It worth mention a significant increment in shear strength and shear deformation capacity of the strengthened walls, which can be identified in the “horizontal load versus horizontal displacement” diagrams (Fig. 3.3 and Fig. 3.4). The tests clearly indicate the beneficial effect of strengthening on both walls sides, which increased the in-plane resistance and reduced the damages, concentrating them at the wall base.

Specimens		A (m ²)	Maximum Vertical Force	Maximum Horizontal Force	E (GPa)
Concrete Block Masonry	non- reinforced	1.50x0.20	230 kN	132 kN	2.20
	reinforced	1.50x0.20	223 kN	158 kN	2.40
Rubble Stone Masonry	non- reinforced	1.05x0.48	415 kN	159 kN	2.00
	reinforced	0.98x0.48	505 kN	263 kN	2.30

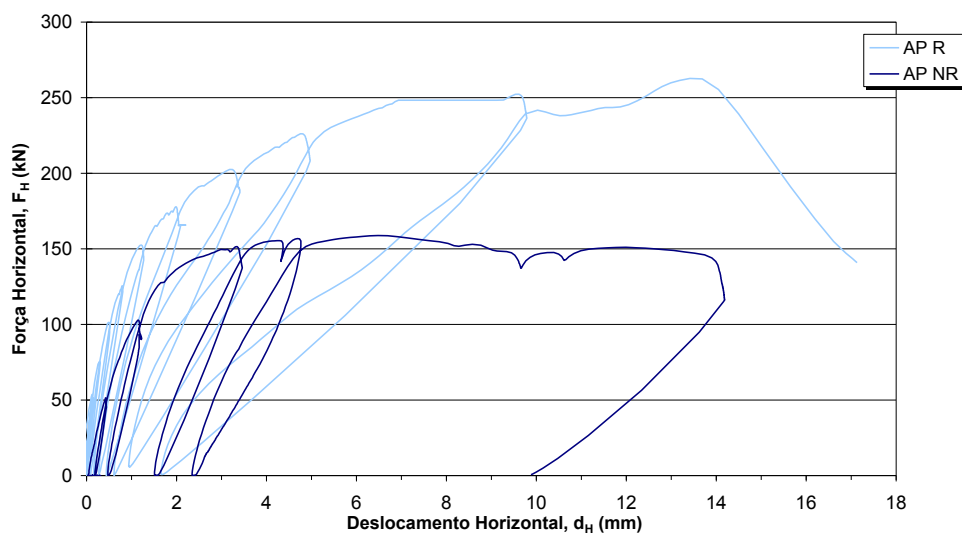
Figure 3.4 Force-Displacement diagrams for the rubble stone masonry specimens (right) – R: reinforced

specimen; NR: non reinforced specimen

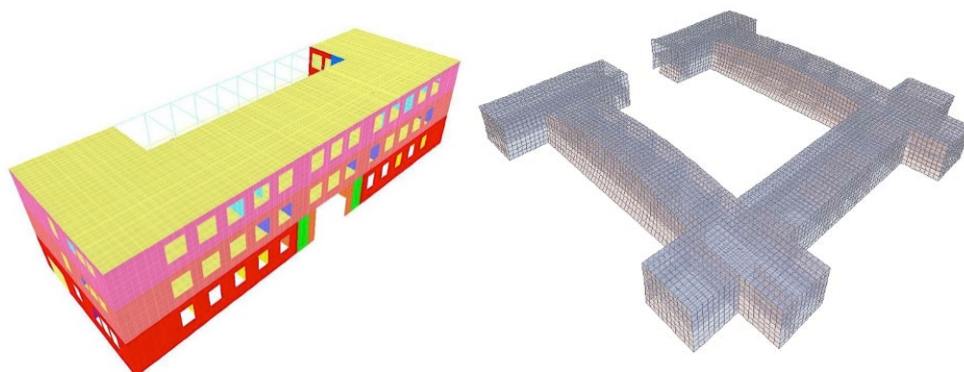
Figure 4.1 Finite Element Models – Left: D. João de Castro School; Right: Sá da Bandeira School

The promising test results led to adopt the present strengthening solution in the seismic strengthening of the loadbearing masonry walls of the Secondary Schools of D. João de Castro, in Lisbon, and Sá da Bandeira, in Santarém. It was intended to obtain by the study and by the implementation of the strengthening solution in these two case studies, experience and standardized procedures to be used in other school buildings with analogous structural systems. In both cases the strengthening of the loadbearing masonry walls was focused on the critical walls to the equilibrium of the whole building. For that, linear elastic finite elements numerical models were built (Fig. 4.1), which helped to identify the more stressed walls in the case of a seismic event. In the finite element models the masonry walls and the reinforced concrete slabs were simulated by four nodes shell elements, with membrane and flexural behaviour. The membrane behaviour was adopted on the slab shell elements to simulate the diaphragm effect of the pavements. The beams and the (rare) columns were simulated by beam elements. A linear elastic behaviour was assumed for all elements and the mechanic characteristics were obtained by calibration of the numerical dynamic characteristics. The numerical fundamental modes of vibration and respectively frequencies (Fig. 4.2) were calibrated with the experimental results, which led to a 2.0 GPa Young modulus for rubble stone masonry and concrete block masonry elements, in the case of the D. João de Castro Scholl; and to a 2.5 GPa Young modulus, also for both types of masonry, in the case of the Sá da Bandeira Scholl. For concrete elements a 29 GPa Young modulus was adopted in both cases. In the seismic analysis a behaviour factor of 1.5 was adopted. To model the unidirectional behavior of the reinforced concrete slabs, the correspondent plate shell elements were defined with different bending stiffness in the two horizontal directions. For the seismic action, the two kinds of earthquakes specified by the Portuguese code [2] were considered. The respective response spectra used were quantified for a damping coefficient of 5%.

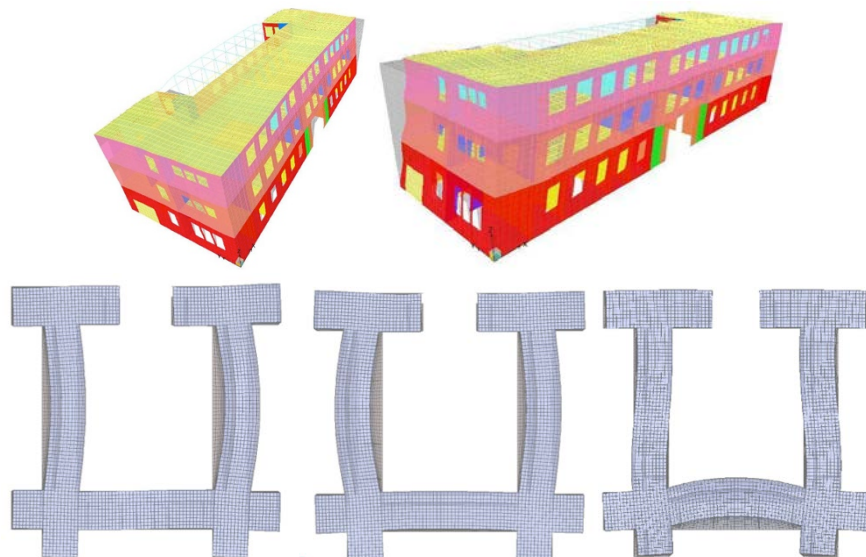
Figure 4.2 Numerical Models –modes of vibration: D. João de Castro School (TOP) 1st mode (4.9Hz) and 2nd mode (5.6 Hz); Sá da Bandeira School (BOTTOM) 1st mode (8.3 Hz), 2nd mode (8.4 Hz) and 5th mode (10.7 Hz)

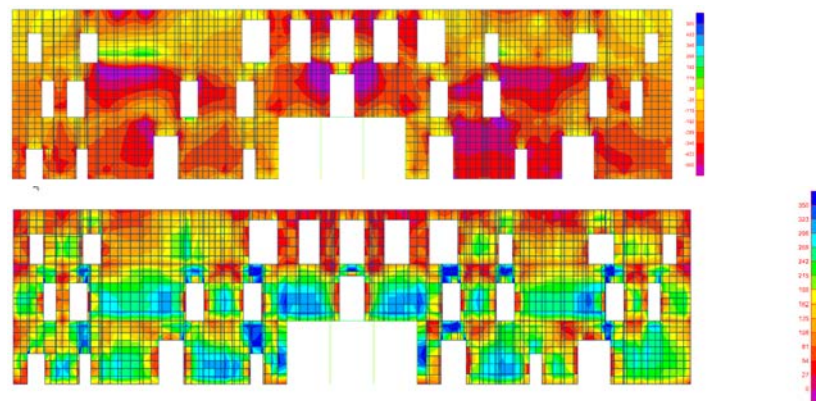
Figure 4.3 D. João de Castro School - Numerical Model: vertical stresses due to dead loads (TOP) and shear stress due to the seismic load (BOTTOM) on the main façade

The numerical models were used to evaluate the vertical stresses on the masonry walls due to dead loads and the shear stresses on the masonry walls due to the earthquake loading (Fig. 4.3). The numerical results for the earthquake loading (defined in accordance with the Portuguese code) were

analysed through a global and a local perspective. In the global point of view, the resultant horizontal seismic force, in both directions, was divided by the walls total cross-sectional area, in the direction under analysis, which was compared to the mean shear stress strength, evaluated from the dead load vertical stress (obtained dividing the vertical resultant by the walls total cross-sectional area) by a Mohr-Coulomb criterion. For the Mohr-Coulomb criterion and for both types of masonry walls, a characteristic value of 0.50 was assumed for the friction coefficient. For the cohesion and also for the both types of masonry walls, the characteristic values adopted for unreinforced and reinforced walls were, respectively, 0.02 MPa and 0.25 MPa.

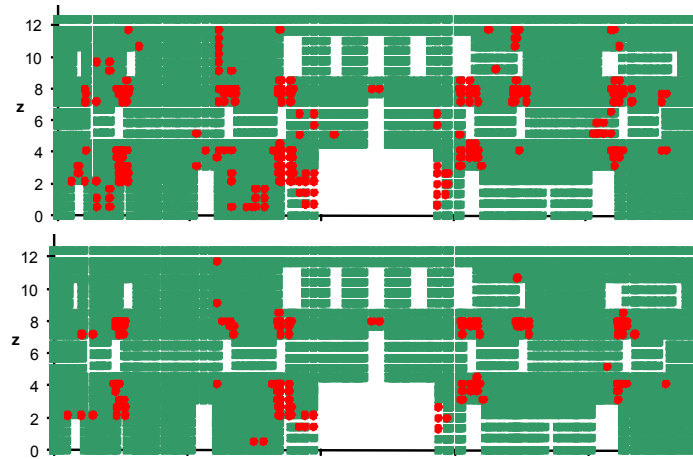
Figure 4.4 D. João de Castro School - Numerical Model: diagram indicating the points where the seismic shear stress exceeds (in red) or not (green) shear strength (TOP: unreinforced wall; BOTTOM: reinforced wall).

The global analysis of the D. João de Castro and Sá da Bandeira Schools showed that in the absence of the strengthening the buildings presented, globally, enough strength to support the seismic load. However, the local analysis, where the seismic shear stress and the shear strength are compared in each integration point, led to the conclusion that the strengthening must be done to avoid the extensive local collapses. Fig.4.4 shows the results of the analysis performed in one of the loadbearing walls, where two possibilities were studied: with or without strengthening. As it can be seen in Fig. 4.4 with the strengthening (which was incorporated in the numerical study by a bigger cohesion) the situations of local collapse declined significantly and are located on areas of reduced axial forces (e.g. beneath the windows and on top of the roof). Thus, if in both buildings the longitudinal inner and outer walls, which support the floor slabs, and some transversal walls are reinforced, the structural integrity of the buildings will not be compromised during an earthquake. However, some local damages can occur.
