Out-of-plane flexural behaviour of masonry walls reinforced with UHPPI

ABSTRACT: Ultra-High Performance Plaster (UHPPI) is an innovative seismic strengthening solution for load bearing masonry wall structures. This solution consists of a lime based plastering mortar, reinforced with a carbon fibre mesh, applied on one (internal or external) or both wall faces. The reinforcing mesh is tied by an evenly spaced grid of connectors, going through the wall thickness, acting also as confinement devices.

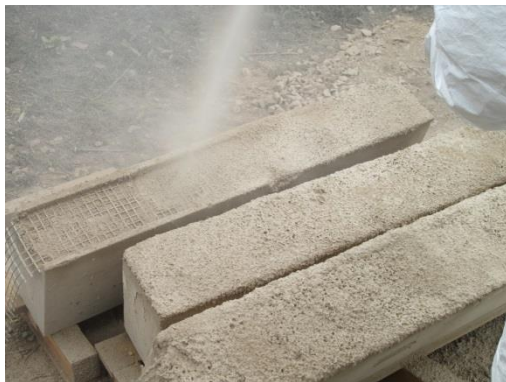
Figure 2. Reinforcement application

For the final stage of the pull-out tests (Phase 3) a mesh with 200 g of carbon per square meter of reinforcement strip was used, the strongest of the two commercial solutions available. Application of the reinforcement mortar was made raising it proud of the surface to enhance the adhesion between the pseudo-masonry beam and the UHPPI strip (Figure 2). Further, to ensure better adhesion between pseudo-masonry and reinforcement strip a set of 2 steel anchors were used. Such connectors were tensioned before the test, with a controlled gripping force of 40 N.m (Figure 3):

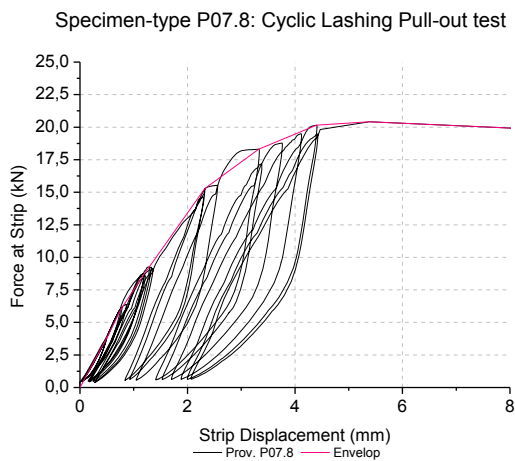
Figure 4. P07.8 cyclic test

Figure 4 and Figure 5 present the results for the Phase 3 tests (specimen's P07.7 to P07.9):

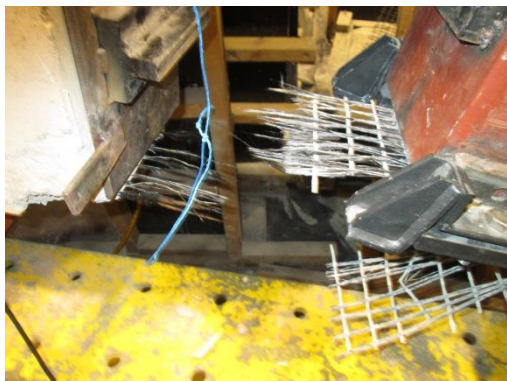
Figure 6. Failure mode

The failure mode of the Phase 3 stage was tensile collapse of the CFRP mesh (for all specimens). Visible damage were observed at the end of the interface between the UHPPI strip and the pseudo-masonry beam, showing that the mortar part of the reinforcement strip is also involved (Figure 6 and 7). Between the steel connectors and up to the other end of the active block no damage was observed to the UHPPI strip:

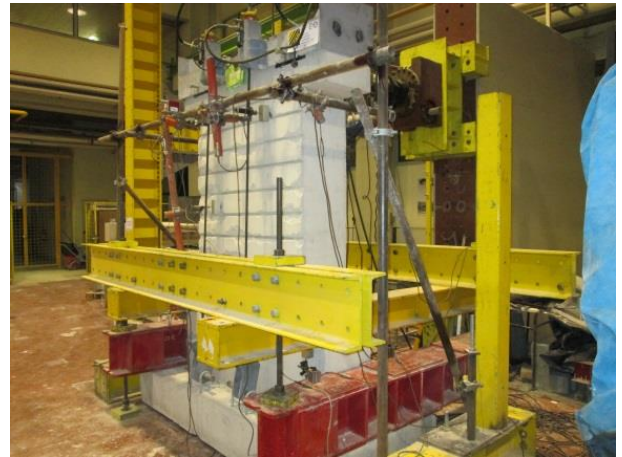
Figure 8. Out-of plane flexural test scheme

Out-of plane cyclic flexural tests (Figure 8) are one of the main experimental methods to characterize the retrofitting technique's structural characteristics:

Horizontal load/displacement was applied at the top of the specimen, by a mechanical actuator attached to a steel casing bearing on the top of the wall. Vertical axial load was kept stable during all the horizontal force application, which represents the state of axial load of a structural wall during a seismic event. Hence the vertical load system was made independent of the support at the base of the specimens, and applied directly to the wall (at its top and base). A horizontal steel frame was introduced at the lower part of the wall to prevent “rocking” or “sliding” rigid body movements, as no

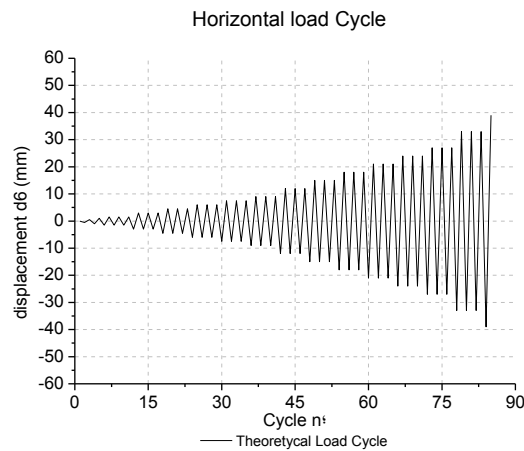
Figure 9. Load Cycle

specific measures to constrain the wall at its base were considered. Horizontal Load cycles (Figure 9) were established according the main principles of the 2005.ASTM E.2126-05 standard:

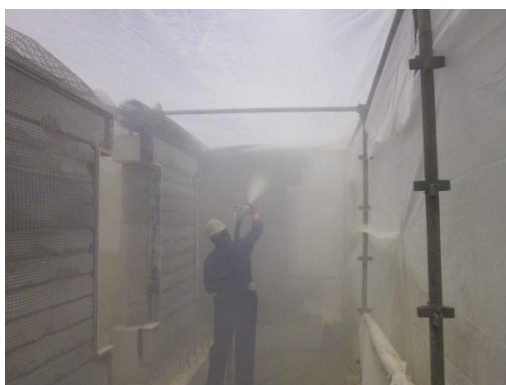
Figure 10. Reinforcement application

Another critical issue to an effective contribution of the reinforcement was its connection to the wall base. The results from cyclic pull-off tests indicated that the preferable solution to assure a proper anchorage of the UHPPI material to the specimen base was to use an organic (epoxy resin) solution, similar to the one used in the pull-off tests. Once it wasn't determined that bonding conditions at the wall ending did not affect the experimental results, this solution proved to be extremely reliable. It was also decided to only proceed with the bonding of the UHPPI after the axial load level desired was applied to simulate the fact that reinforcement is applied to the wall under normal serviceability conditions of the building (Figure 10).

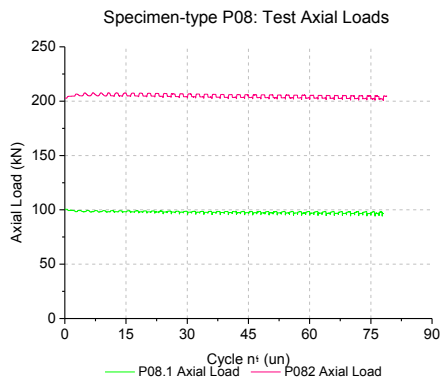
Figure 12. Reference Test Axial Loads

Near constant vertical axial load was applied (Figure 12), and the energy dissipated by each wall during the test is presented in Figure 13:

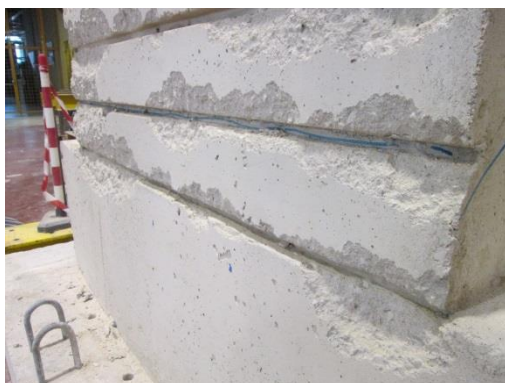
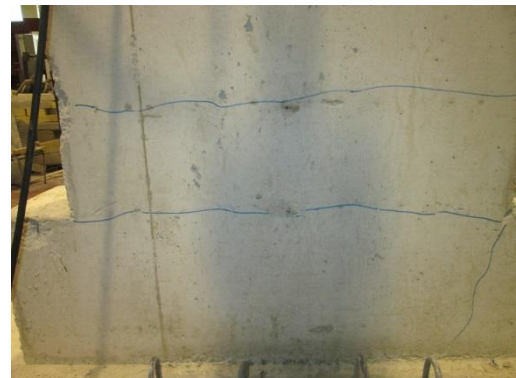
Crack damage was observed at the sides of the tested walls, with horizontal fissures at the base of the pseudo-masonry pier (reduced cross section) (figures 16 and 17).

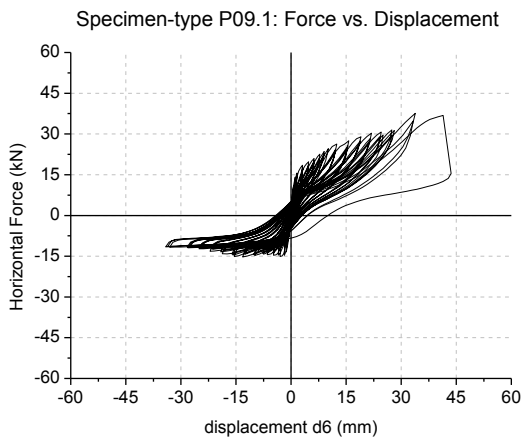
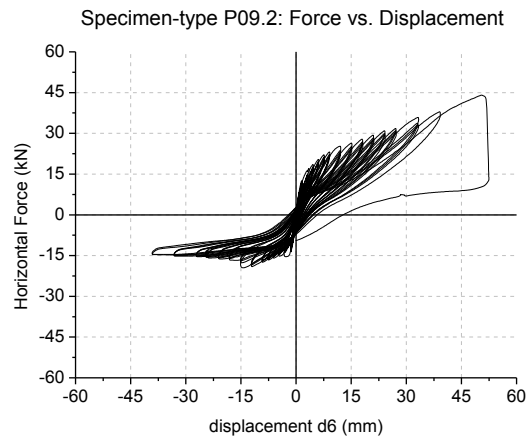
For the experimental tests of walls with installed steel connectors (P09.1 and P09.2) (Figure 22), the horizontal force vs. displacement diagrams are shown in Figures 20 and 21. The diagrams are asymmetric (regarding the displacement axis), as a consequence of applying the reinforcement only to one face of the walls. The wall's resistance to out-of-plane movements was greatly enhanced, when the reinforcement was subjected to tensile stresses. When load was applied from the other side resistance was only marginally increased when compared with the Reference Test with the same axial load.

The behaviour of the wall, when the reinforcement was subjected to tension, was also significantly modified, emphasizing the fact that much larger ultimate displacements were reached, thus representing a significant increase in ductility.

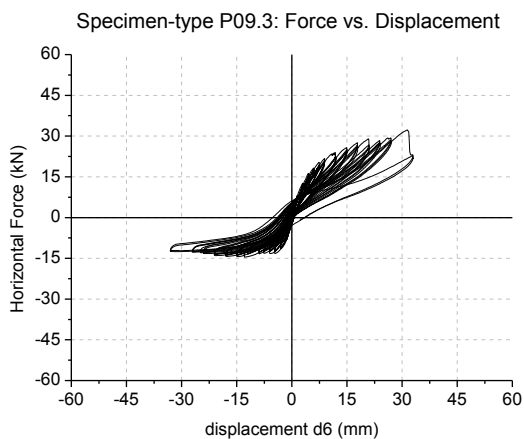
For the experimental tests of walls without installed steel connectors (P09.3 and P09.4) (Figure 26), the horizontal force vs. displacement diagrams are shown in Figure 24 and 25. The diagrams are similar to the ones concerning P09.1 and P09.2, although the wall's resistance was slightly decreased, when the reinforcement was subjected to tensile stresses.

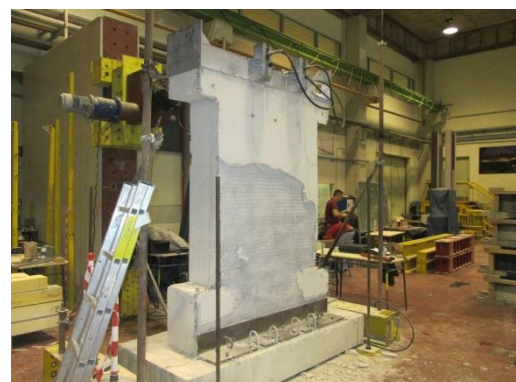
Figure 27. P09.4 damage

The damage, cracks and fissures were very similar to those observed in walls P09.1 and P09.2. With respect to its reinforcement, although the CFRP mesh had not fractures, it was observed to be detached where it had been mortared in (Figure 27).

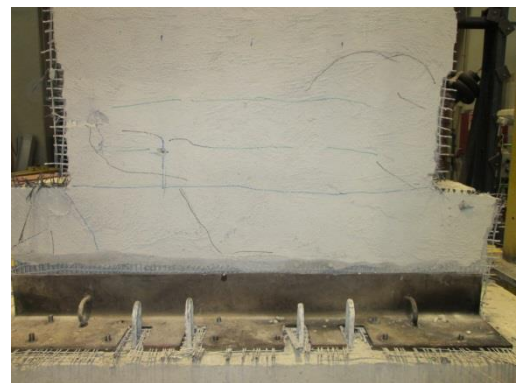
Figure 37. P10.4 damage

Damage, cracks and fissures were again very similar to the ones observed in walls P10.1 and P10.2. The CFRP mesh had fractured, and there was some detachment of UHPPI mortar, but not as significantly as for the tests with low axial force without steel connectors (Figure 37).
