Seismic evaluation of old masonry buildings. Part I: Method description and application to a case-study

Rafaela Cardoso*, Mário Lopes, Rita Bento

DECivil, Instituto Superior Técnico, Av Rovisco Pais, 1, 1049-001 Lisbon, Portugal

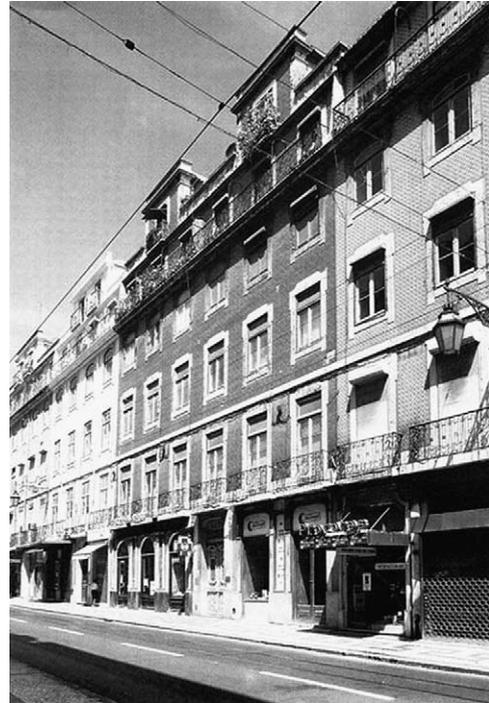
Fig. 2. 'Pombalino' building from Lisbon Downtown [3] (Prata Street, 210 to 220).

'Pombalino' buildings, as shown in Figs. 1 and 2, are old masonry buildings that can be identified by the presence of a three-dimensional timber structure named 'gaiola pombalina' enclosed in interior masonry walls above the first floor. The other interior walls (partition walls) are wooden panels without structural functions. Façades are made of masonry columns and beams without the 'gaiola' structure. The doors and windows define the geometry of the façade masonry structural elements. Roofs are made with timber truss and ceramic tiles and may include window openings. Floors are wood slabs and should be considered as flexible diaphragms. Ground floor interior walls are masonry walls supporting a system of vaults made of blocks of ceramic masonry and stone arches. Foundations include short and small diameter woodpiles connected by a wood grid (Fig. 1).

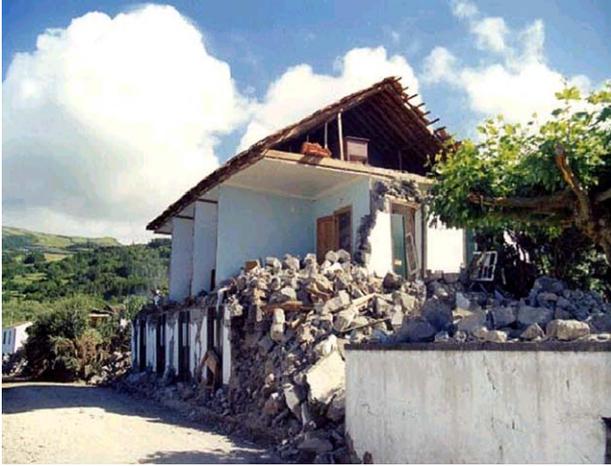
Fig. 4. Fall out-of-plane of the exterior walls without complete collapse (1998 Azores earthquake).

In the following steps of analysis higher levels of damage associated to the out-of-plane displacements of the front façade were obtained without increasing the value of γ_{sis} . The collapse mechanism was reached after three steps of calculation. As all γ_{sis} values were equal to 0.25, the collapse of the structure is sequential, as described in Section 4.3. This type of mechanism was observed in small buildings during the 1998 Azores earthquake, as shown in Fig. 4.
