Infrastructures and Geotechnics

Risk management applied to cultural heritage buildings. The effect of soil settlements and vibrations induced by underground structures.

Georgios Karanikoloudis

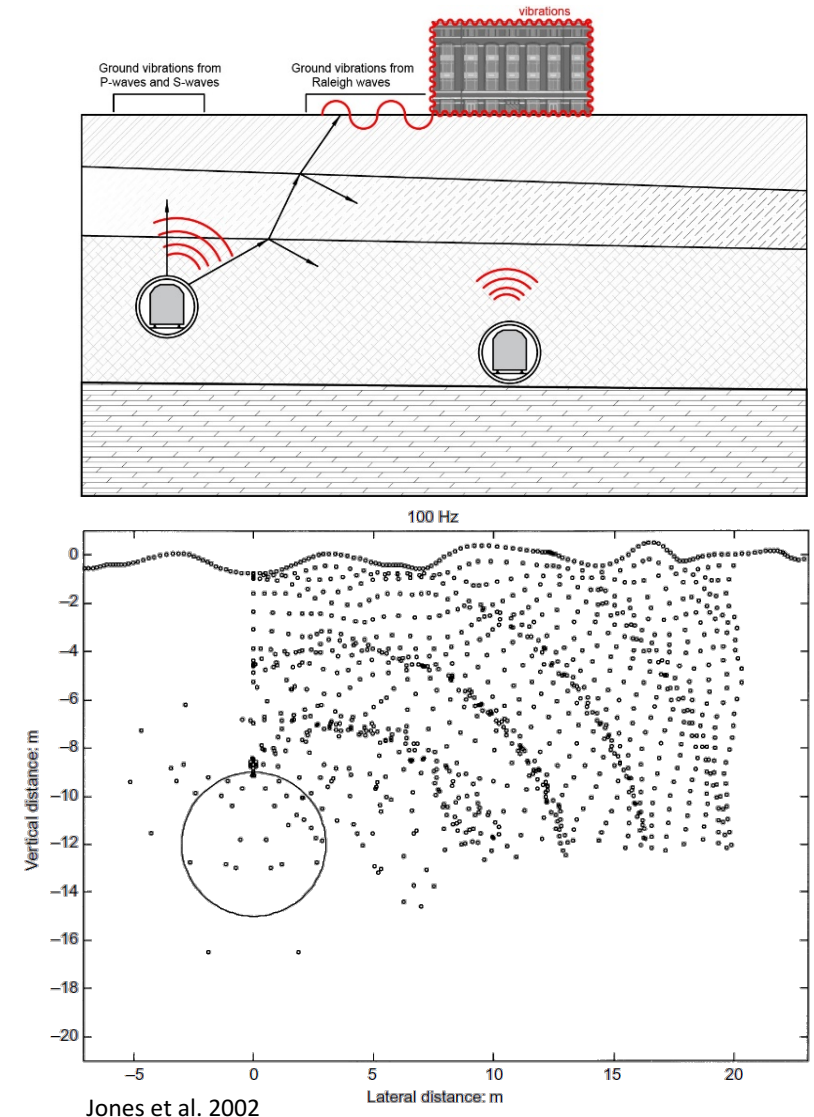
- Wave propagation in the elastic half-space

P-wave, S-waves, Rayleigh waves

- Quasi-static, dynamic axle loads
Unevenness of wheels and track lines
- High frequency content 30-250 Hz
- The type of building: dimensions, structural system and material properties
- The level of exposure: duration, amplitude, number of cycles
- Soil type: energy content in different frequency range

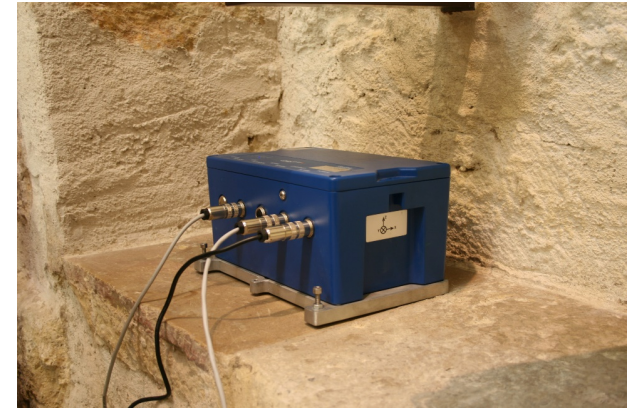
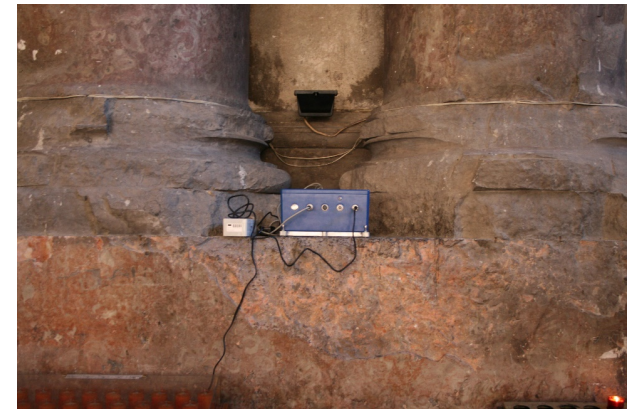
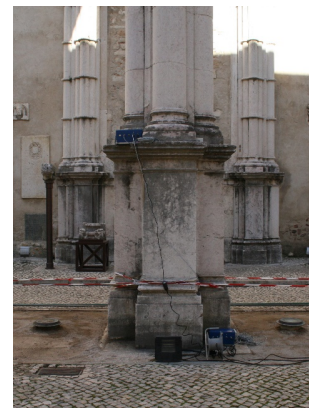
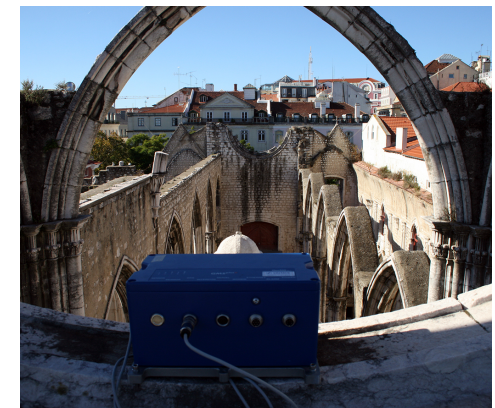
- ❑ Monitoring of metro induced vibrations during operational time in cultural heritage buildings
3 reference case studies in Lisbon
- ❑ Passing trains at regular intervals of 5-7 min
- ❑ Assessment through different national standards • use of kinetic quantities
- ❑ Expected high energy content at frequencies from 30 to 250 Hz
- ❑ Triaxial seismographs with GPS time base • continuous time intervals during night time and early morning (13^h)
- ❑ Dynamic identification tests
Overall structural performance

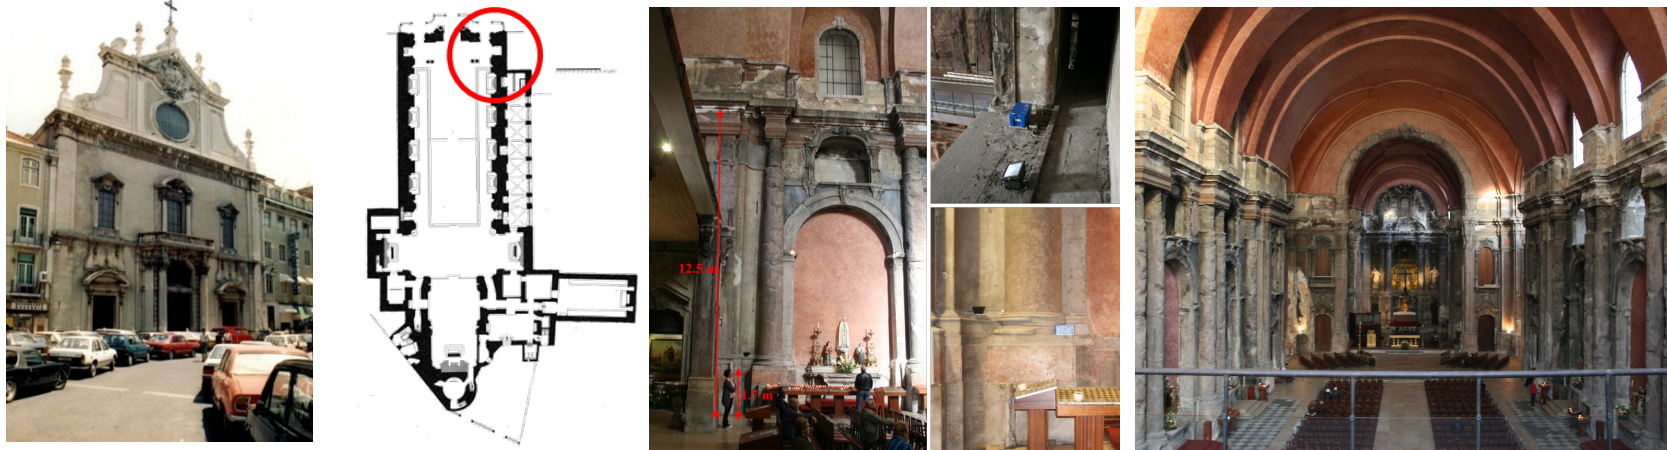
Church of São Domingos, Lisbon: Baroque architecture (13th c.). Severely damaged by fire in 1959. **Metro line in close proximity to west facade.**

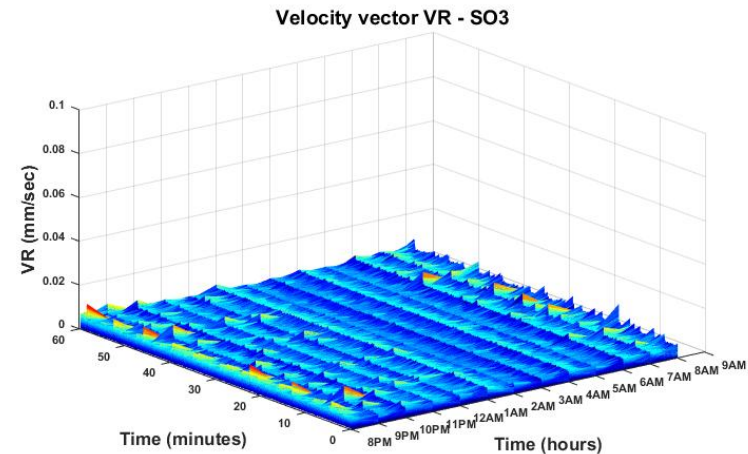
Carmo Convent, Lisbon: Monitoring points at the base and in elevation. Velocities in the range of 0.012 mm/s.

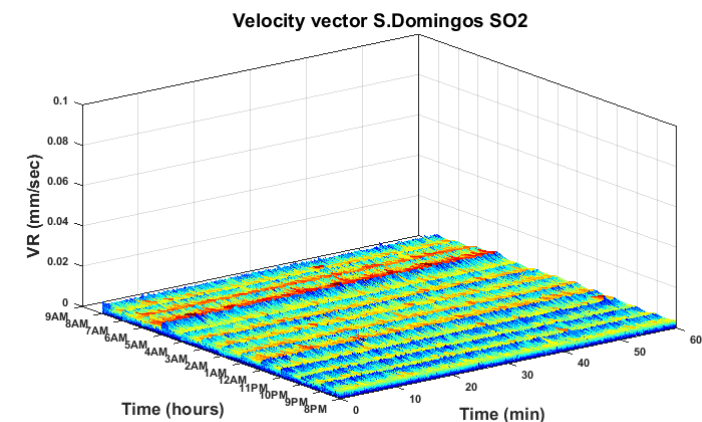
Church of São Domingos, Lisbon: Measurements close to the base of stone masonry pillars. Max velocity vectors: 0.005-0.008 mm/s.

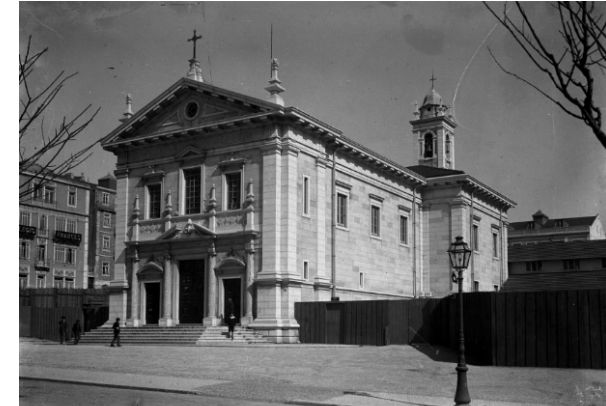
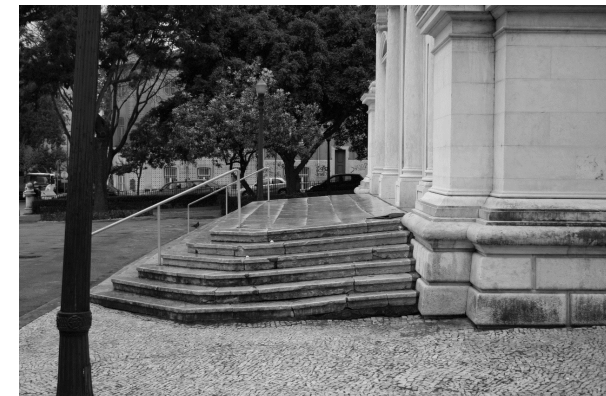
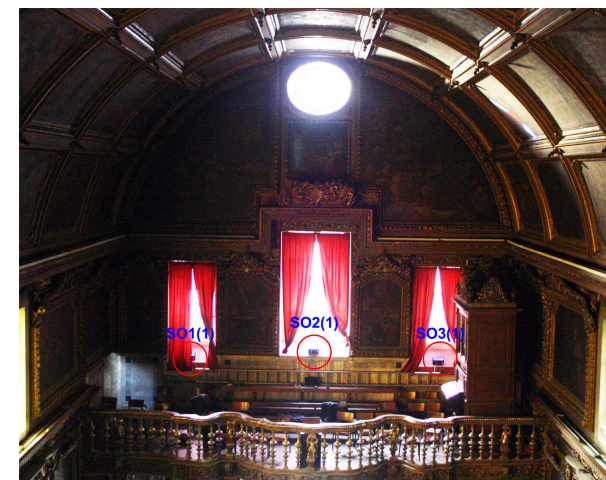
- ❑ Baroque and neoclassical style. Constructed in 1910 as a replica of a former demolished church
- ❑ Barrel vault with baroque gilded carvings
- ❑ Evident settlements in the front part
- ❑ Monitoring points at the base and at intermediate heights in the front façade
- ❑ Amplification during metro operation
- ❑ Higher energy content x-x and z-z frequency range 50-85 Hz
- ❑ Maximum vector of velocities in the range of 0.02 mm/sec

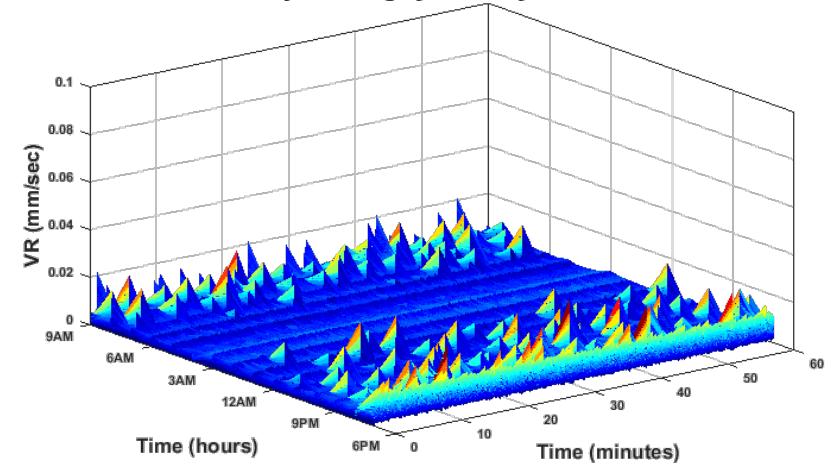
Velocity vector Igreja dos Anjos - base S02

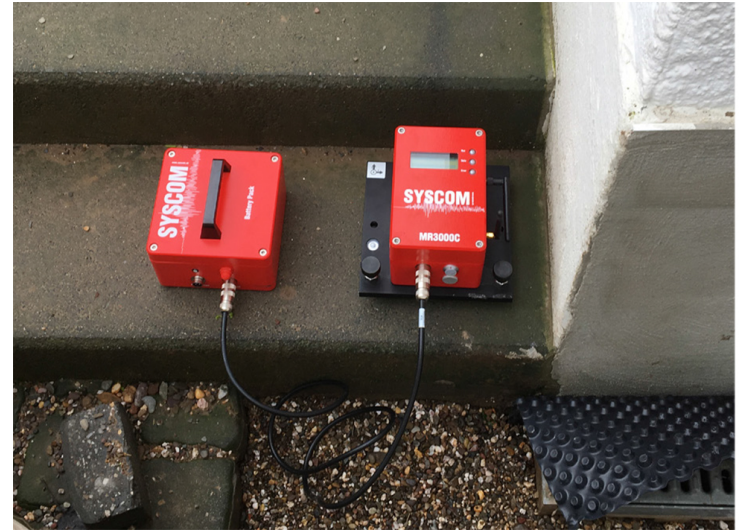
- ❑ Church of the Angels: induced vibrations of very low amplitude
- ❑ Further investigation and monitoring
- ❑ New equipment: triaxial velocity sensors
Increased accuracy and correlation
- ❑ In-situ measurement of shear wave velocities: Soil stiffness at low strains
