Lessons from the 2017 Central Mexico Earthquakes: the seismic performance of historic adobe buildings in the State of Morelos

RAMÍREZ EUDAVE, Rafael

ISISE- Institute for Sustainability and Innovation in Structural Engineering. University of Minho, Guimarães, Portugal.

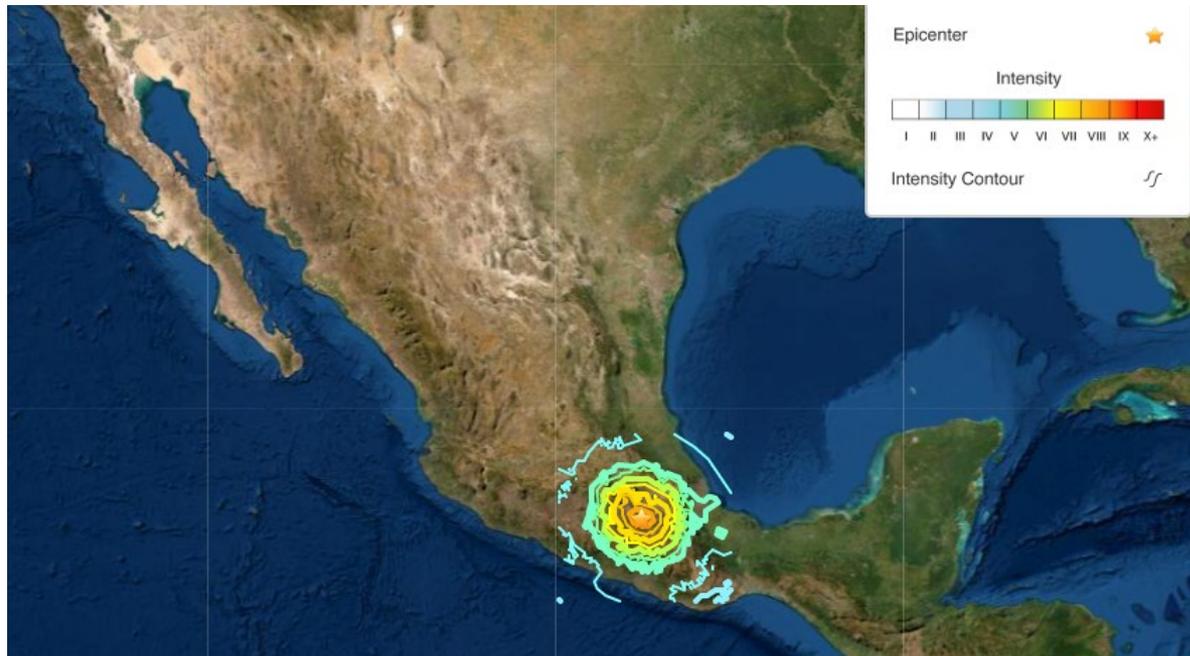
USGS Puebla-Morelos MW 7.1 Earthquake Intensity Map Report

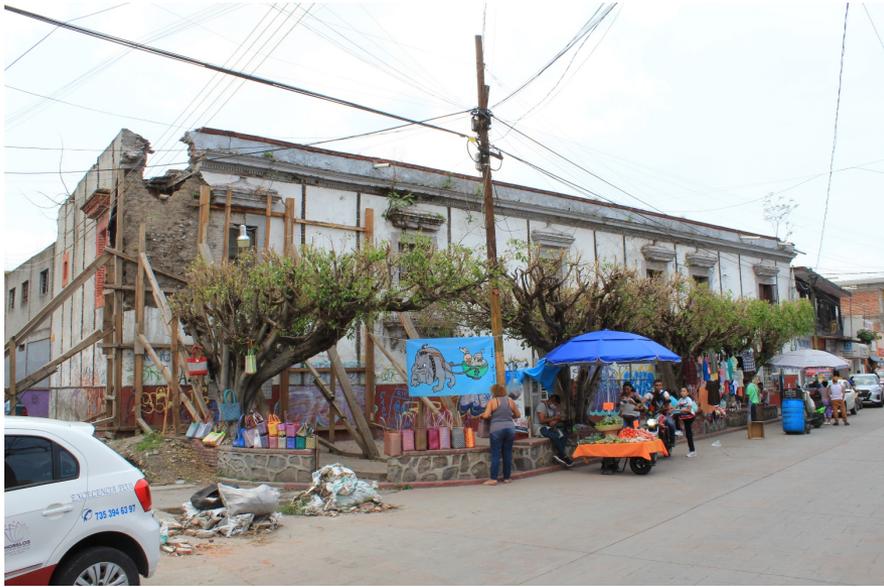
School in Yautepec

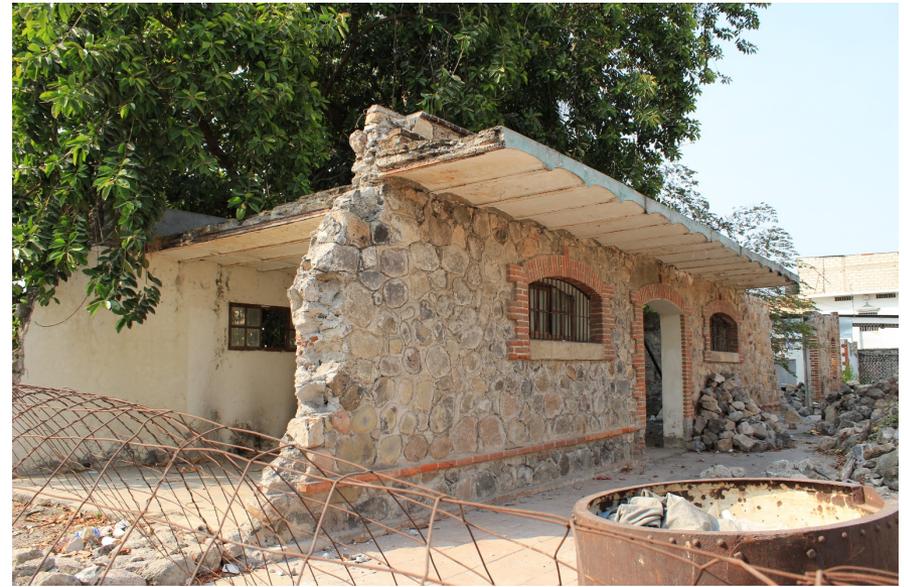
Train station in Jojutla

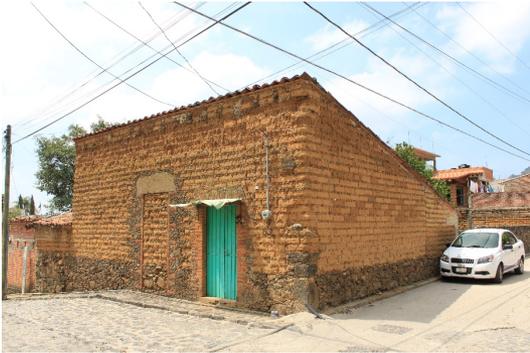
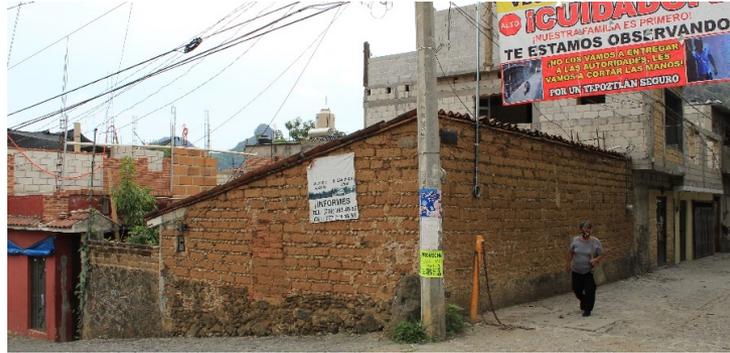
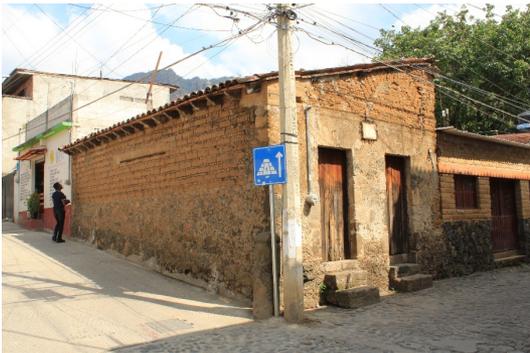
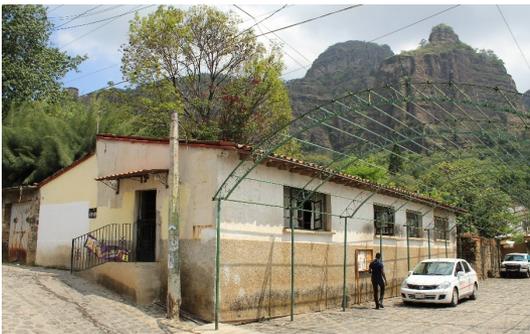
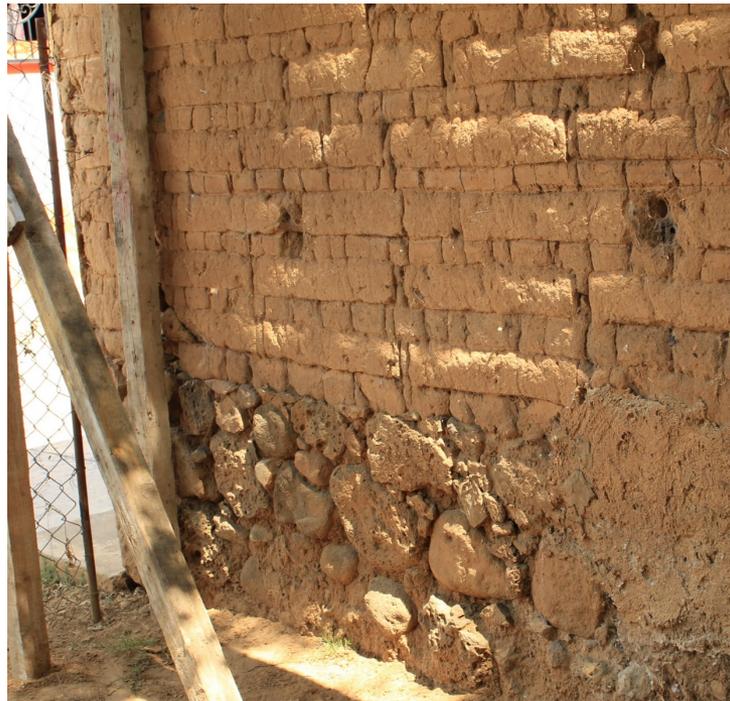
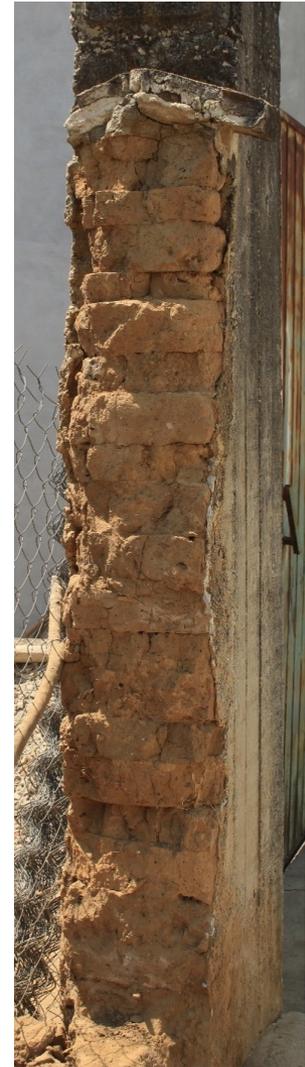
Typical structures in the rural environments of Morelos

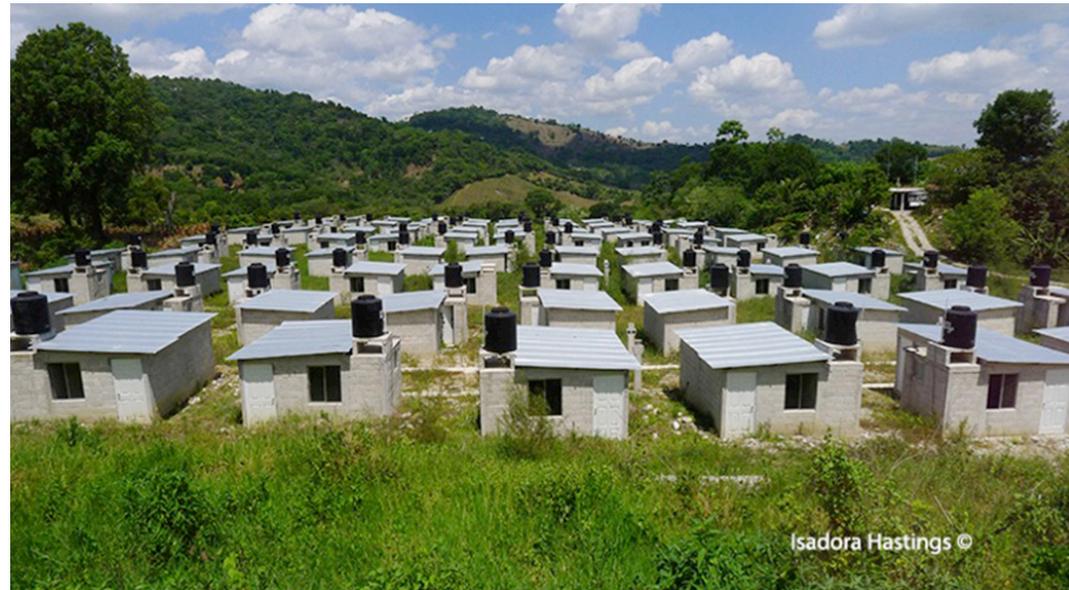
Example of new houses for replacing adobe damaged buildings. (Isadora Hastings).

There was a systematic replacement of damaged adobe constructions with new houses by using more industrial materials, including prefabricated modules, disregarding reparation and strengthening actions. This was the product, among others, of the lack of reliable techniques for assessing the safety and vulnerability of existing constructions.

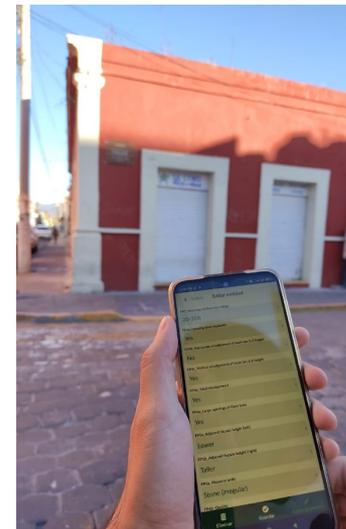
National Catalogue of Historical Monuments entry

- Visual confirmation of the descriptive information contained in the National Catalogue of Historical Monuments.
- Photographical survey. In many cases, the access was restricted.
- Damage questionnaire. The people were asked to describe the damages experienced after the 2017 Earthquakes. The diagram of the EMS-98 damage scale was shown in order to better classify the level of damage.
- Obtention of general dimensions (e.g., exterior measures for contextualizing the architectonic plan drawing of the Catalogue).
- Acquisition and grading of missing parameters.

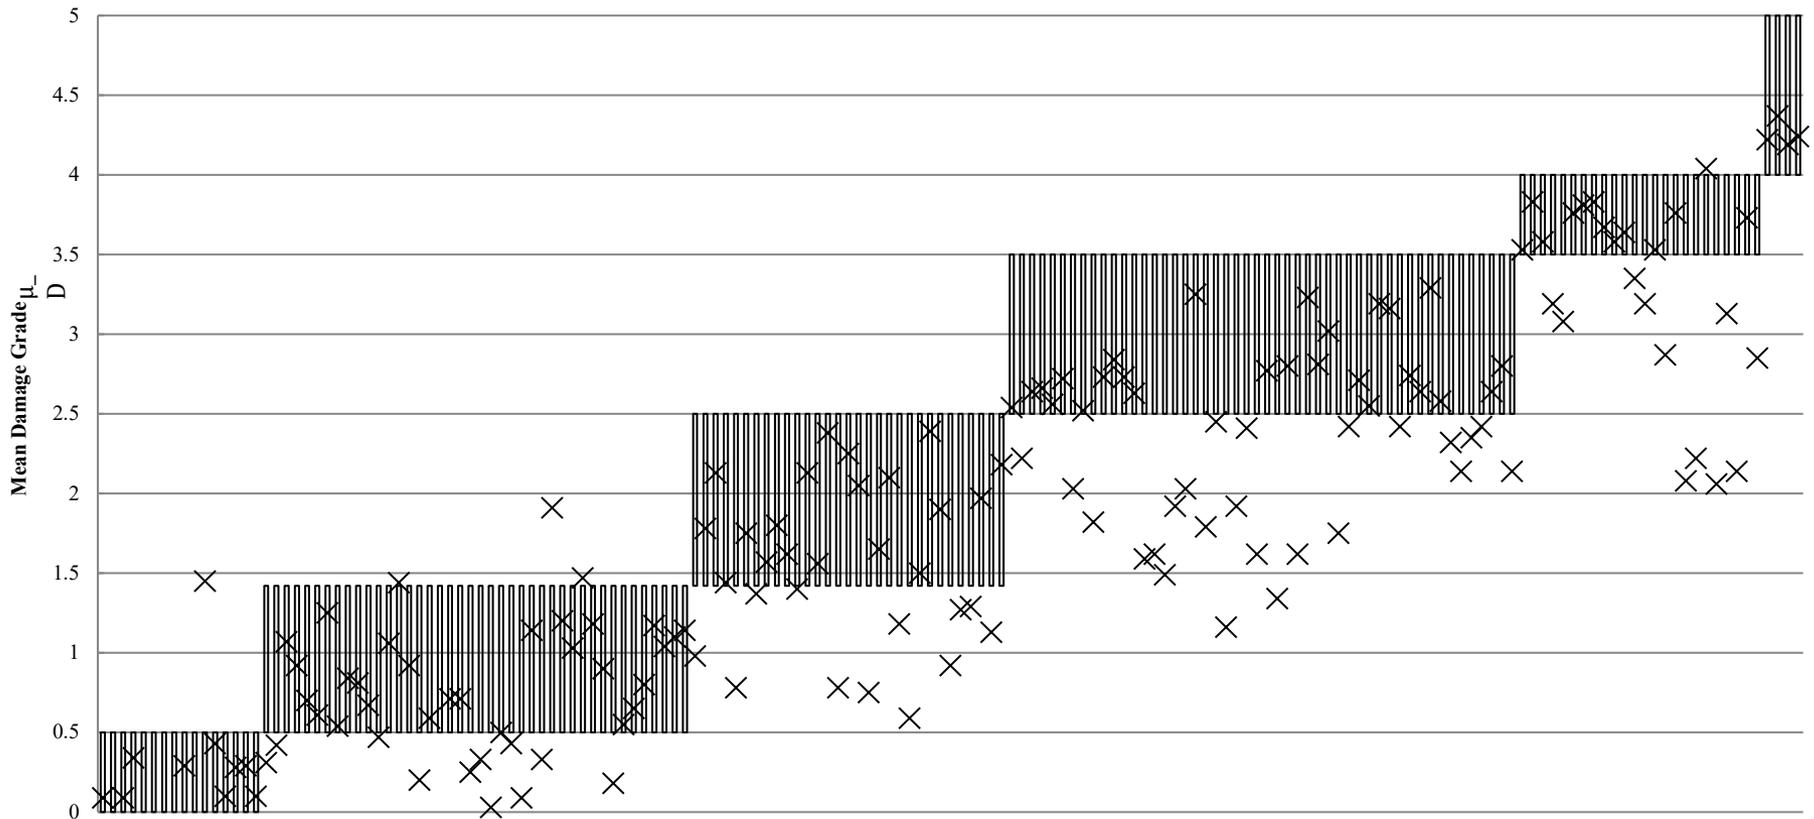
In total, 167 buildings were assessed. The first comparison consisted in checking if the analytical value obtained for μ_D was comprised in the interval of the real damage $D_{k,2017}$.

A total of 104 out of the 166 samples (62.28%) accomplished this initial condition

Comparative between the intervals for real damage (bars) and analytical damage (black crosses)

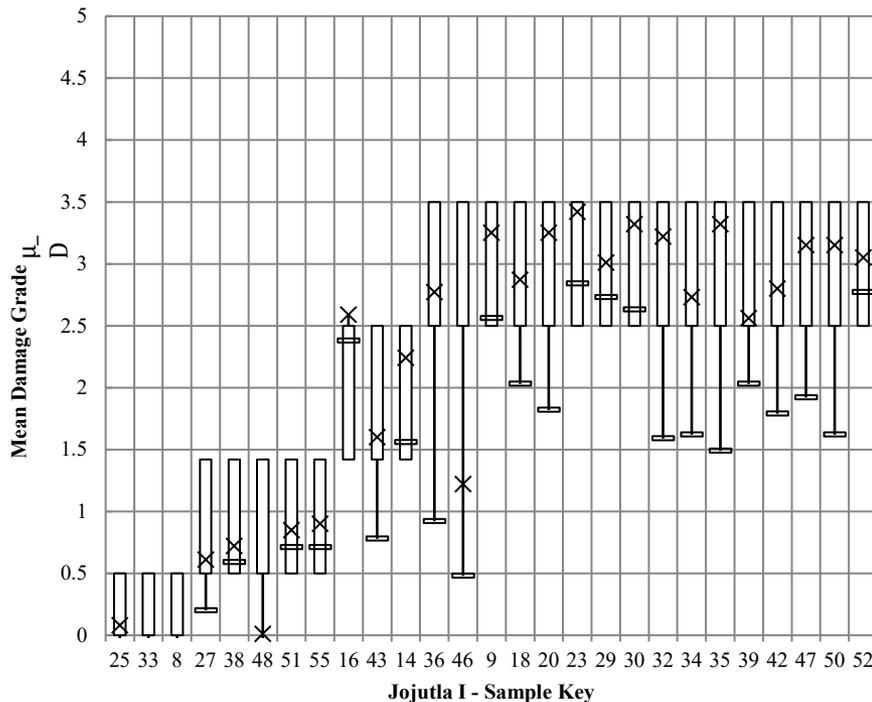
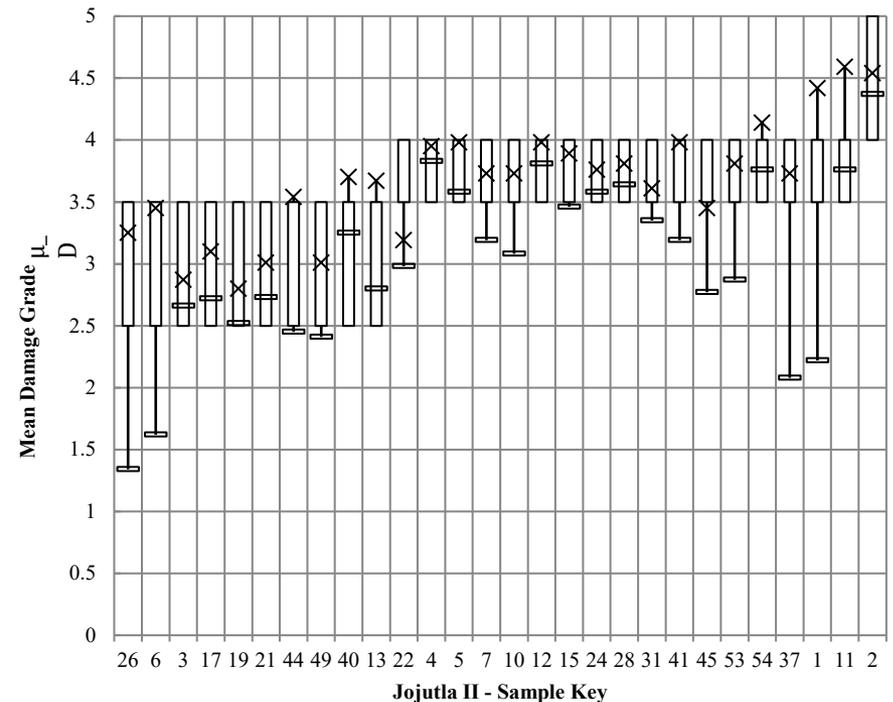
Given the limitations during the field works it was decided to consider the interval-based approach proposed for the city of Atlixco (Ramírez Eudave et al., 2022). This approach offers an analytical damage interval μ_D and $\mu_{D,conservative}$, facilitating the interpretation of the overlapping among both intervals.

With this approach, the vast majority of predicted damage intervals (93.41%) are been overlapped with the corresponding intervals of observed damages

Comparative between the intervals for real damage (bars), analytical damage (black bar) and conservative analytical damage (black crosses)

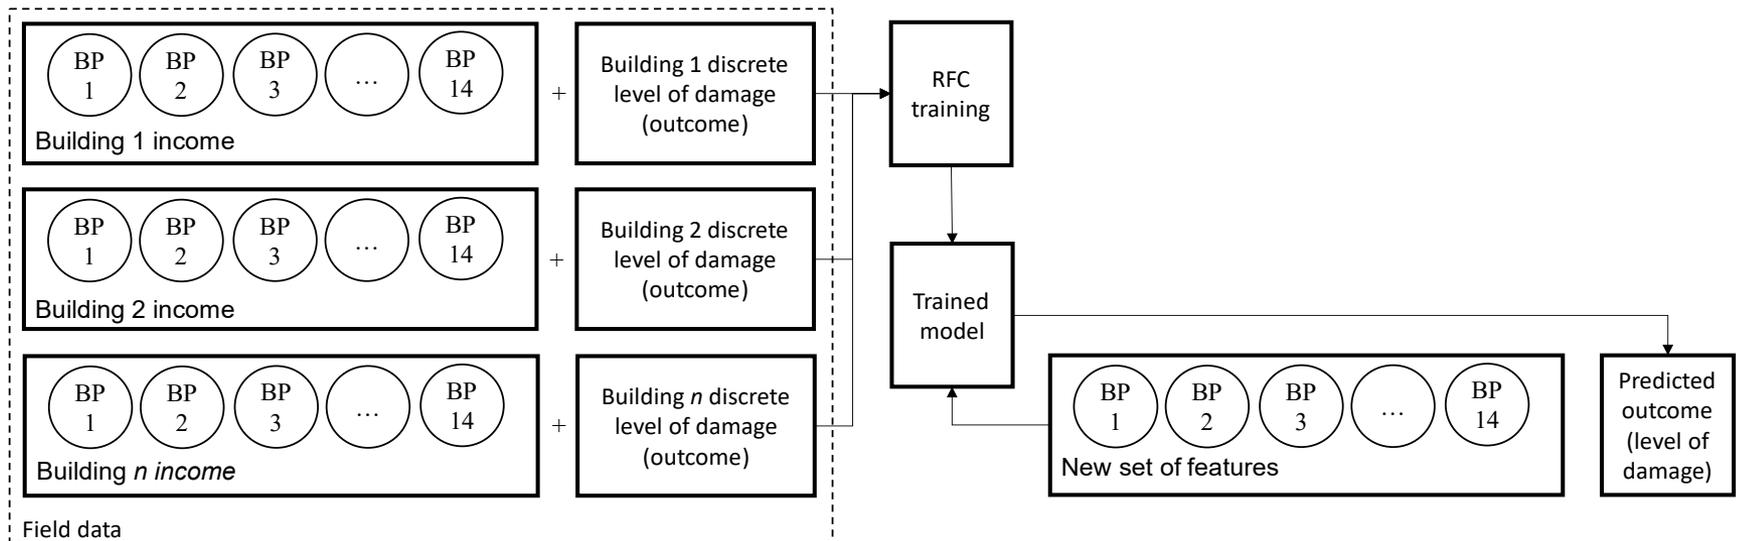
For this work, a Supervised Learning approach (i.e., data for training the association between features and specific outcomes that we expect to further predict for new sets of features) was conducted.

Schematisation of the training procedure of the model

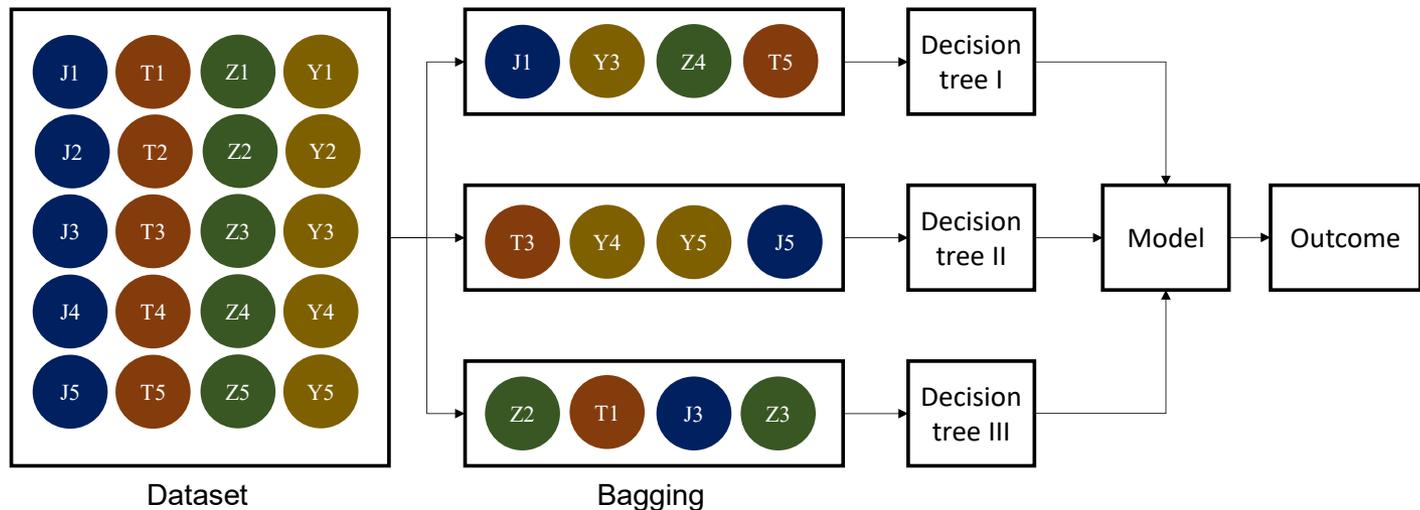
By following the observations of (Buitinck et al., 2013), this problem was modelled by the means of the Random Forest Classifier (RFC) learning algorithm, that ensembles numerous decision trees (i.e., flowchart models in which an outcome is product of a specific path of several conditional statements or nodes) that fit fractions of data instead of creating a unique tree model.

Data is split in several random subsets that will train different independent models. For this process, a random selection of 80% of field data was used for training the model, while the other 20% was later used for assessing the accuracy of the model.

Schematisation of the bagging and decision tree assembling processes.

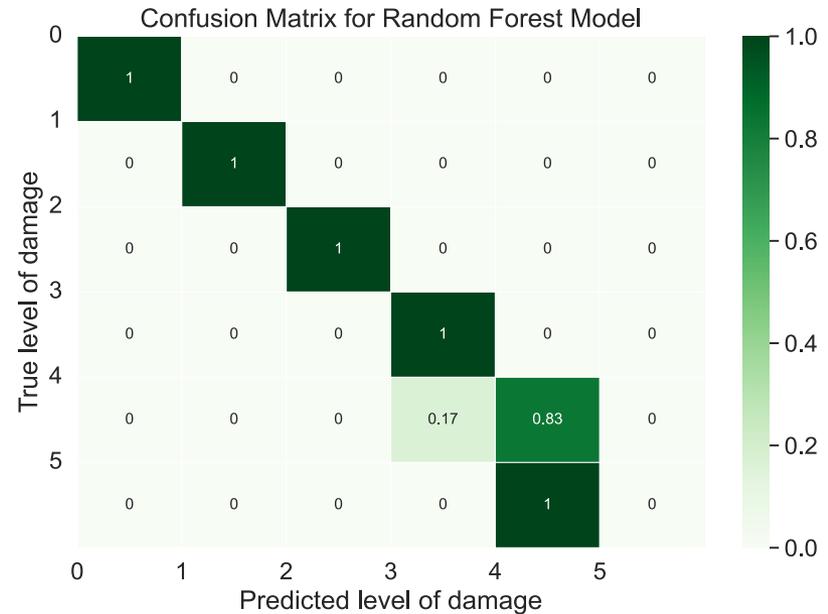
The correspondence between the true and predicted damage grades is shown in the confusion matrix. It exhibits how most of the classes were correctly identified by the model, but there is a lack of representativeness for identifying the level of damage $D_K = 5$.

This phenomenon can be easily associated to the relatively small number of samples that presented this class (4 out of 167, 2.4%, but it appears only once in the test split of the sample).

Confusion Matrix

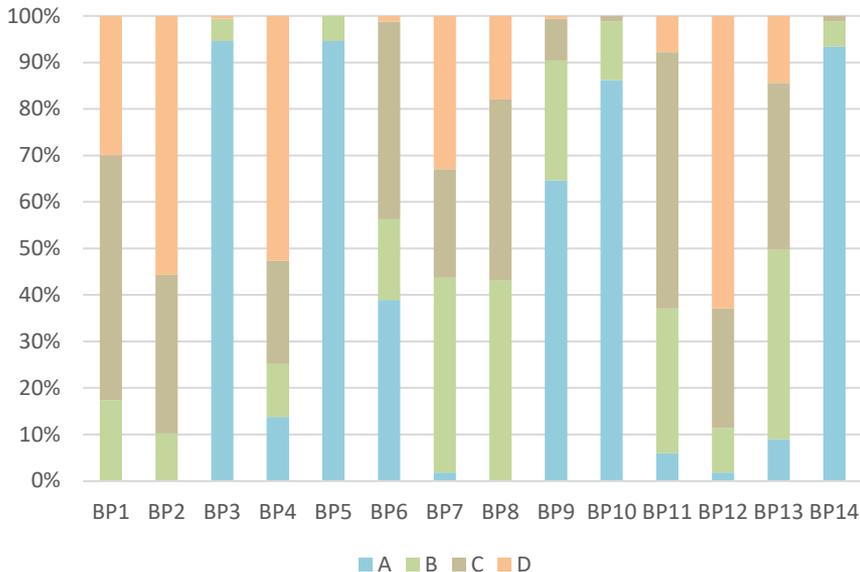
It is possible to retrieve which is the relative impact that every parameter has for the classification process. At this point, it becomes convenient to be aware of the limits imposed due to the variability throughout the sample, i.e., the impact of a determined parameter will be smaller if it does not present relevant variations for differencing samples. The sample studied in this work presented a relatively small variation of some parameters given the typological coherence among the structures.

Parameter grade distribution throughout the whole sample

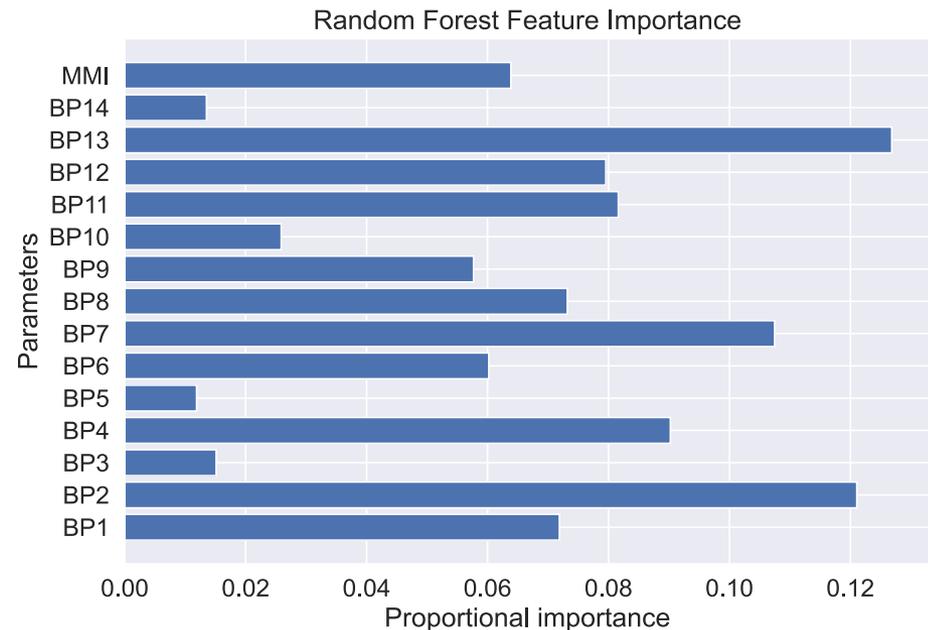
Proportional importance by parameter according to the ML model

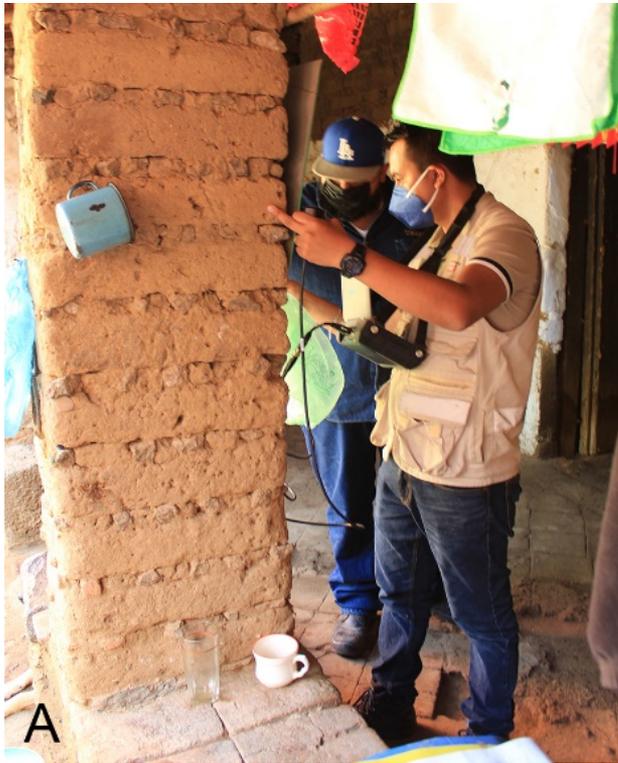
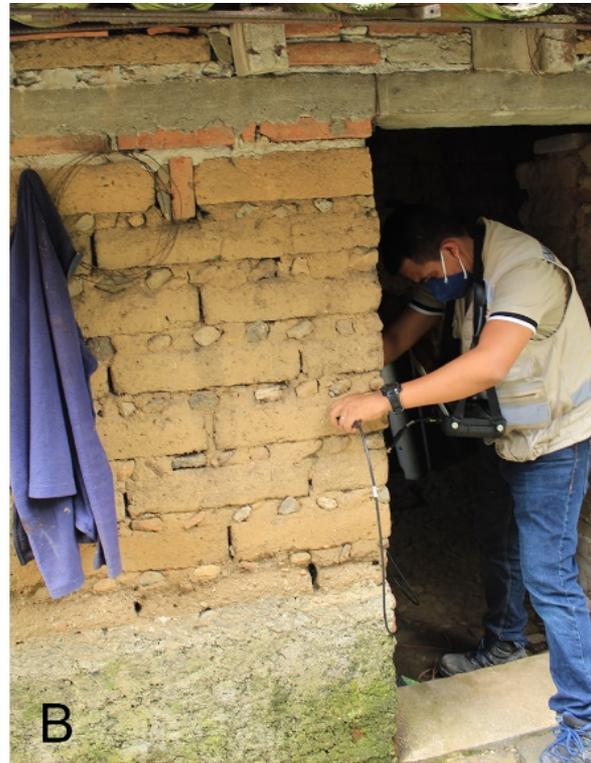
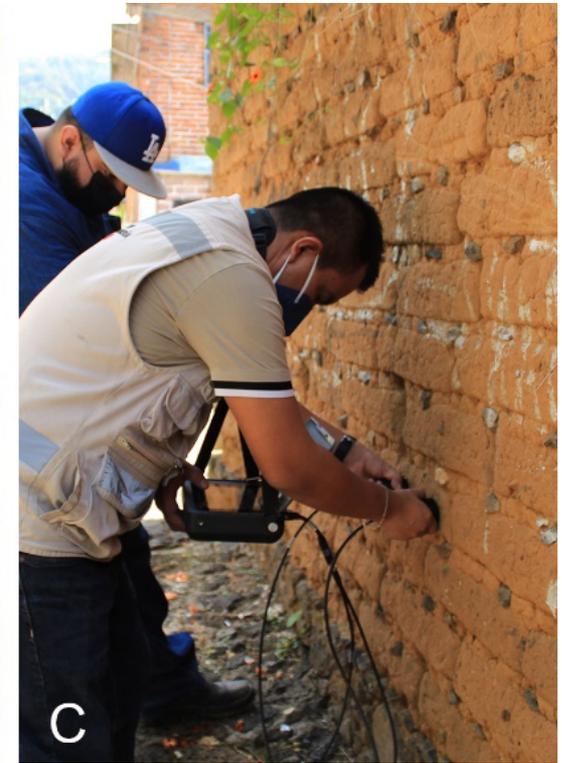
In parallel to the data acquisition and analysis herein performed, a series of tests were in Tepoztlán for determining the velocity of propagation for ultrasonic waves.

A total of 39 tests in 13 different buildings were performed. The results are still under analysis.

Ultrasonic testing campaign

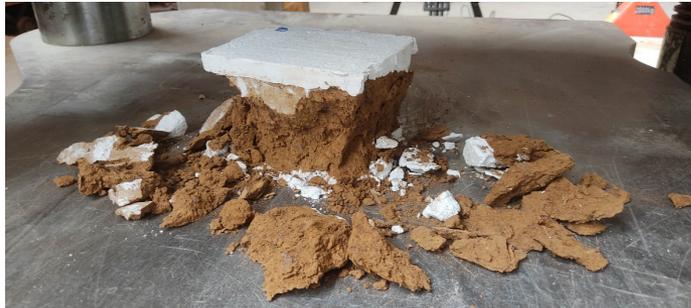
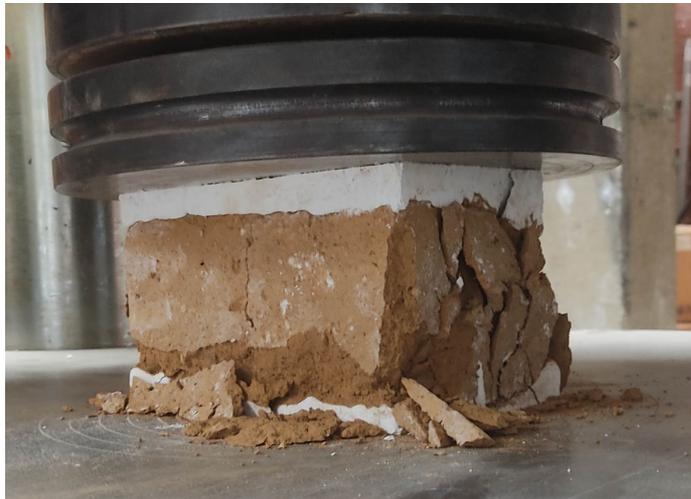
a) Preliminary compressive tests until the failure of the small samples (A, B, and C) for obtaining an estimate of the compressive strength for the material. This value can then be used to calibrate suitable load cycles for the remaining samples;

First tested sample

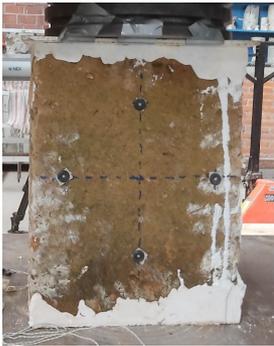
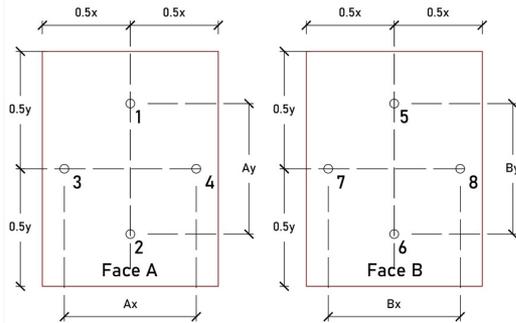
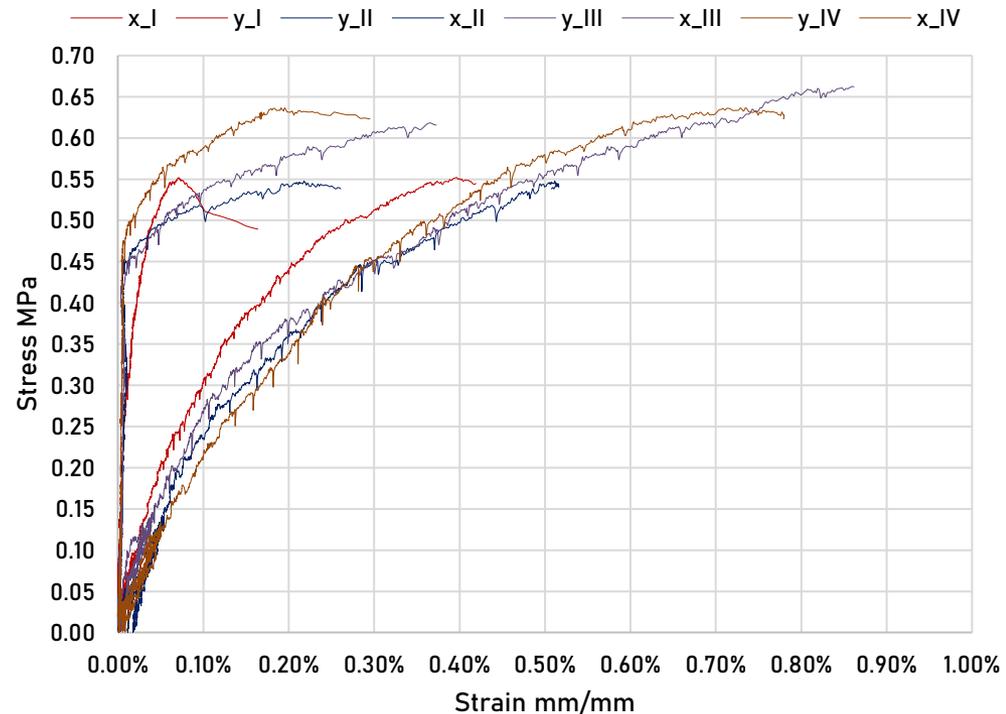
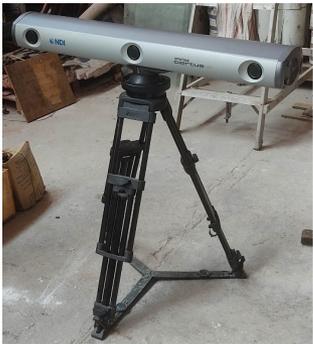
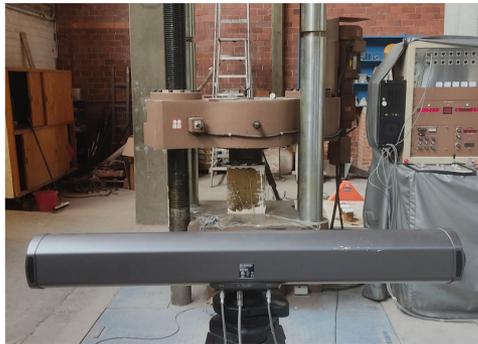
- b) Compressive tests on the complete adobe blocks (I, II, III and IV) with three cycles of charge and discharge below the indicative elastic limits of compressive strength. Strains were monitored by the means of an OptoTrack system.

Setup of the OptoTrack system
