**Rehabilitation and strengthening  
of old masonry buildings**

H. Meireles; R. Bento

**Relatório ICIST  
DTC nº 02/2013**

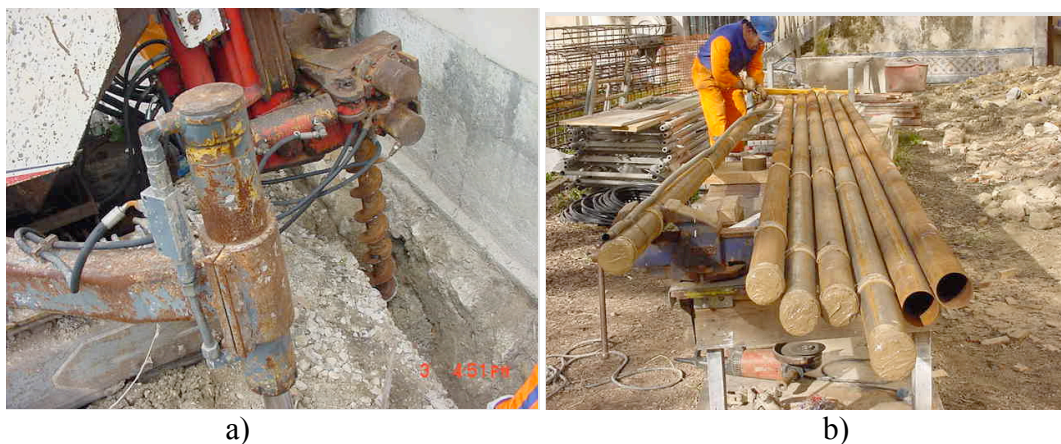
**Fig. 5 a) Machine to drill the holes, b) micro piles casing to be filled with cement grout [photos by Appleton, 2011]**

In Fig. 5 one can see in a) the machine to drill the holes and in b) the micro piles casing to be filled with cement grout.

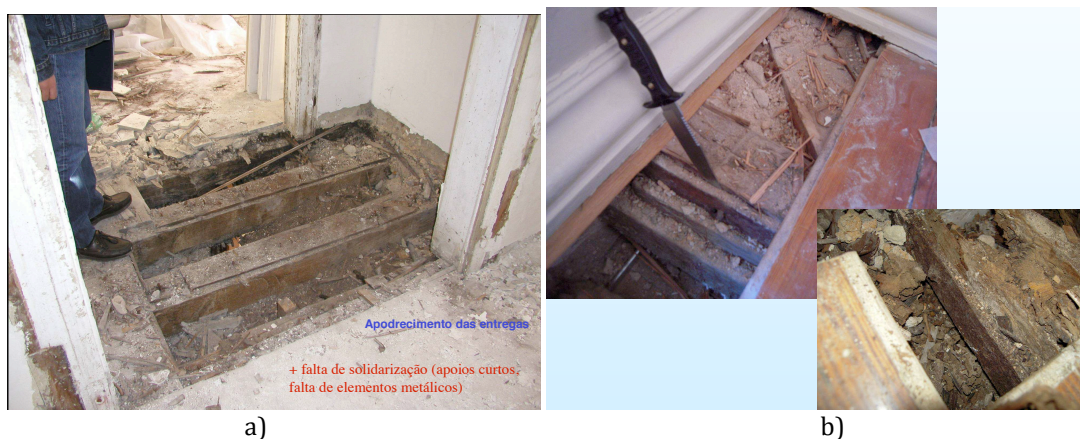
Fig. 9 a) Rotten wood joists at the connection to the wall; b) Rotten wood elements [Cruz, 2012]

These are repair techniques and not strengthening solutions. The reduced existence of pieces of natural wood of considerable dimension nowadays makes it difficult to substitute complete pieces of damaged wood with natural wood elements. In this way one can find several substitutes of wood. The damaged wood elements may be replaced by glued laminated wood, for instance. The damaged wood elements can be replaced also with epoxy resin mortar and this mortar has similar mechanical characteristics to the wood to be reconstructed. In this technique, it is advisable that the connection between existing wood and mortar be enforced by mechanical connectors. It is necessary also that there is enough protection of the mortar against fire given the susceptibility of this material to high temperatures. In Fig. 9 a) it is depicted rotten wood joists and in Fig. 9 b) more rotten wood elements.

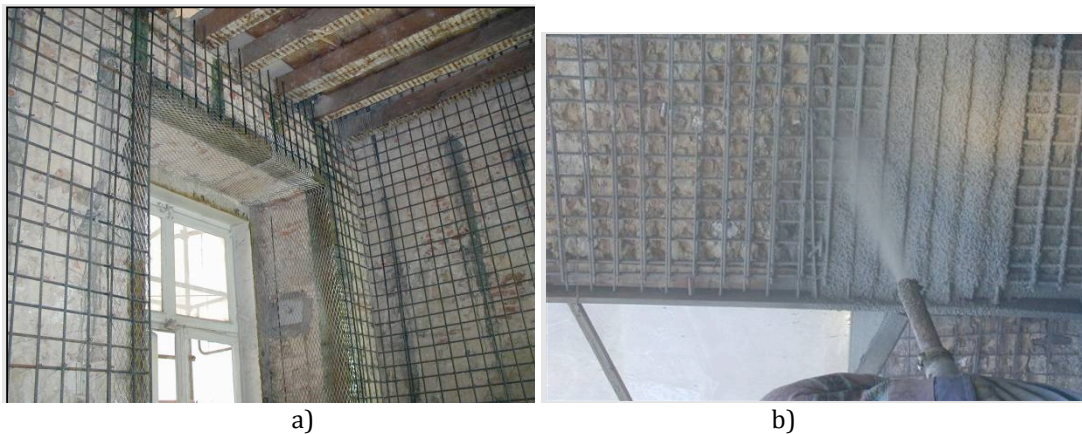
**Fig. 10 a) Masonry wall from the inside with steel mesh, b) spraying of the cement grout into the wall [fotos by Appleton, 2011]**

In this case (Fig. 10 a) and b)) one places thin (less than 10 cm) layers of coatings of cement reinforced with steel (or glass fiber or plastic meshes, see section d)) on masonry walls. The coating increases the walls strength and ductility. It can be placed in the outside or in the inside or both, depending on the most accessible areas.

It is thought that a wall of rubble (stone) masonry with 0.60 m of thickness reinforced with two layers of cement coating with steel meshes and with 0.10 m thickness in total, may have increased its strength in compression and shear of 3 to 6 times its original strength, at least [Appleton, 2009].

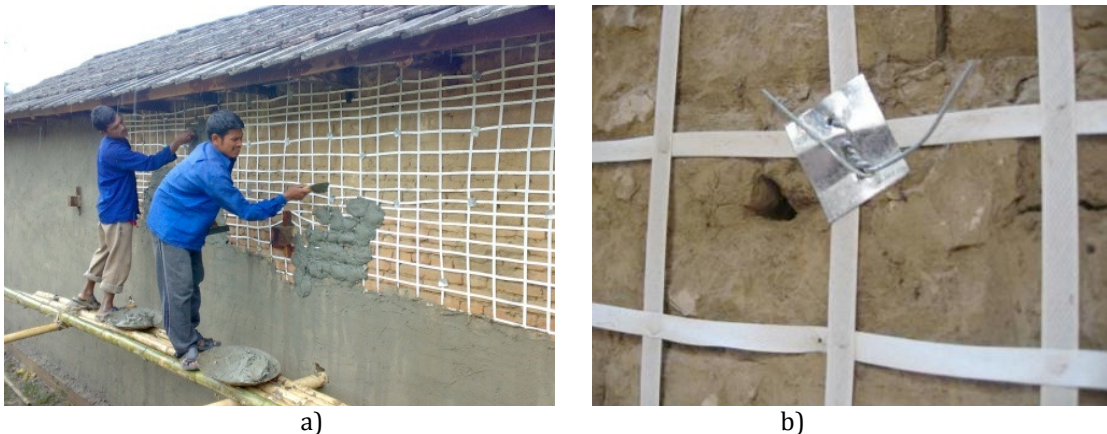
**Fig. 11 Implementation of PP band method of retrofitting in Kathmandu Valley (a) and anchorage throughout the wall (b) [Shrestha et al. 2012]**

Polypropylene meshing uses common polypropylene packaging straps (PP-bands) to form a mesh, which is used to encase masonry walls (Fig. 11 a)), preventing both collapse and the escape of debris during earthquakes. PP-bands are used for packaging all over the world and are therefore cheap and readily available while the retrofitting technique itself is simple enough to be suitable for local builders. PP-meshing has been applied in Nepal, Pakistan and more recently in China. This method is most readily applicable in terms of low-cost upgrading of traditional structures to limit damage caused by normal earthquakes and give occupants a good chance of escape in an once-in-a-lifetime large earthquake. Non-engineered masonry is widespread throughout the developing world and replacement of all such dwellings is both unfeasible and undesirable, given that they are often the embodiment of local culture and tradition. It is therefore often more feasible to consider low-cost retrofitting of

To enable the behaviour of both elements (existing and new) to work together one places anchorages throughout the wall (Fig. 11 b)).

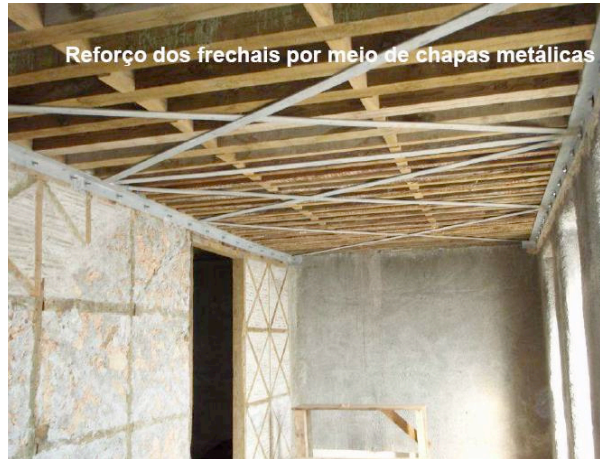
**Fig. 13 In-plane stiffening with metallic diagonals and reinforcement of connection floor-wall (Pombalino building) [photo from Edifer]**

Another possible technique is the idea of including on the floor a horizontal bracing composed of steel ties and arranged in crosses (Fig. 13) and this technique has been developed for many decades. Care is taken to improve the connection between the floor and the masonry wall with L-shaped steel plates (Fig. 13). On the contrary to the previous technique this one does not increase significantly the mass of the floors and is reversible.

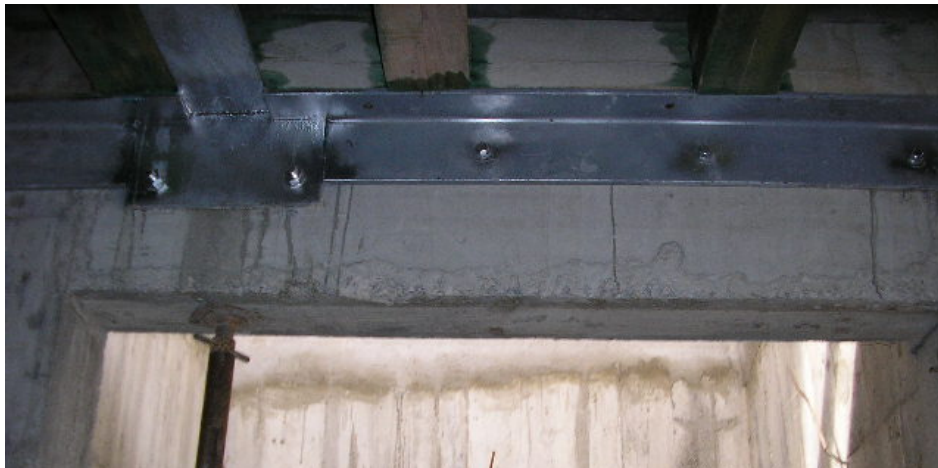
**Fig. 14 Photo of the connection with L-shaped steel plates between wooden floor and masonry wall**

In the Fig. 14 one can see a photograph of the connection with L-shaped steel plates between wooden floor and masonry wall.

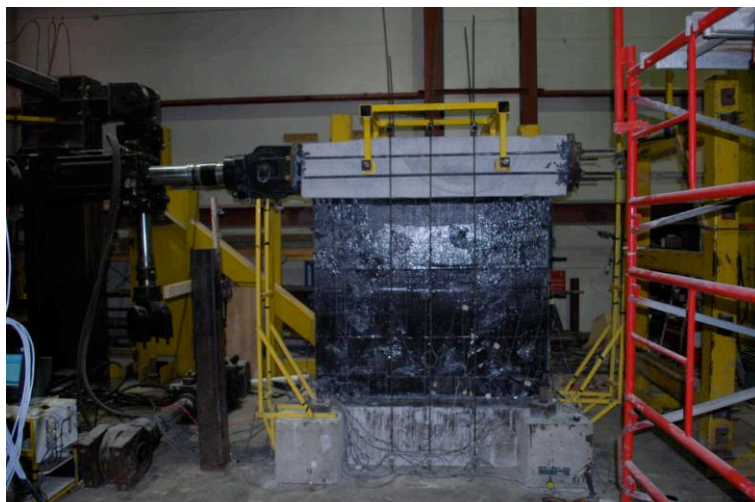
Fig. 16 Wall to be tested in-plane of brick masonry, strengthened with CFRP [Arifuzzaman and Saatcioglu, 2012]

In Fig. 16, a wall specimen to be tested was retrofitted with two layers of Carbon Fiber Reinforced Polymer (CFRP) sheets, one in each direction, covering the entire surface of the wall. CFRP sheets are applied in only one side of the specimen. The first layer had fiber orientation parallel to bed joints and the second layer had fibers oriented 90° with the horizontal. They were applied on one side of the wall, while the other side remained with exposed block masonry. CFRP was applied using the wet layup procedure. The wall surface was first prepared prior to the application of CFRP. The preparation involved; i) surface cleaning by wire brush, followed by air pressure to remove loose mortar, ii) application of putty consisting of two-component epoxy and silica fume to cover head and bed joints and to smoothen the wall surface, iii) removal of any extra putty by a plastic putty knife, iv) after curing for a day, inspection of the surface and covering any noticeable air bubbles with putty using the same plastic knife and finally v) sanding the surface by sand paper after two full days of curing.

Once the wall surface was ready for the application of CFRP sheets, the sheets were cut to required sizes and applied on the wall surface. The application involved the following steps:

- i. Application of a layer of two-component epoxy on the surface.
- ii. Application of the first layer of CFRP whose fibres were parallel to the bed joint, saturated in epoxy.
- iii. Removal of extra epoxy and air pockets by means of a ribbed steel roller.
- iv. Application of another layer of epoxy prior to the placement of the next layer.
- v. Application of the second layer of CFRP perpendicular to the bed joint after saturating it in epoxy and following step iii.

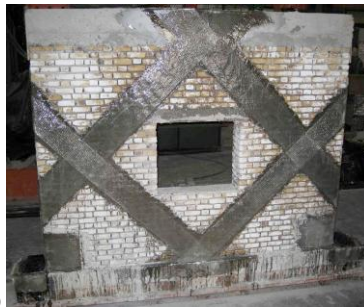
**Fig. 17 Wall to be tested in-plane, strengthened with GFRP [Kabir et al, 2012]**

In the following wall specimen to be tested under in-plane loads, the brick masonry wall was strengthened with GFRP strips in both sides of the wall (Fig. 17).

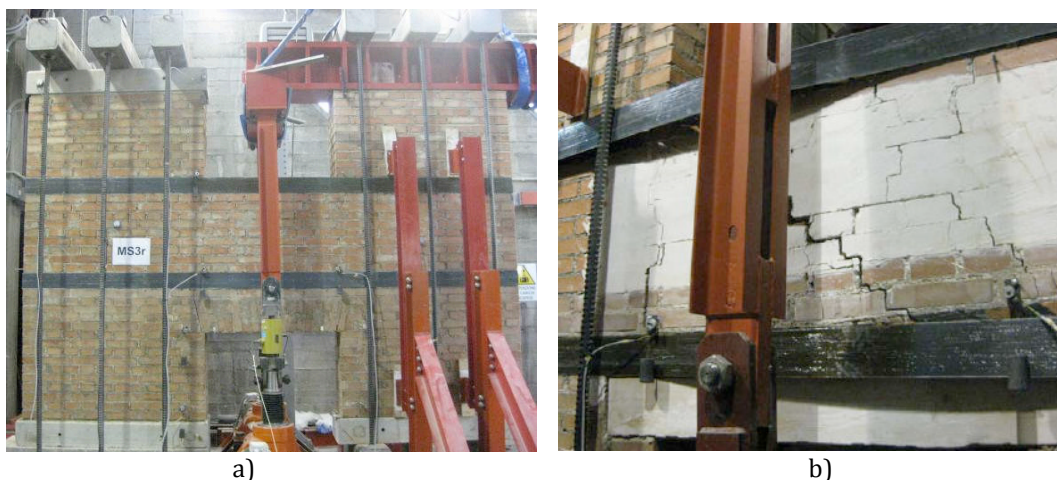
**Fig. 18 (a) Wall to be tested in-plane with strengthened spandrels with CFRP (b) view of strengthened spandrel after testing showing debonding of the CFRP [Amadio et al, 2012]**

Furthermore, Fig. 18 shows a wall specimen to be tested under in-plane loads with the spandrels strengthened with CFRP strips (on both sides), before testing (Fig. 18 a)) and after testing (Fig. 18 b)). After testing it can be observed the debonding of the CFRP strips from the masonry face, implying a reduction in shear strength.

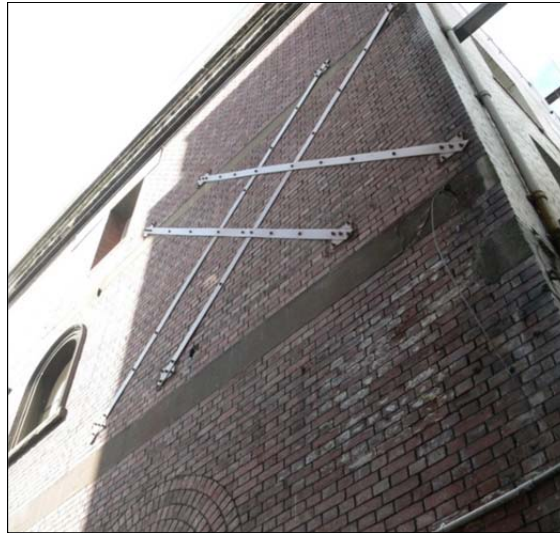
Fig. 19 Simple and visually interesting in-plane strengthening with FRPs [Ingham, 2012]

If a building has insufficient shear capacity in a particular direction, the capacity of existing walls can be increased instead of inserting an additional structure. In the Fig. 19 one can see the application of an additional layer of material (CFRP or GFRP) bonded to the surface of the URM wall aiming to increase its strength.

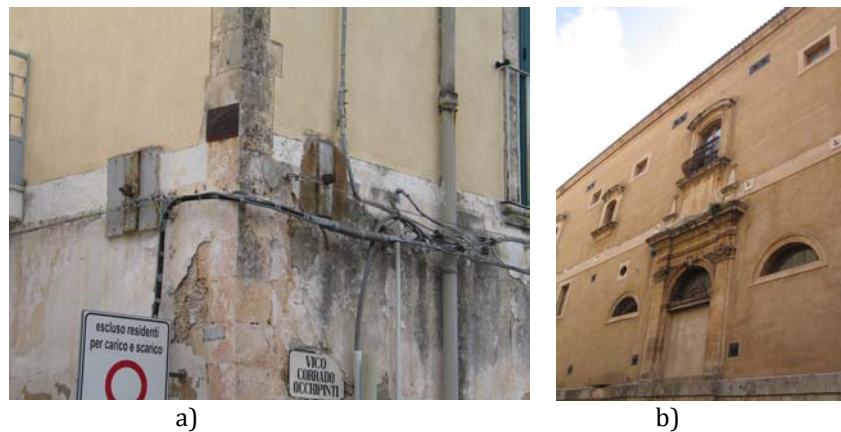
Fig. 20 Using tie-rods to connect parallel walls [A. Costa, 2008]

Tie-rods in steel can be used in several applications of old masonry buildings. For instance, they can avoid or at least decrease the probability of out-of-plane failure. Fig. 20 a) and b) show the application of horizontal tie-rods to connect parallel walls at the level of the floors.

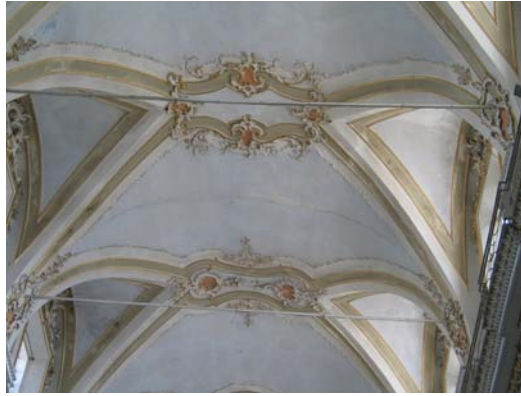
**Fig. 21 Utilizing tie-rods to absorb horizontal impulses in arches [A. Costa, 2008]**

Tie-rods can be also used in arches to absorb horizontal impulses (Fig. 21 and Fig. 22).

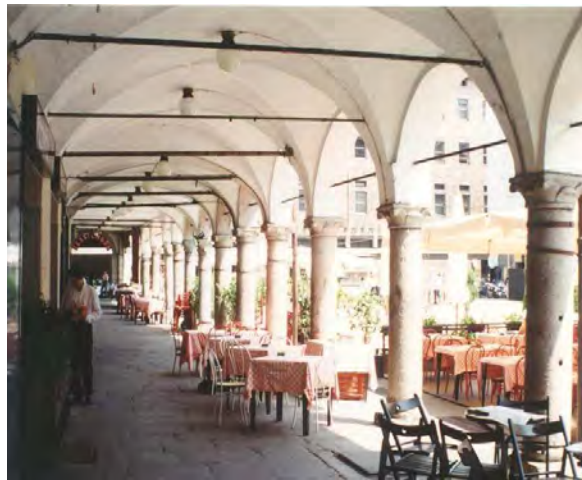
**Fig. 22 Tying of masonry vaults with tie-rods in steel (Santos, 2003)**

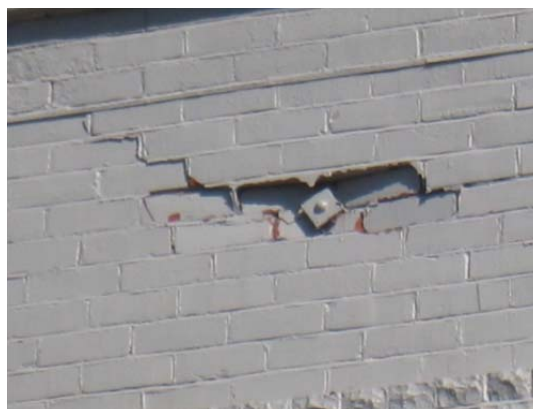
**Fig. 23 Close up of partial anchorage failure. Photograph of damage in the 2010 Darfield (Canterbury) earthquake due to deficient anchorages [Ingham, 2012]**

In Fig. 23 one can see a failure of the anchorage of the tie-rod after an earthquake, because the plate was too small. In Fig. 24 it is shown the successful behaviour of the tie-rods, spaced close together.

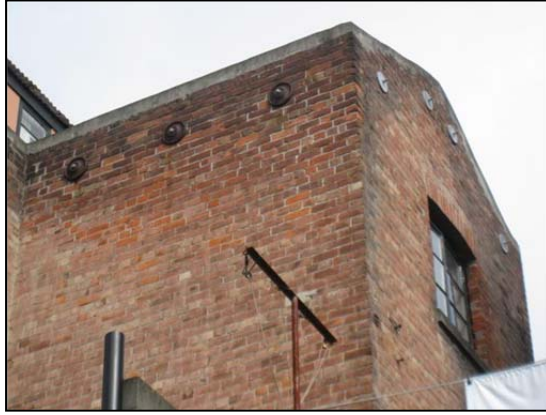
**Fig. 24 Successful anchorages spaced close together. Photograph of building after the 2010 Darfield (Canterbury) earthquake [Ingham, 2012]**

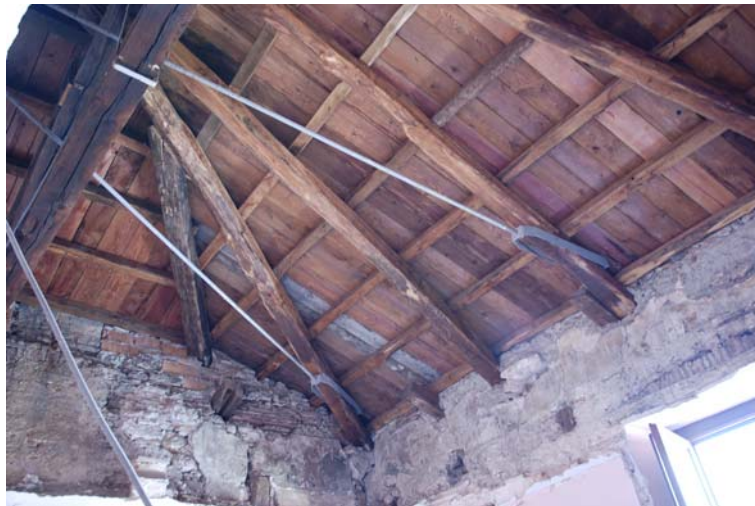
**Fig. 25 Using tie-rods in roofs [M.A. Parisi et al., 2012]**

Finally, in Fig. 25 one can see the utilization of tie-rods in a wooden roof.

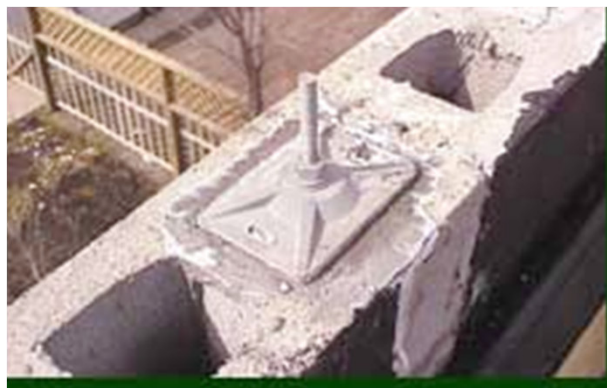
Fig. 27 Close-up view of a post-tensioning anchorage [Ahmad, 2012]

In Fig. 27 one can see in close up view a post-tensioning anchorage.

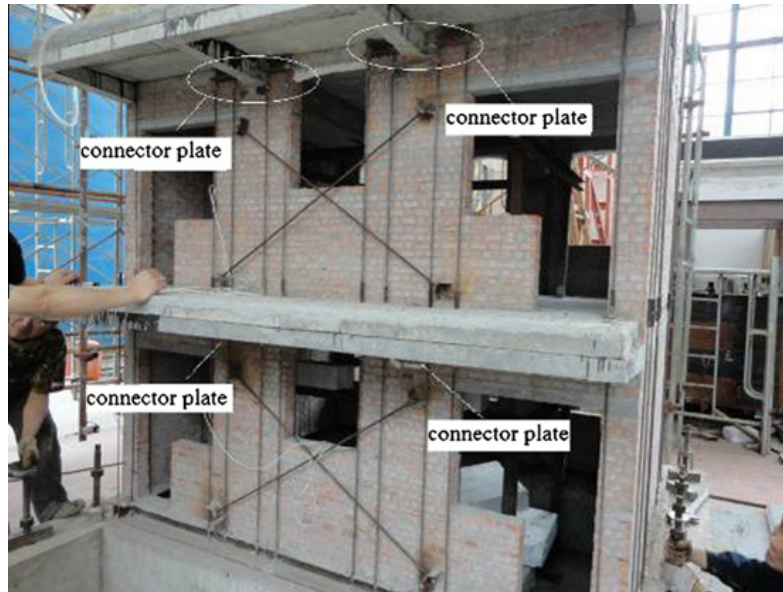
Fig. 28 Cross bracing struts at the first two storeys

Regarding the placing of post-tensioning tendons externally at discrete locations, Ma et al [2012] placed vertical and cross bracing struts at a building in the laboratory. This is to improve the shear capacity of the walls (Fig. 28).

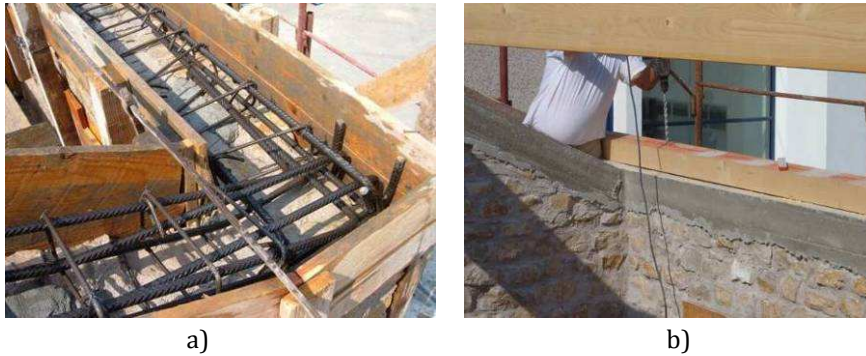
**Fig. 30 Details of the reinforcement of the ring beam (left) and view of the ring beam after filling with the concrete (right) [Magenes et al, 2012]**

A reinforced concrete ring beam, 20 cm high and 32 cm wide (as the wall in Fig. 30), was cast at the roof level, on top of the perimeter façades (Fig. 30 a) and b)) in the experimental work of Magenes et al. [2012]. The reinforcement consisted in  $4\phi 16$  longitudinal bars and  $\phi 8$  stirrups at a spacing of 20 cm, coherently with the prescriptions of the Italian Building Code.

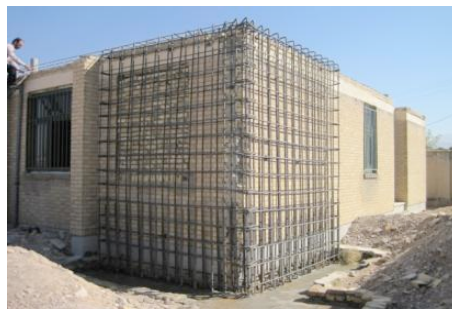
**Fig. 31 Photo of the reinforcement of two perpendicular shear walls [Mahdizadeh et al, 2012]**

If the rigidity of the slab is sufficient then lateral strength of a building can be increased by the placement of RC shear walls. A structural engineer can rapidly calculate number of shear walls and their lengths and bars arrangement by calculation of base shear. The strength of the masonry building is neglected in the calculation of the shear walls. In the following Fig. 31 is depicted this retrofitting solution in a school building.

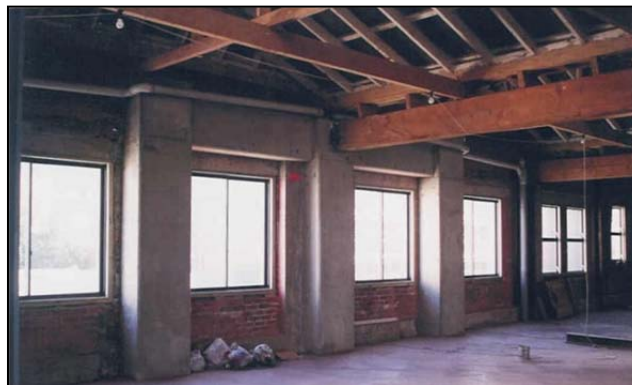
**Fig. 32 A concrete moment frame inside the façade of a large URM building in Wellington (Dunning Thornton Consultants)**

Fig. 32 shows a large new moment frame of RC inside an URM building.

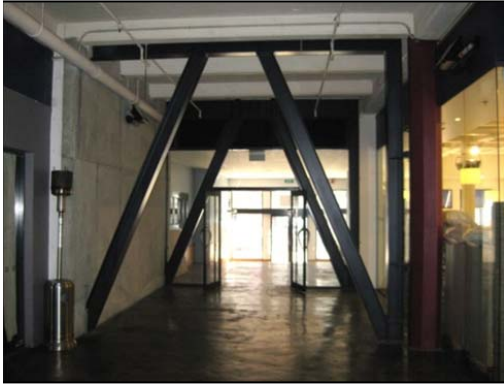
**Fig. 33 a) Eccentric bracing in a walkway; b) Eccentric bracing core (Dunning Thornton Consultants)**

Fig. 33 a) and b) show braced frames inside two different buildings.
