**Seismic Assessment of a  
'Placa' Building**

M. Monteiro; R. Bento  
- Outubro 2012 -

**Relatório ICIST  
DTC nº 20/2012**

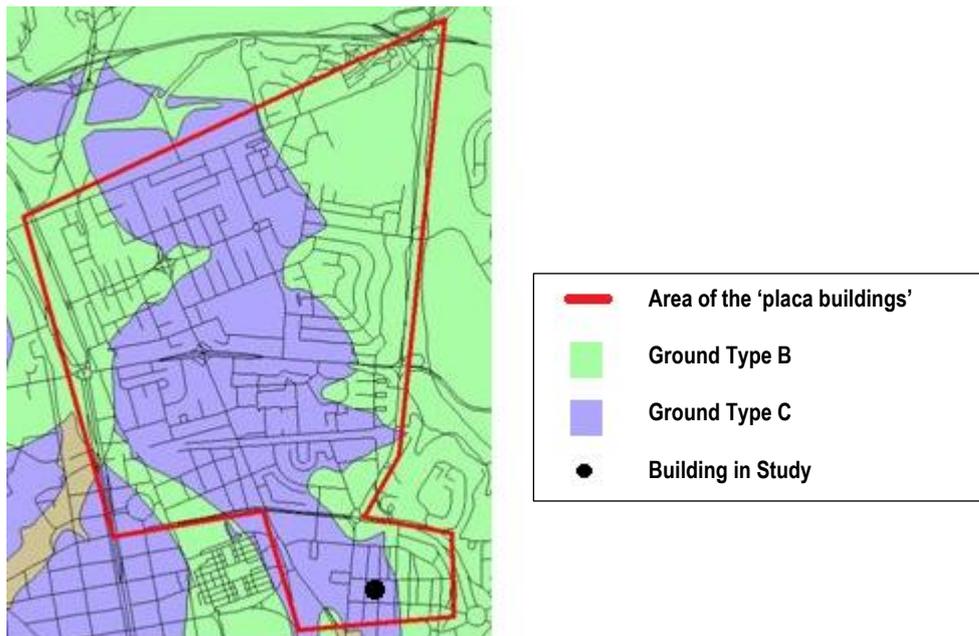
Figure 3 - Location of the building under study according the Geotechnical Plant of Lisbon. [adapted from (Almeida, 1997), (Almeida et al., 1986) and (CML, 2008)]

According to the "Descriptive Memory", the ground was considered in "favourable conditions" (Descriptive Memory, 1939). However, as shown in Figure 3, the building under consideration is located in a ground type C, according to the classification criterion of Eurocode 8 (EC8.1, 2009).

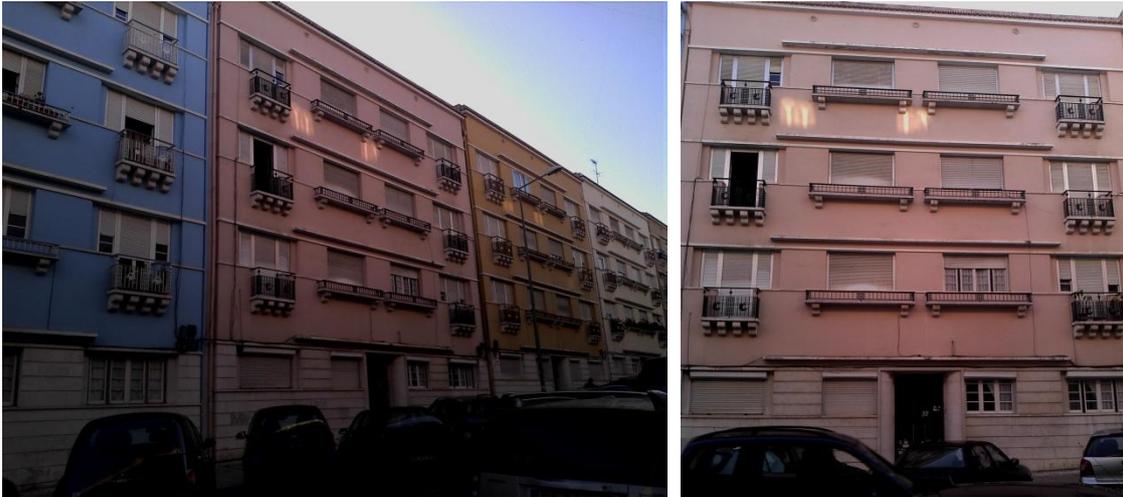
**Figure 4 –Building façade.**

The building chosen has four floors (ground floor and three floors high), as shown in Figure 4. The story height is constant with 3.0 m, while the ground floor has a story height of 3.25m.

The total height of the building is around 17m, from the street level until the top of the roof. The façade of the building has a length of 14.5m and has 20.5m in depth.

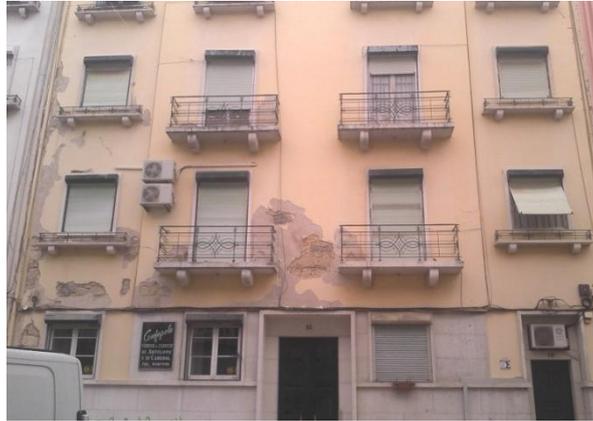
Figure 9 – Photograph taken during the repair works of the façade on the building in front.

According to the information available in the Municipal Archives of Lisbon (1939) this building was targeted of rehabilitation works in 1988. However these works were not structural works aiming the seismic strength of the building; they were only to repair the exterior of the façades, roofs and staircase (Figure 9).

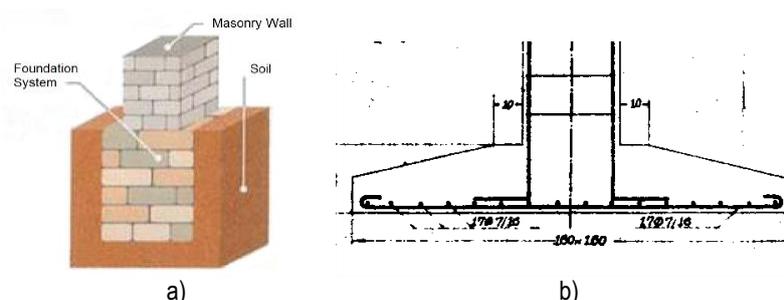
Figure 10 – Foundation system: a) Continuous walls in limestone masonry (Appleton, 2003) b) Reinforced concrete foundations (Descriptive Memory, 1939).

In this building it was used two different types for the execution of foundations (Figure 10). In general, the foundations were executed continuously over all masonry walls, with about twice the thickness of the walls so as the maximum stresses do not to exceed 2 MPa according to the original design (Descriptive Memory, 1939). As this building has a reinforced concrete frame structure on the back of the building, the column foundations were also made of reinforced concrete (Figure 10 b). The foundation layout is defined in Figure 11.

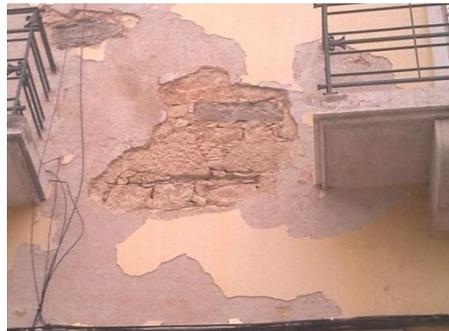
Figure 13 – Rubble masonry walls - Photograph taken during the repair works of the façade of the building in front.

The interior walls are made by brick masonry (solid and hollow) and the wall thickness varies from 0.10m to 0.20m. All the walls that supporting loads (including the stairs walls) are made by solid brick with 0.2m (Figure 14). The other partitions walls are made by hollow brickwork with 0.1m of thick, thus they do not really contribute to the seismic resistance of the building.

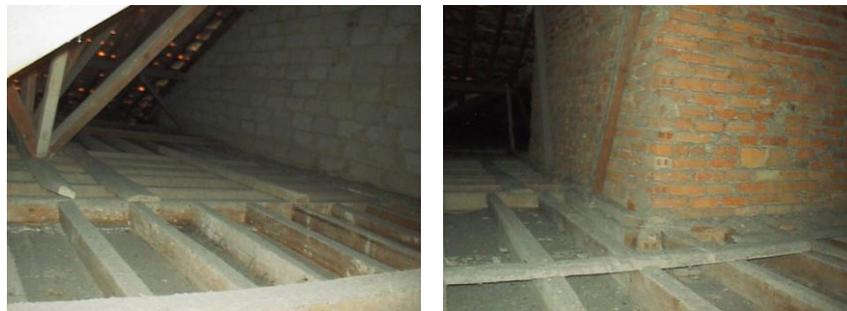
In this period, there are references to the first use of the concrete blocks in the walls of buildings (Figure 14). These blocks were used in the gable walls. It should be refer that the gable walls on each building of the quarter are not shared.

Figure 14 - Gable wall (on the left) and the stair wall (on the right) in another building at the same period.

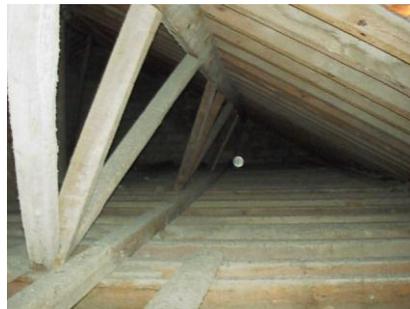
The roof of the building consists of ceramic tiles, which are supported on a wooden structure that is composed by a set of parallel trusses connected by purlins (main beams) and common rafters and slats (Figure 17).

Figure 17 – Wooden structure on the coverage in another building at the same period.

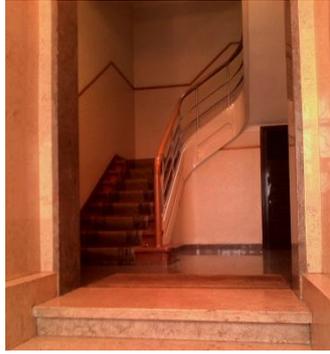
The main staircase is built by a wooden structure to be compatible with the wooden floor (Figure 18), while the secondary stair was built by iron structure (Figure 19).

**Figure 18 – The main stairs of the building in study**

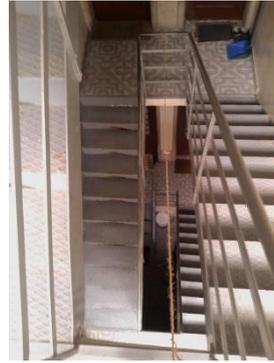
**Figure 19 - The service stairs of the building in study**

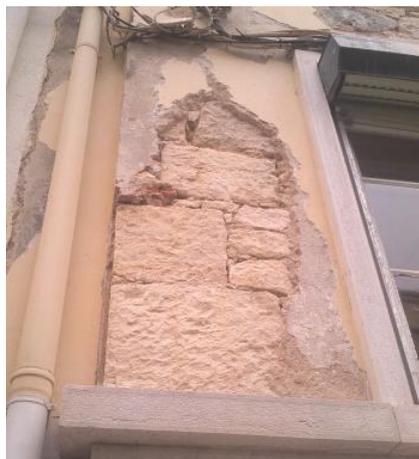
Figure 20 – Photograph taken during the repair works of the façade, on the building in front, where it can observe little mortar on the middle of the rubble masonry.

Figure 20 shows that there is little mortar in the connection of the masonry blocks. So it is possible that the strength values can be even smaller.

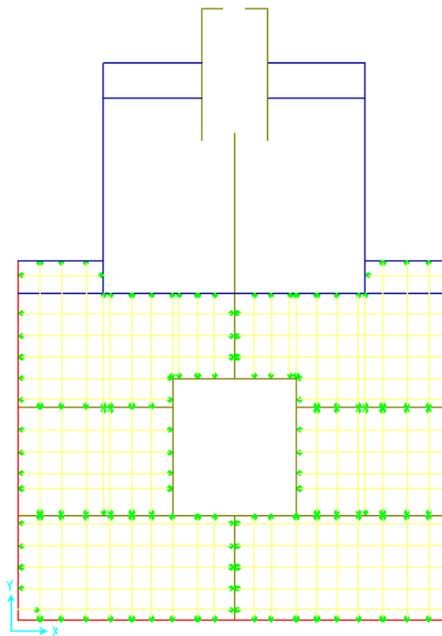
Figure 26 - Placement of the hinge bars at the ends on the links between the wooden beams to masonry walls.

Since it is unknown the conditions of connections between the wooden beams to the masonry wall, another study was performed, as these connections to the masonry could be weak points of the structure.

So, was chosen to label the ends of the bars that connect to the masonry (Figure 26). However, this modification did not cause significant changes to the response of the structure.

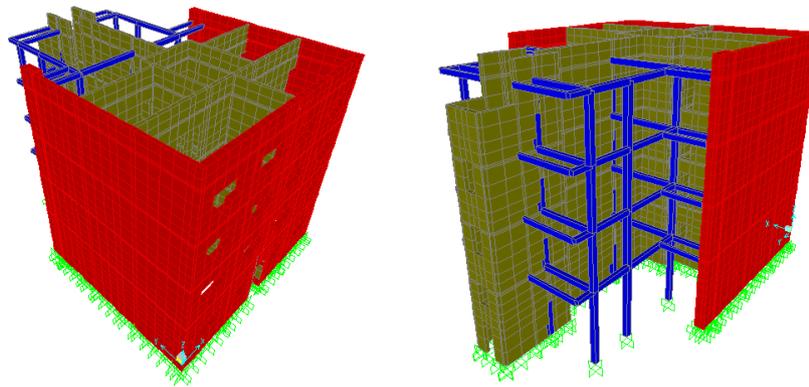
Figure 27 - Model without the exterior walls on the back to show the reinforced concrete frame.

In this type of buildings the reinforced concrete frame structure started to appear at the back of the buildings that corresponds to the humid zones (kitchens and bathrooms). However these elements were designed with minimum dimensions and only for the vertical loads.

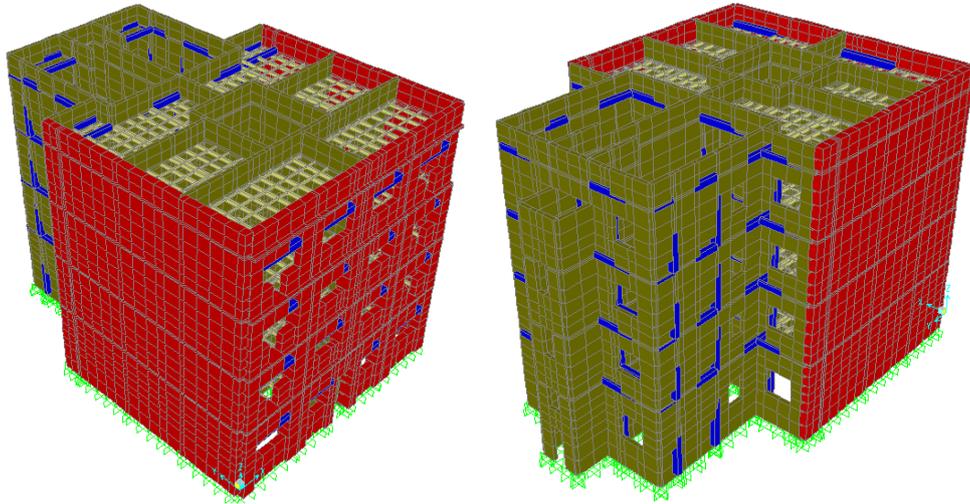
Figure 29 – 3D Model perspective.

After defining materials, the structural elements of the building and the values of the mass, the model has been analysed, in a general way. Figure 29 and Figure 30 show various views of the model, to provide a general insight of the model defined.

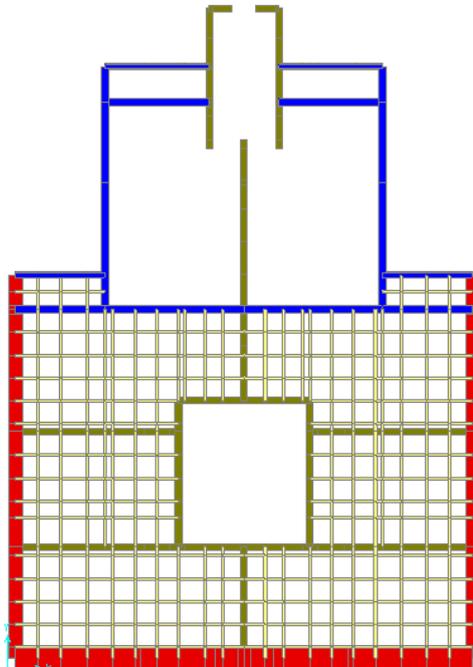
Figure 30 - Plant model of the building.

The foundations were considered fully restrained, because most of the settlements have already occurred and the land has good features according to the geological map of the area (e-Geo).

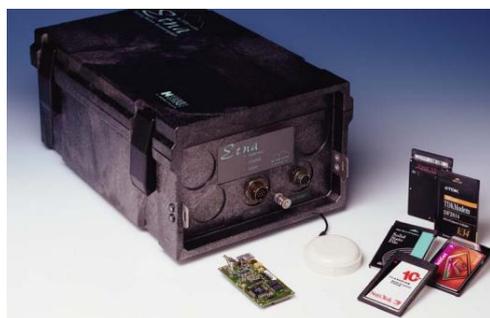
These devices are brand Kinematics model Etna, with internal sensors Episensor, whose specifications are listed in the following (Figure 31 and Figure 3.2):

- Dynamic range greater than 135dB;
- Bandwidth of the DC sensor to 200 Hz;

- Full-scale is selectable through hardware-between 0.25 g and 4.0 g (corresponding to the gravitational acceleration g) and are particularly adjusted for low frequency vibrations (0-10 Hz).

Figure 32 – Etna device (Kinematics)

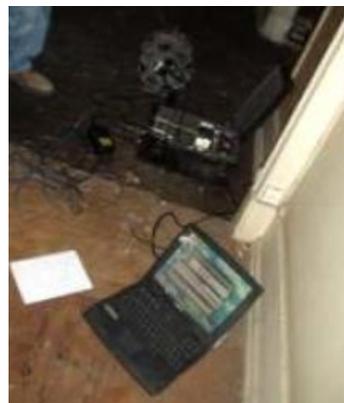
Figure 31 - Equipment connected to computer, which read the signals of acceleration in each direction.

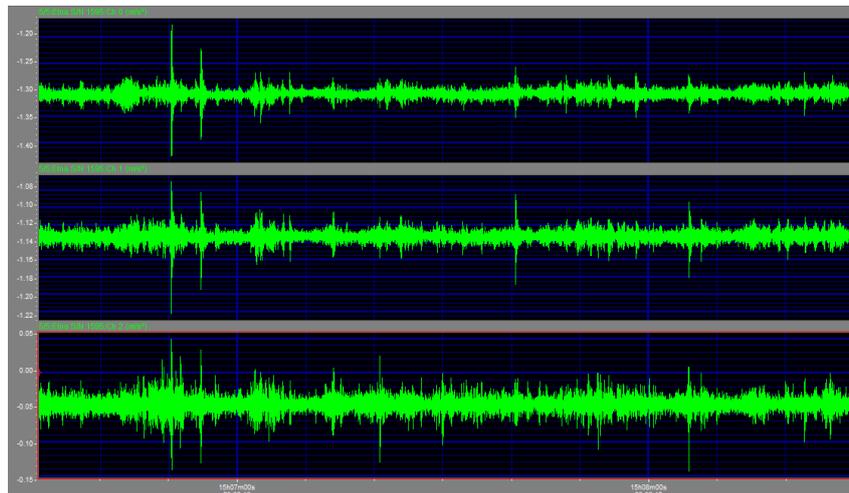
The following graph (Graph 1) shows an example of the GE002 recorded accelerogram for each channel. The signals from the other tests are similar. The program used for reading the accelerograms called TSoft (TSoft).

Graph 1 - Accelerogram recorded for the test GE002: the signals correspond to channel of the X-Y-Z direction by this order; the maximum amplitude is about  $0.1 \text{ m/s}^2$

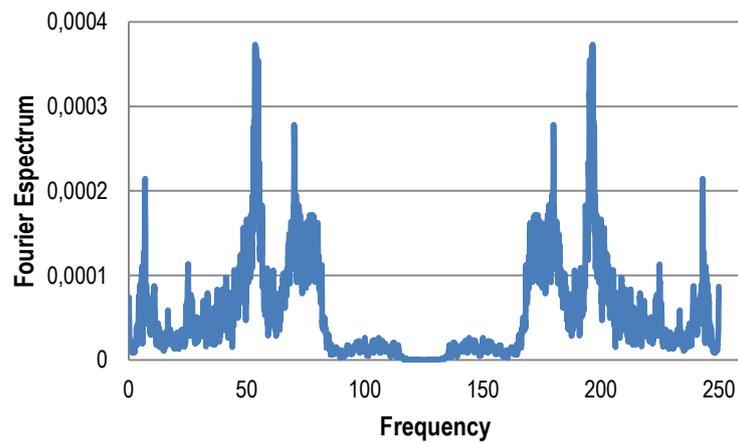
**Graph 2 – The Fourier spectrum for the record in the X channel.**

Based on all registered signals the results obtaining the Fourier spectrum that identified the natural frequencies for each direction were processed. The concepts and calculations made are shown in annex (Annex 2) (Branco, 2007). The example of the Fourier spectrum for X-direction based in all the records is shown in the graph below (Graph 2).

In the Z-direction only were recorded very high excitation frequencies, as expected, which correspond to vibration modes with small contribution of the mass, caused by vertical translations of the floor. As this direction has little practical interest to dynamic characterization of the building, it will only be analysed in greater detail the results from the X and Y channels.

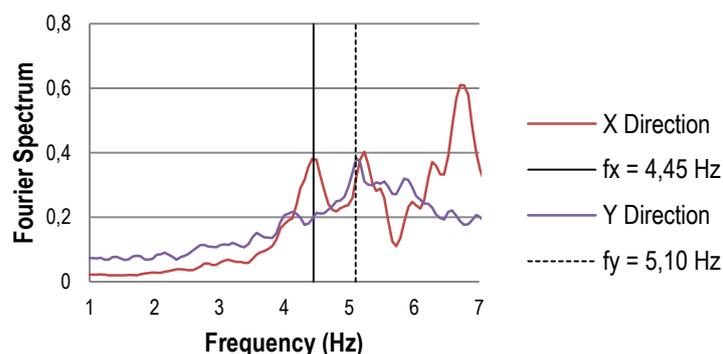
Graph 3 – Fourier Spectrum in each direction between the 1 and 7 Hz.

The Graph 3 represents the overlap of both Fourier spectra (X and Y directions) for the range between 1 to 7 Hz, which corresponds the main frequencies of the building under study.

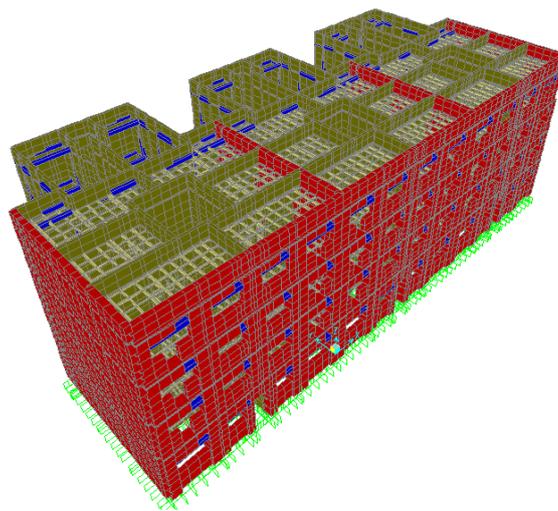
Figure 34 – The model with the adjacent buildings in each side.

Since the frequencies obtained experimentally were high, it was considered relevant to the study the building take into account in the model the influence of adjacent buildings, which somehow increase the stiffness due to the quarter effect. So in the model, the building has been replicated for each of the sides with the same properties (Figure 34).

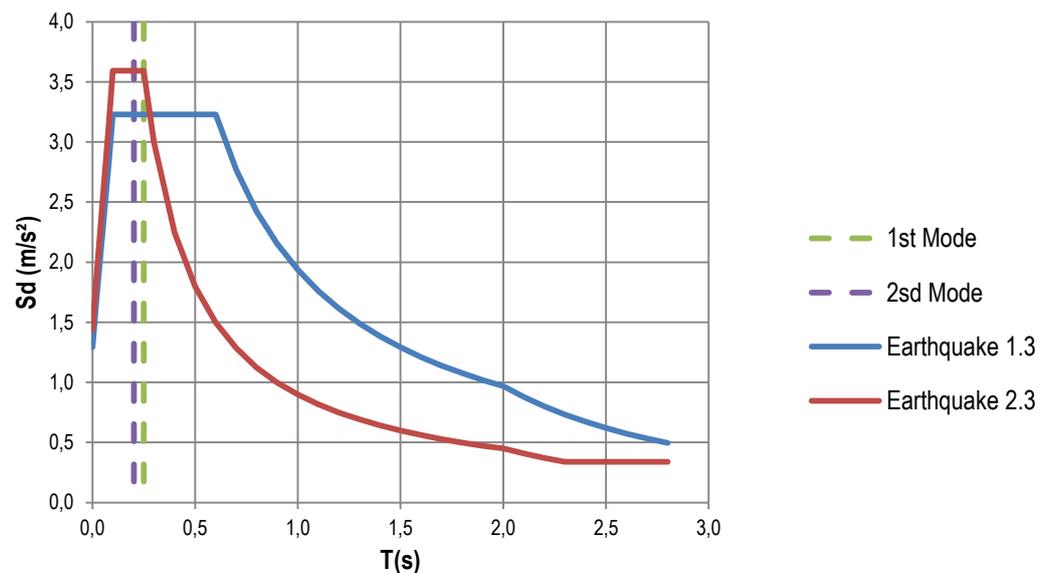
Graph 4 - The design spectrum for the both earthquakes

Thus, the required parameters for the both response spectra were calculated, which are illustrated in Graph 4.

By analysing the graph, it is observed that the earthquake 2.3 is the determinant earthquake according to the fundamental periods of the structure (the periods correspondent to the first and second modes are depicted in the graph).

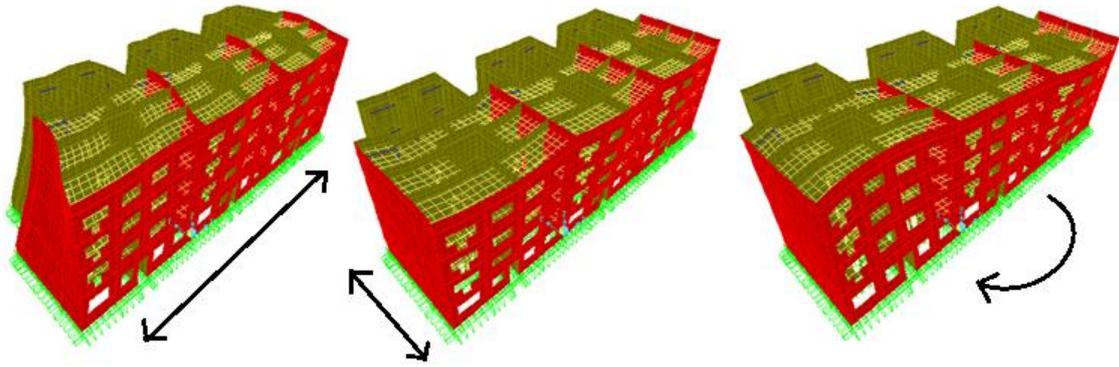
Figure 35 - The first three vibration modes of the model.

Modes	Period [s]	Frequency [Hz]	Translation in X		Translation in Y		Rotation in X	
			%	$\Sigma$ %	%	$\Sigma$ %	%	$\Sigma$ %
1	0.24	4.12	0.64	0.64	5.1E-09	5.1E-09	0.24	0.24
2	0.20	5.03	1.8E-08	0.64	0.70	0.70	0.12	0.36
3	0.19	5.24	3.6E-04	0.64	4.9E-08	0.70	0.32	0.68
4	0.18	5.67	2.0E-07	0.64	4.9E-03	0.70	8.2E-04	0.68
5	0.16	6.18	0.09	0.74	5.7E-09	0.70	0.02	0.69
6	0.14	7.00	0.00	0.74	8.1E-09	0.70	0.01	0.71

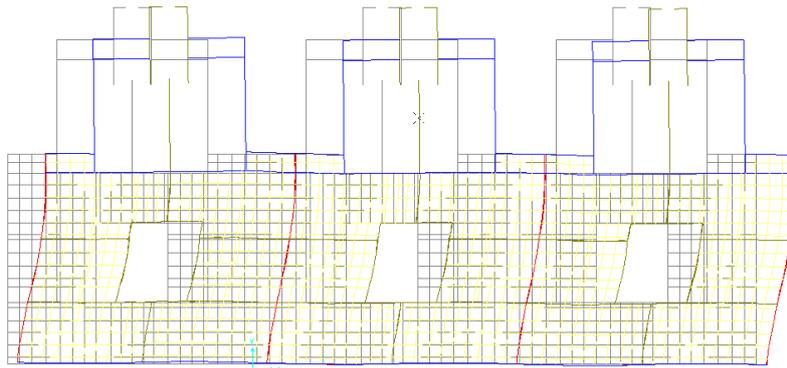
The first mode has a natural frequency of 4.12 Hz and has a participation of mass around 65%. This vibration mode is an overall translation of the building according to X-direction, because is the direction which has a smaller rigidity due to having only the façade wall (with openings) as a resistant wall.

Figure 36 - The first vibration mode of the model.

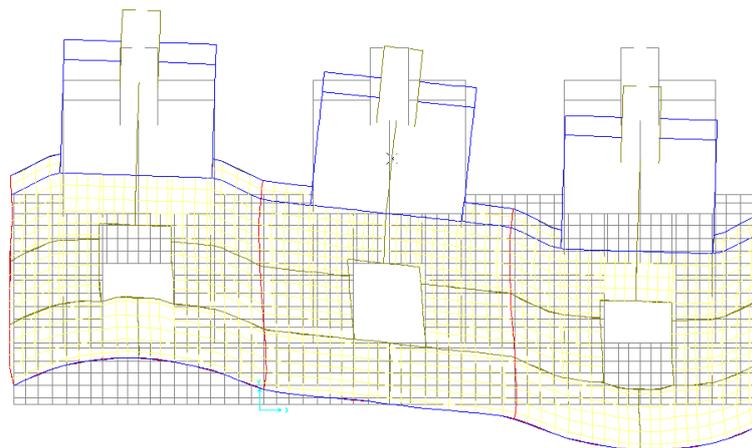
**Figure 38 – The third vibration mode of the model**

Finally, the third mode vibration is a global torsional mode with a frequency of 5.24Hz but only with 30% participation of mass, with the effect of aggregate buildings restricts the rotation capacity.

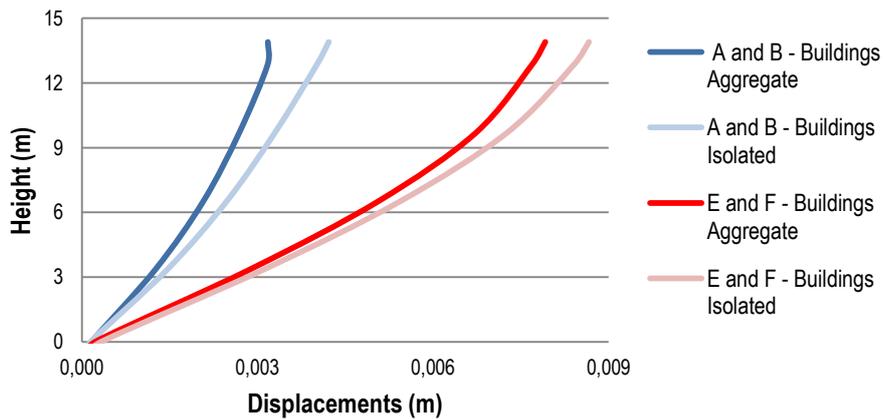
Graph 5 – Displacements in X direction for each model considering the building isolated and the building aggregate.

Taking into account only the difference on the behaviour of the structure isolated and the one inserted on the quarter, from Graph 5 can be observed that the horizontal displacement in the longitudinal direction (alignment of front façade) is larger when the structure is considered isolated, as expected.

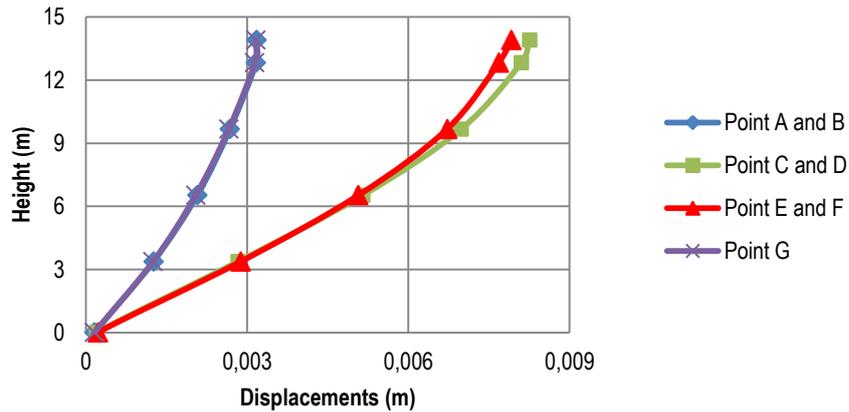
Graph 7 – Displacements in X direction for the model adopted.

In the following graphs (Graph 7 and Graph 8) are indicated the displacements in different points at the building plant, according the Figure 39, along the height and in both directions of the model adopted for the study.

In relation to the values of displacements at the back of the building (point E and F), it can be observed that these are higher than the displacements in alignment of the front façade (except for point G), since this part of the building works almost like an isolated body, that has only one constraint which connects the central body, and it has more mass on the floors due to the concrete slab (i.e. higher inertia forces). So this body on the back is more flexible and therefore has greater displacement, where the displacements in the x-direction are greater than the y-direction.

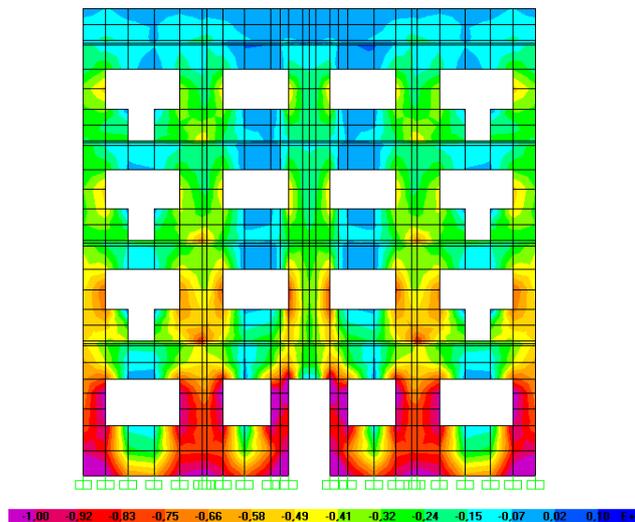
Figure 41 - Vertical stress diagram for the masonry of the façade due to the seismic load combination (maximum compression stress)

In general, according with the distribution of stresses in the masonry presented in the previous figures, there is a stress concentration close to the openings. In fact, the corners of the doors and windows are areas of stress concentration because of the discontinuities that existing in the façade (Figure 42). This zones corresponding to the areas where the cracking is expected.

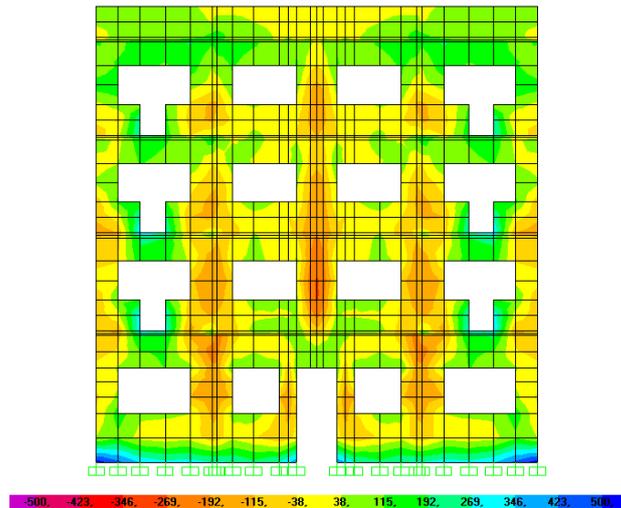
**Figure 42 - Vertical stress diagram for the masonry of the façade due to the seismic load combination (maximum tensile stress)**

In the vertical elements of the façades at the level of the ground floor there are considerable axial tensile stresses (Figure 42) but which do not exceed the resistance values (just 60% of the total). Although it is considered that the joints between the stone elements of masonry does not resist to tensile forces, the occurrence of tensile stresses do not mean occurring directly the collapse of the structure but only some tensile cracks in the joints.

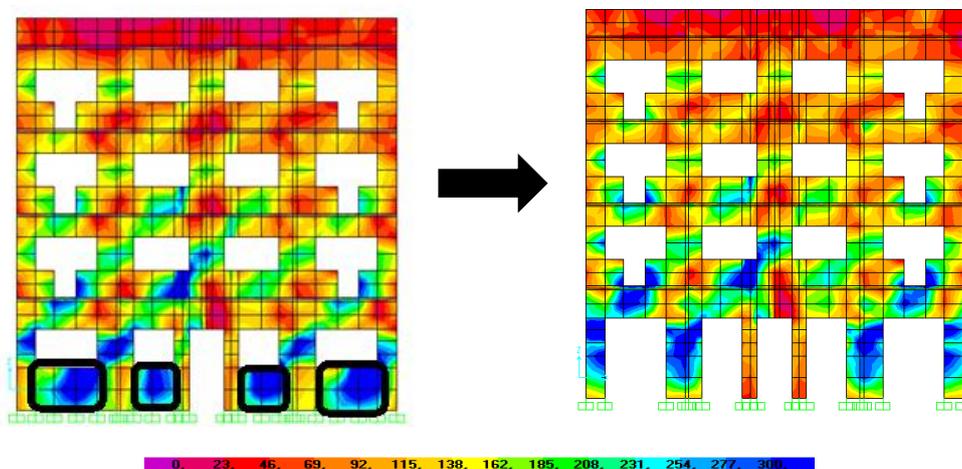
Figure 44 - Shear stress diagram for the masonry of the façade due to the seismic load combination – the areas with reduced thickness are neglected in the model.

Thus, in a parallel study it was decided to remove the masonry elements in those areas of the model, ignoring their contribution in order to verify the difference in the behaviour of the shear stresses in the façade (Figure 44).

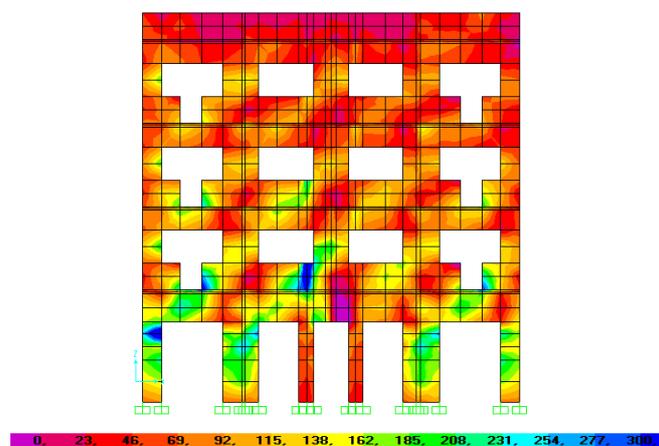
**Figure 45 – Shear stress diagram for the masonry of the façade due to the seismic load combination with a reducing of 65% according the Italian Regulation.**

After reducing the intensity of the seismic action as suggested in Italian Regulation, a reduction of shear stresses around to 0.2MPa was verified, as shown in Figure 45. However the values are still higher in the base of the façade than the maximum strength (0.1 MPa).

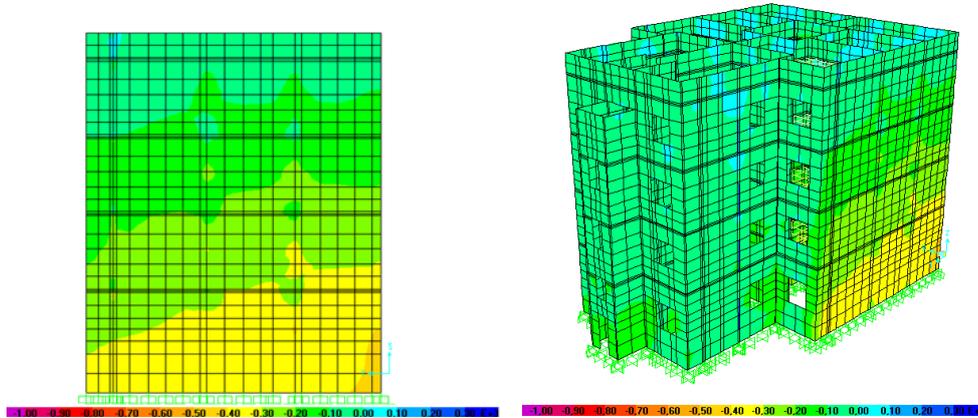
Figure 46 - Vertical stress diagram for the elements of the gable wall and exterior walls due to the quasi-permanent loads.

Since the stress distribution in the both gable walls is equal, it was decided only show one side of the building.

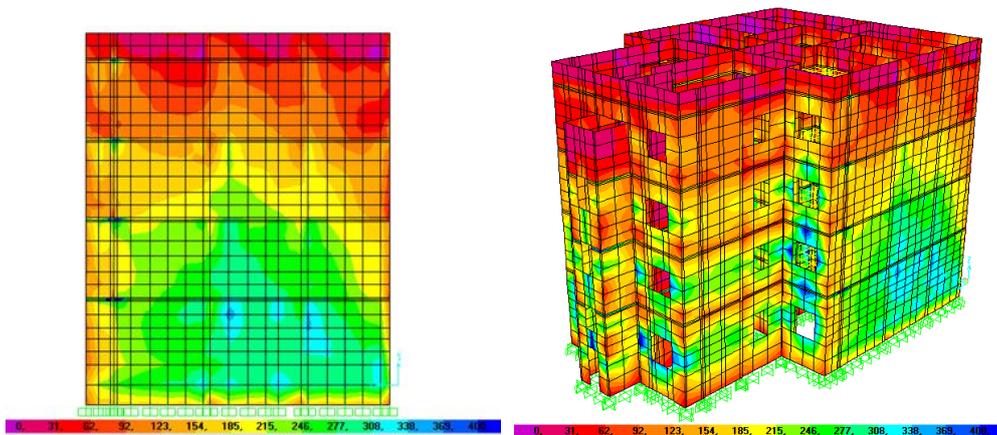
Figure 49 - Shear stress diagram for the elements of the gable wall and exterior walls due to the seismic load combination.

For the shear stresses, Figure 49 shows higher values than the resistant values in the area of the 1st floor in the gable wall.

In this case, the first damage (cracking) in these elements will occur for lower values of the seismic intensity estimated. However, according to Oliveira (2009), the reduction in stiffness of the gable walls associated with increase of the cracking due to increase of the seismic action, can give rise to the redistribution of the efforts in the structure, which by itself does not change significantly the behaviour of these elements.

Besides that, there are also high shear stresses in the exterior walls of brick masonry, mainly close to de windows that are near to the gable walls. However, in this part of the building there is also a reinforced concrete structure, so that it is not just the masonry walls which resisting to the seismic loads. The question remains whether the reinforced concrete structure is in good conditions and if it has the enough resistance.

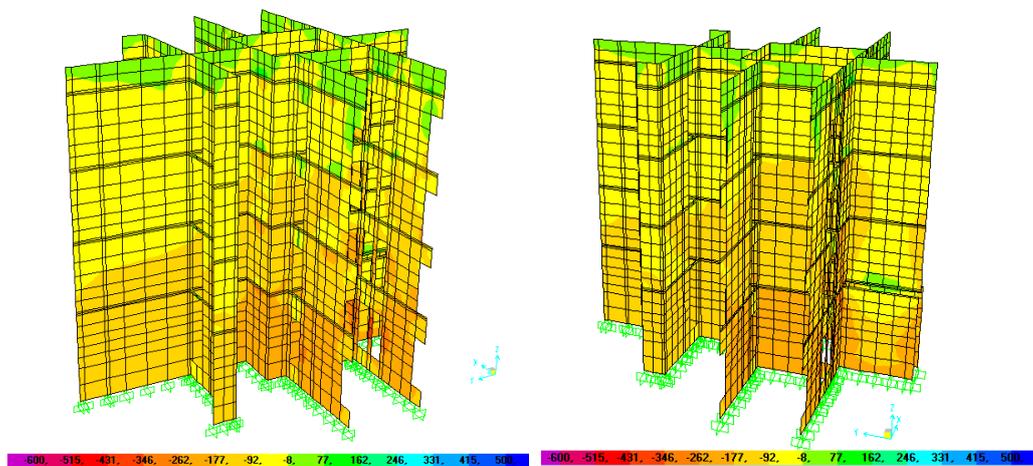
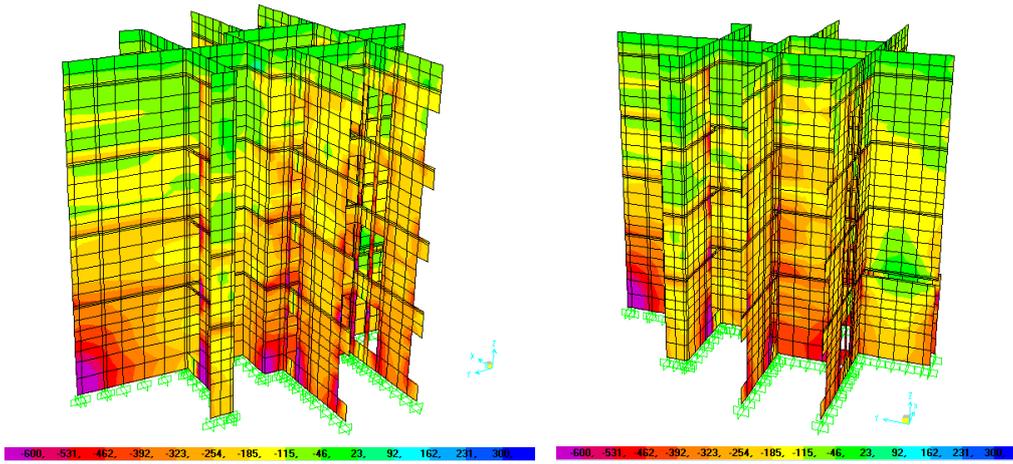
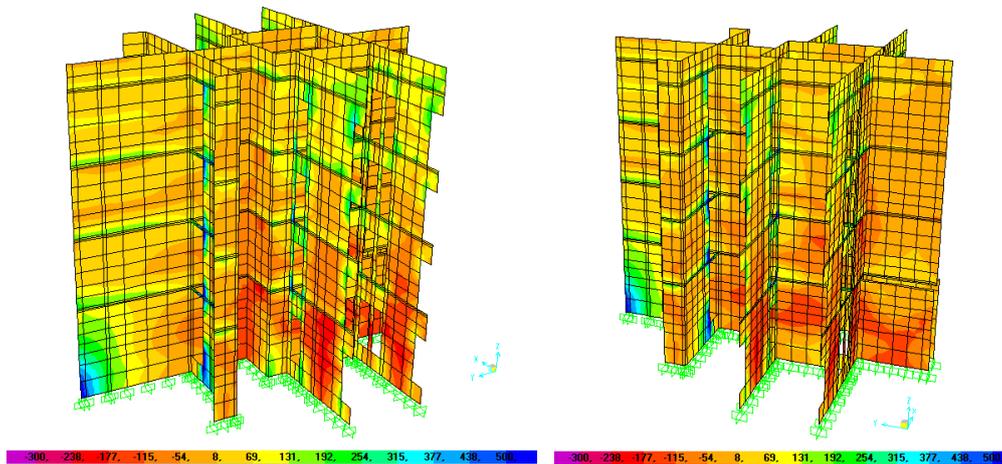
In this section are presented, from Figure 50 to Figure 53 the stress distribution in the interior walls of brick masonry. It is essential to refer again that these walls have a significant importance in the resistance of the structure, because there is not a load distribution of the floor due to the wooden floor neither vertical elements that supporting the vertical loads.

Figure 50 - Vertical stress diagram for the masonry of the interior walls due to the quasi-permanent loads.

**Figure 51 - Vertical stress diagram for the masonry of the interior walls due to the seismic load (maximum compression stress).**

**Figure 52 - Vertical stress diagram for the masonry of the interior walls due to the seismic load combination (maximum tensile stress).**

In relation to the compression stresses, it is in the base of the walls that higher values are shown, as expected. However these values are smaller than the capacity ones. For the tensile stresses, there are high values in the area of the openings as well as the base of the walls; however these areas are not significant to the overall resistance of the structure.

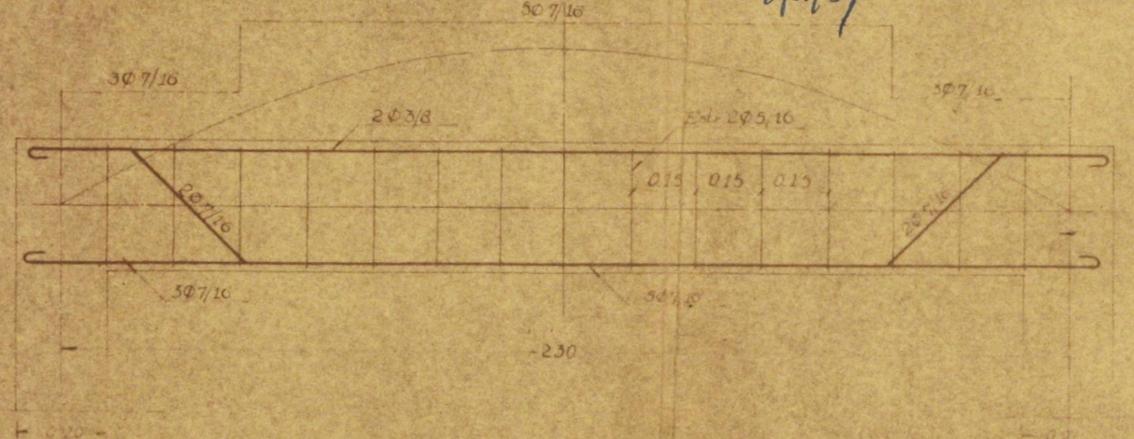
VIGAS B<sub>5</sub> e B<sub>6</sub>

h<sub>t</sub> = 30 cm b = 13 cm

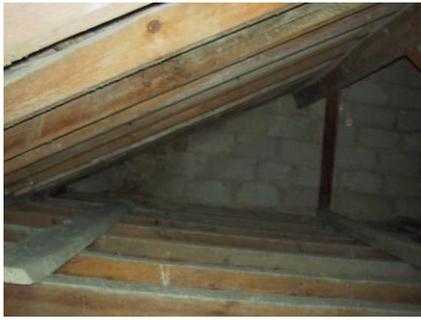
This building has the same structural elements than the building on study. The façade wall is made by rubble masonry, the gable walls by concrete blocks and the interior walls made by brick masonry. In relation to the floors, on the front there is a wooden floor and on the back there is a concrete slab supported on the reinforced concrete frame.

**Figure 6 – Photograph of the gable wall.**

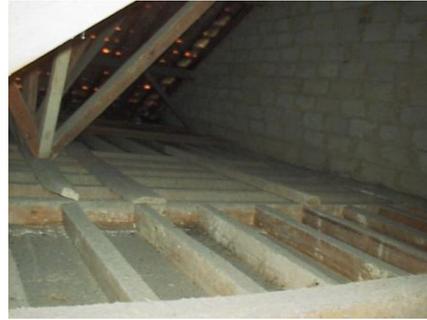
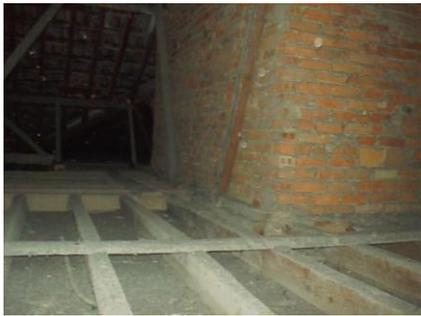
**Figure 7 - Photograph of the stair wall on the coverage.**

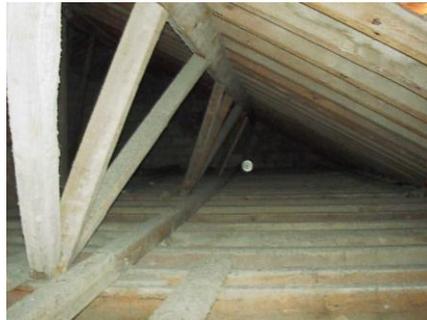
**Figure 8 - Wooden structure on the coverage**

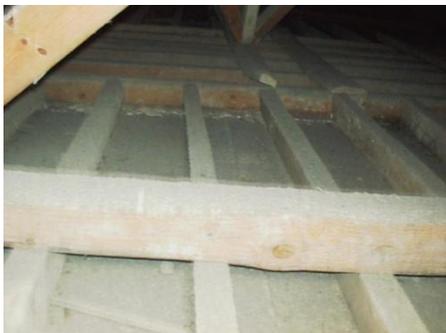
**Figure 9 - Wooden floor on the roof**

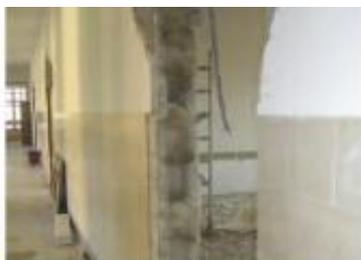
Basically, the structure of the original building consisted of load bearing walls made of stonemasonry (the exterior ones) and voided concrete blocks (the interior ones), which support the horizontal elements, beams and slabs, of reinforced concrete. The building's exterior outline and the earth retaining walls are made of stone masonry and are between 35 and 80cm thick (Figure 67). The interior voided concrete block masonry walls are 25 to 35cm thick (Figure 66). The floor slabs are of reinforced concrete and 12 to 15cm thick, and the roof slab, also made of reinforced concrete, incorporates precast reinforced concrete joists, voided concrete blocks and cast in place concrete screed (Figure 15). The floor slabs and the roof slab, reinforced in one direction with smooth steel rebars, are supported on the exterior walls (stone masonry), on the interior walls (voided concrete blocks) and on the reinforced concrete beams, with these last being supported on the exterior masonry wall and interior walls. On the ground floor, in the covered courtyard areas and the main entrance of the original building, where space had to be freed up to facilitate movement, the masonry walls were replaced by reinforced concrete columns, which support reinforced concrete beams with a generous cross-section, and these in turn support the voided concrete block masonry walls of the upper floors. The foundation ground exhibits good strength characteristics and so the foundations are direct.

Figure 13 – Voided concrete block interior masonry walls

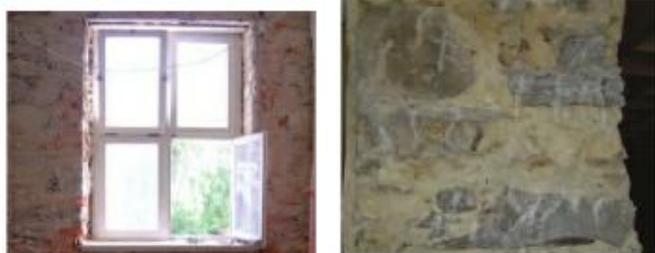
Figure 14 – Exterior Stone Masonry Walls

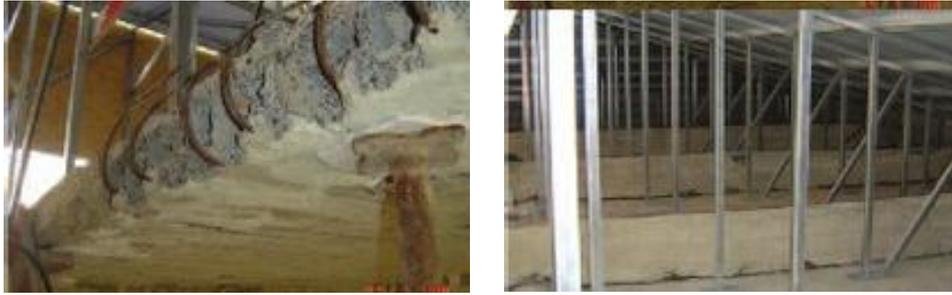
Figure 15 – Roof slab supported on inverted reinforced concrete beams

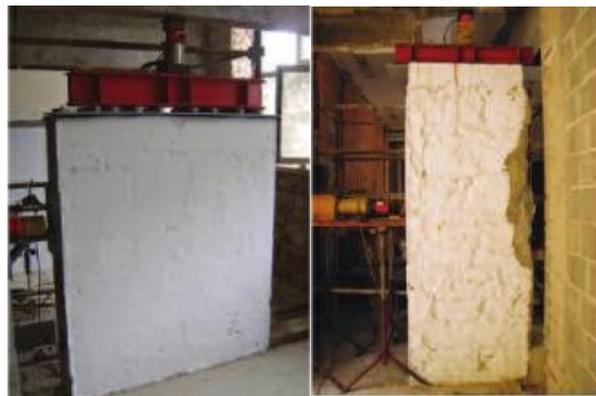
The strength behaviour of the voided concrete block and stone masonry walls was assessed by experimental tests carried out. They consisted of applying horizontal and vertical loads to stretches of the two kinds of wall in both the original state (Figure 16).

Figure 16 - General view of the two experimental models, voided concrete block and stonemasonry walls

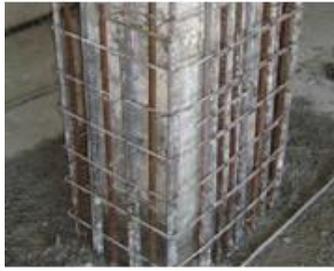
Figure 18 – Strengthening of a reinforced concrete column by jacketing. Cross section and detail

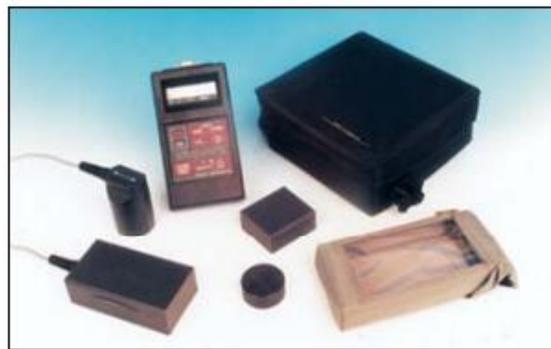
The main purpose of this test it was to confirm the existence of reinforced concrete elements in the structure as well as to confirm their position according with the Descriptive Memory (1939). So some experimental tests were conducted using the cover meter. This equipment is a sophisticated device for the non-destructive location of reinforcement and for the measurement of concrete cover, using the 'Eddy Current Theory' with pulse induction as the measuring method.

Figure 22 – Cover Meter

First, it was possible to confirm the difference between the two types of floors existing in the building (concrete slab and wooden floors). At the front of the building, the device did not detect any metallic element as was expected and on the back, the equipment detected the presence of reinforcement mesh in the zone of the concrete slab. The concrete cover for steel bar recorded ranged from 2 to 3 cm.
