Seismic Vulnerability of Old Masonry Buildings – SEVERES Project

Jelena Milošević, Rita Bento, António Sousa Gago and Mário Lopes

I. EXPERIMENTAL RESULTS

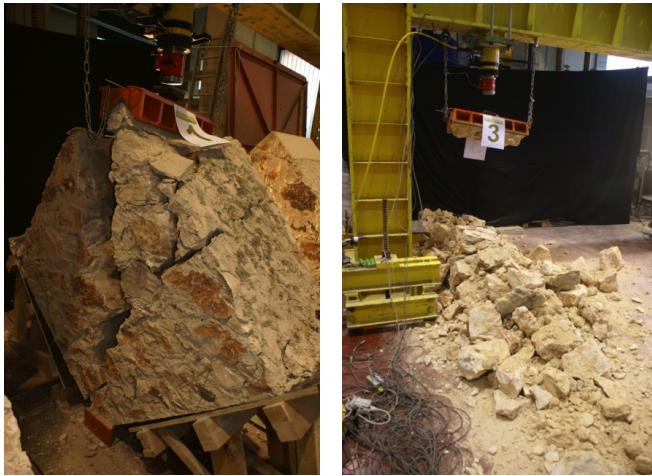
(a) Specimen W1 made with hydraulic mortar (b) Specimen W2 made with air lime mortar

Fig. 2. Collapse of masonry specimens.

Due to the different mechanical properties of mortar, the specimens showed different behavior after the collapse, despite of its brittle nature in all cases. The specimens with air lime mortar (W2 and W3) were disintegrated after the collapse, while the specimens, which were built with hydraulic mortar (W1 and W4), broke in two parts, each remaining in one piece.

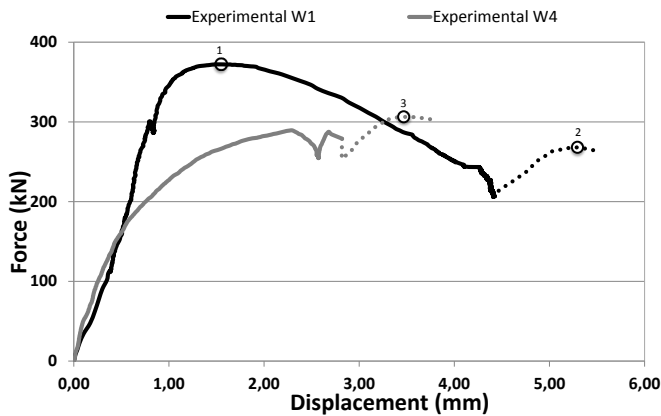
Fig. 3. Experimental results - Walls W1 and W4: Force vs. Vertical displacement diagram (note: vertical displacement measured at the top of the specimen).

2) *Masonry specimens built with hydraulic mortar:* The force-vertical displacement diagram (where vertical displacement represents average values of the measurement recorded using LVDTs 3 and 7), for the specimens with hydraulic lime mortar, is presented in Figure 3. As can be seen on this graphic the maximum load for specimen W1 was 372 kN, with a vertical shortening of 1.55 mm (Point 1). In this specimen the collapse occurred later, at a load of 268 kN and with a vertical shortening of 5.29 mm (Point 2). In specimen W4 the point on the collapse was the one at which the maximum load was applied, with a magnitude of 306 kN and a vertical displacement of 3.47 mm (Point 3). It is important to say, that this apparent ductile behavior of

specimen W1 is related to the stone arrangement, since the specimen W1 was built with horizontal stone layers, (at 45° to the external inclined surfaces), whereas the other three specimens were built with diagonal layers (45°), to be representative of the real masonry walls.

It is worth to refer, that for safety reasons, the transducers were removed before the end of the test (except the transducer that was placed under the hydraulic jack). In order to define the complete behavior of the walls, the dotted parts of the curves in Figure 3 were obtained by

interpolation using the measurement of the transducers under the hydraulic jack.

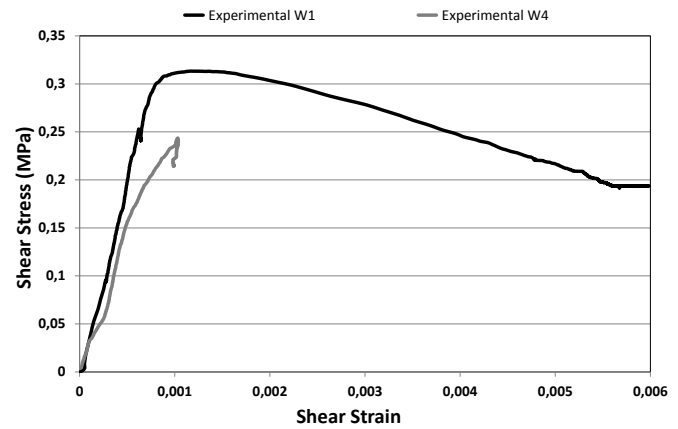
Fig. 4. Experimental results - Walls W1 and W4: Shear Stress vs. Shear Strain diagram.

The behavior of the tested panels can also be analyzed in terms of shear stress–shear strain curves, as presented in Figure 4, where the shear stress and shear strain were calculated according to ASTM standard [1]. Results for diagonal compression test are presented in Table I.

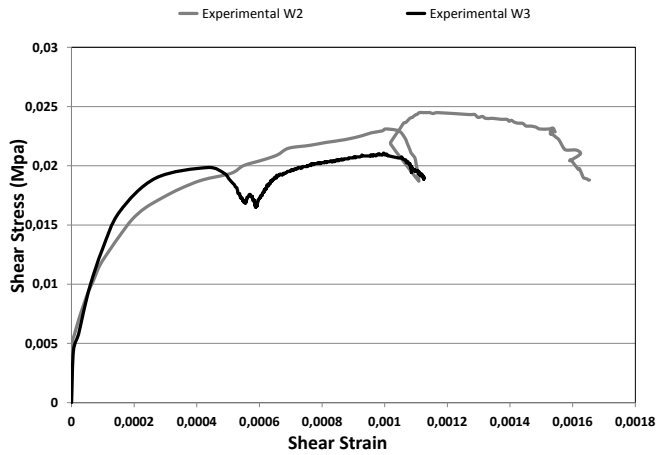
Fig. 6. Experimental results - Walls W2 and W3: Shear Stress vs. Shear Strain diagram.

The results for these masonry specimens are given in Table I. Furthermore, the curves shear stress–shear strain are determined and shown in Figure 6.

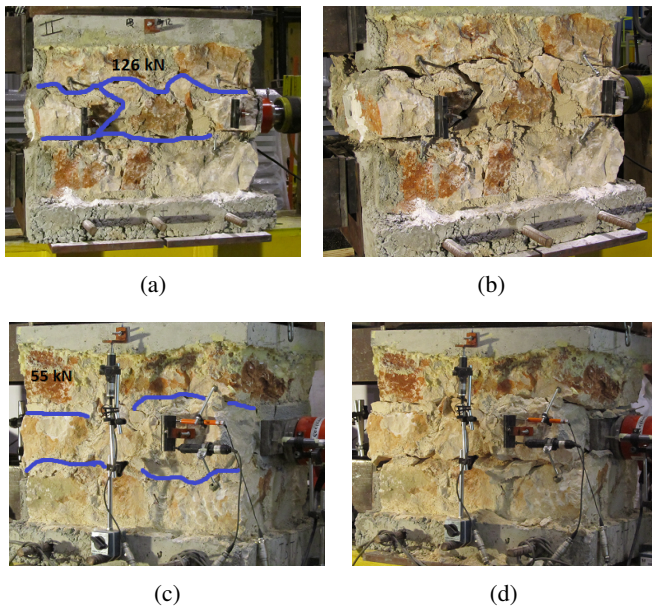
Fig. 7. Crack pattern (a) and (c) and Collapse (b) and (d) of masonry specimens: (a) and (b) specimen T1 made with hydraulic mortar; (c) and (d) specimen T7 made with air lime mortar

Nine masonry specimens were built for triplet tests. Five masonry specimens were built with hydraulic mortar, whereas the remaining four specimens were based on air lime mortar. The specimens were built with three stone layers, which lead to a shear collapse mode by

sliding of the medium layer. All specimens followed the expected failure pattern, which is represented in Figure 7.

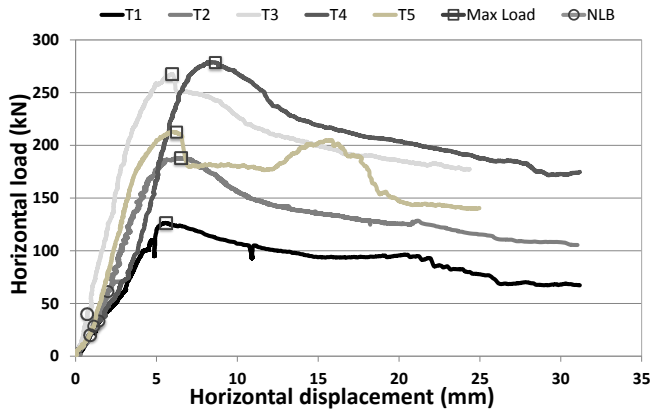
(a) Horizontal load vs. Horizontal displacement; Note: Max Load – maximum load; NLB – end of linear behavior

Fig. 8. Experimental Results for Triplet test – Walls T1; T2; T3; T4; T5 (hydraulic mortar).

1) *Specimens built with hydraulic mortar:* The experimental results for the triplet tests on specimens built with hydraulic mortar (series 1, 2, 3) are depicted in Figure 8(a). As can be seen in the load-displacement diagram (displacement was measured with transducer TSH2), the collapse load for specimens tested with a pre-compression of 0.1 MPa, were 126 kN, with an horizontal displacement of 5.56 mm, in specimen T1 and 188kN, with an horizontal displacement of 6.50 mm, in specimen T2. For a compression of 0.2 MPa the collapse load for specimens T5 was 213 kN, with horizontal displacement of 6.09 mm. Two more specimens, T3 and T4, were tested with a 0.3 MPa pre-compression level and the collapse loads were respectively, 267 kN, with an horizontal displacement of 5.95 mm, and 279 kN, with an horizontal displacement of 8.42 mm. As it was expected, higher pre-compression levels produced higher shear resistances.

In Figure 8(a) and 8(b) the points where the linear behavior ends and the points of maximum force are marked. It can be notice that the vertical displacement started to increase after the end of the linear behavior.

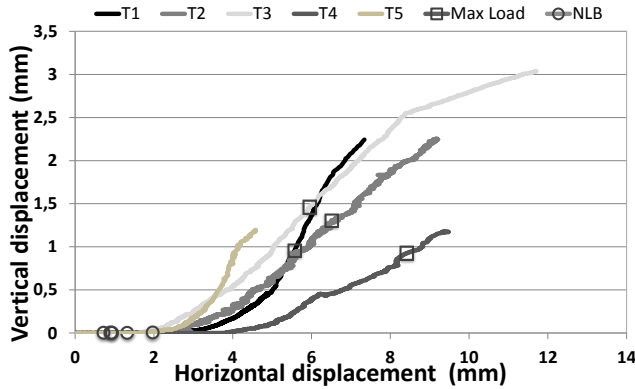
(b) Vertical displacement vs. Horizontal displacement; Note: Max Load – maximum load; NLB – end of linear behavior

An important issue regarding shear tests is the dilatant behavior of masonry joints. The dilatancy, i. e. the relation between the vertical and the horizontal strains, has a significant role in numerical modeling and can be much more relevant in rubble stone masonry walls than in brick masonry walls. Figure 8(b) shows the vertical displacement that can be considered measure of dilatancy, as a function of the horizontal displacement. It is important to note that the vertical displacement

showed in Figure 8(b) were calculated using the average of displacement recorded by LVDTs 12 and 13 and the corresponding horizontal displacement was recorded using the transducer placed on the horizontal actuator (TSH2).

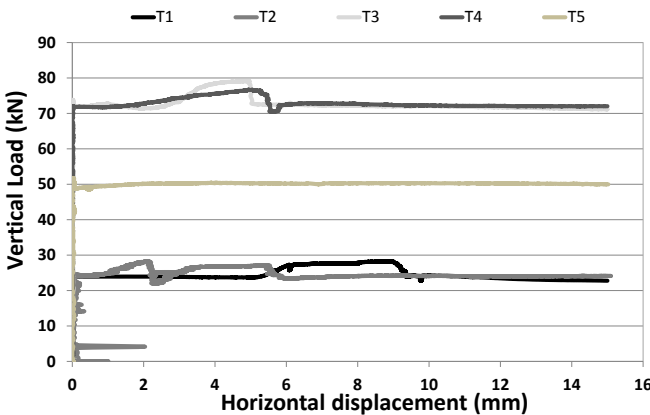
(c) Vertical load vs. Horizontal displacement

In Figure 8(c) is depicted the relation between vertical load and horizontal displacement, where it can be seen that during the tests the vertical load was almost constant, as was required.

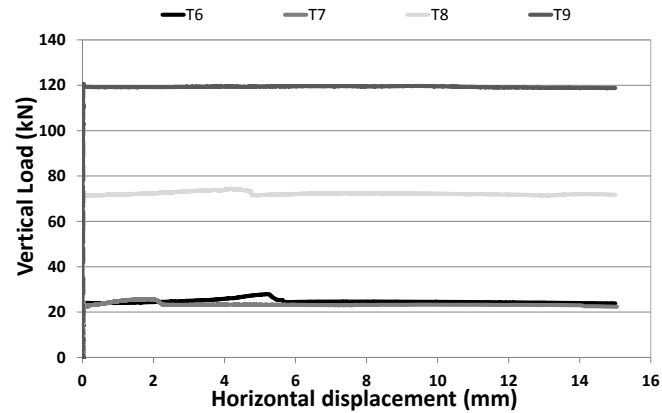
(c) Vertical load vs. Horizontal displacement

Fig. 9. Experimental Results for Triplet test – Walls T6; T7; T8; T9 (air lime mortar).

2) *Specimens built with air lime mortar:* The experimental results for the triplet tests on specimens built with air lime mortar (series 4, 5, 6) are depicted in Figure 9(a). As can be seen in the load-displacement diagram (displacement was measured with transducer TSH2), the collapse load for specimens tested with a pre-compression of 0.1 MPa, were 64 kN, with an horizontal displacement of 13.10 mm, in specimen T6 and 56 kN, with an horizontal displacement of 5.57 mm, in specimen T7. For a compression of 0.3 MPa the collapse load for specimens T8 was 139 kN, with horizontal displacement of 8.23 mm. The last specimen, T9, which was tested with compression of 0.5 MPa, showed the collapse load of 161 kN, with value of horizontal displacement 13.75 mm. Similarly, as in case of hydraulic mortar, higher pre-compression levels produced higher shear maximum loads. As already mentioned, the important issue regarding the shear tests is the dilatant behavior of masonry joints. The relation between the vertical and the horizontal displacements can be seen in Figure 9(b), where vertical displacement represents average values of the measurement recorded using LVDTs 12 and 13. In Figure 9(c) relation between vertical load and horizontal displacement can be seen and also can be noticed that vertical load was almost constant during the tests.

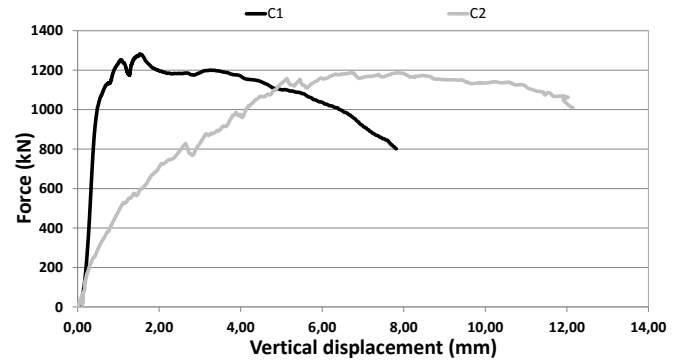
Fig. 11. Experimental results - Walls C1 and C2: Force vs. Vertical displacement diagram .

As already mentioned, the compression tests were performed on two small masonry specimen, C1 built with hydraulic lime mortar and masonry specimen C2 built with air lime mortar. The experimental results

for the compression tests are depicted in the force-displacement diagram in Figure 11. For the hydraulic lime specimen (C1) the collapse load was 1282 kN, with vertical displacement of 1.53 mm, whereas for the air lime specimen (C2) the collapse load was 1186 kN, with vertical displacement of 6.71 mm. Results for compression test are presented in Table III. The Table III also shows the Youngs Modulus (secant value at 1/3 of the ultimate load). The behavior of tested panel was also analyzed in terms of compressive strength-strain curves, as can be seen in Figure 12.

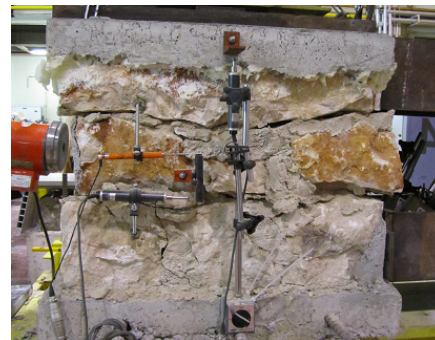
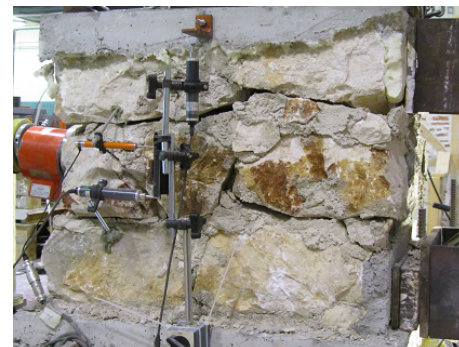
(a) Crack pattern of the specimen T2

(b) Collapse of the specimen T2

(c) Crack pattern of the specimen T3

(d) Collapse of the specimen T3

(e) Crack pattern of the specimen T4

(f) Collapse of the specimen T4

(g) Crack pattern of the specimen T5

(h) Collapse of the specimen T5

Fig. 14. Crack pattern and Collapse of masonry specimens made with hydraulic mortar

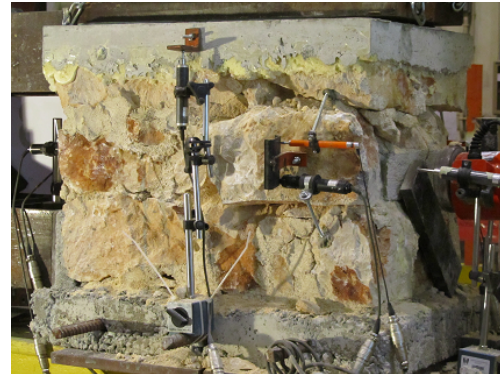
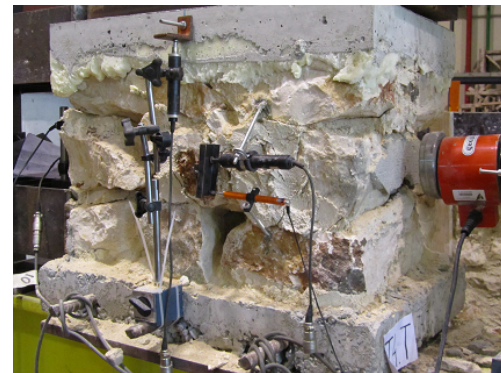
(a) Crack pattern of the specimen T6

(b) Collapse of the specimen T6

(c) Crack pattern of the specimen T8

(d) Collapse of the specimen T8

(e) Crack pattern of the specimen T9

(f) Collapse of the specimen T9

Fig. 15. Crack pattern and Collapse of masonry specimens with air lime mortar.

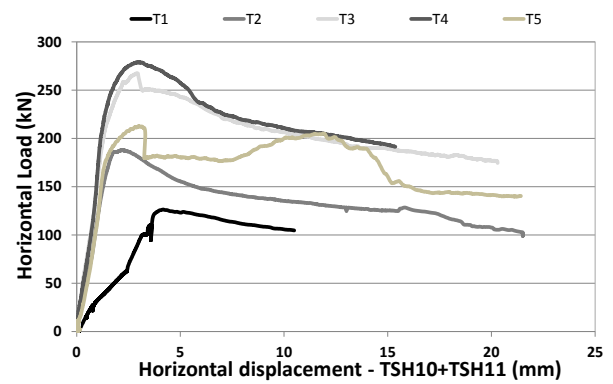
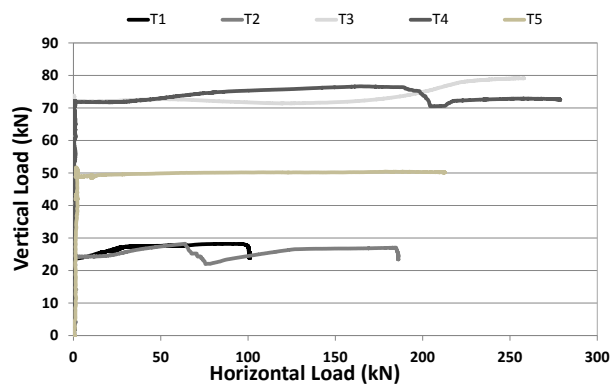
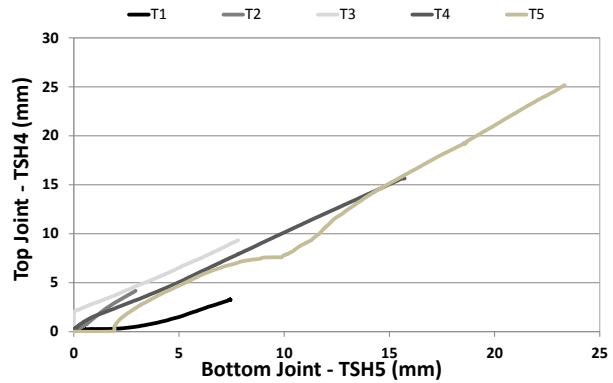
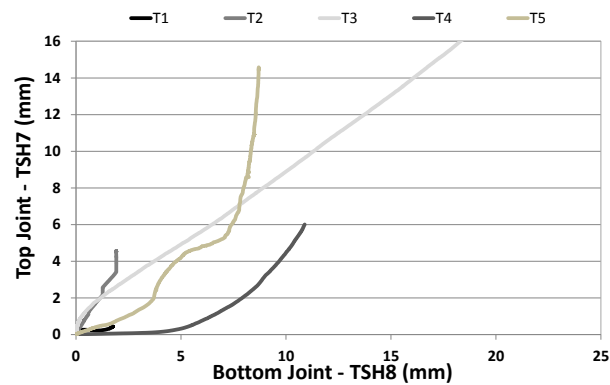
(a) Horizontal load vs. Horizontal displacement-TSH1 and TSH3

(b) Horizontal load vs. Horizontal displacement-TSH10 and TSH11

(c) Vertical load vs. Horizontal load

(d) Relation between the horizontal displacement of the joints-TSH4 and TSH5

(e) Relation between the horizontal displacement of the joints-TSH7 and TSH8

Fig. 16. Experimental Results for Triplet test – Walls T1; T2; T3; T4; T5 (hydraulic mortar).
