Experimental Tests on Rubble Masonry Specimens – Diagonal Compression, Triplet and Compression Tests

J. Milosevic, A. S. Gago, M. Lopes & R. Bento

ICIST, IST, Technical University of Lisbon, Portugal

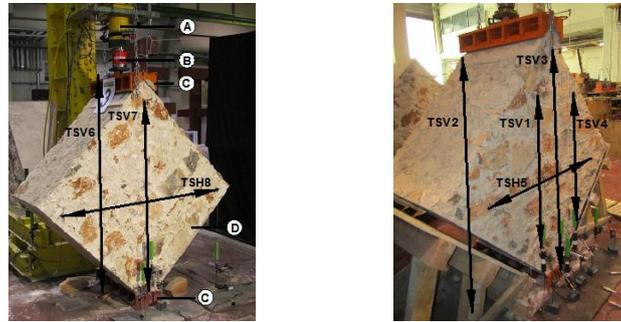
The test setup is composed of two steel loading shoes, which were fixed on the two opposite corners on the panels. The load is applied to the panel by a hydraulic jack on the steel loading shoes positioned on top of the specimen and transmitted to the other shoe which was placed at the bottom of the specimen, as can be seen in Fig. 2.1(a).

Figure 2.1. Test setup and Position of transducers for diagonal compression test
A – Hydraulic Jack; B – Load cell; C – Loading shoes; D – Masonry specimens

The shortening of the vertical diagonal and the lengthening of the horizontal diagonal under load were measured with linear voltage displacement transducers (named TSV and TSH, respectively) placed on both sides of the specimens. Nine transducers were placed on each specimen (Fig.2.1), namely five transducers on one specimen's side, three transducers on the other side and one transducer to measure vertical displacement under the hydraulic jack. In order to avoid any damage of the instrumentation, the transducers were removed when the behavior of the specimen started to indicate that it could be close to failure. After that the load was continuously applied until the collapse of the specimen.

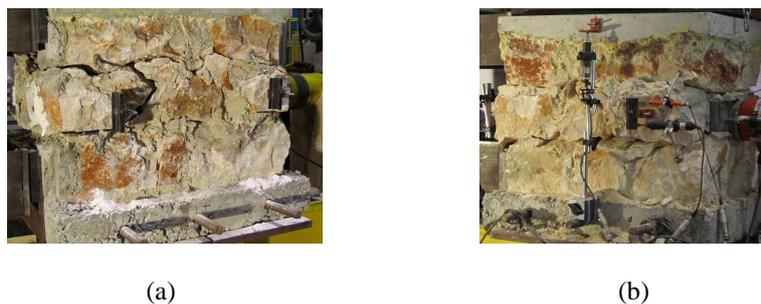
As already referred, nine masonry specimens were built for triplet tests. Five masonry specimens based on hydraulic mortar, whereas the remaining four specimens were based on air lime mortar. The specimens were built with three stone layers, which lead to a shear collapse mode by sliding of the medium layer. All specimens followed the expected failure pattern, which is represented in Fig. 3.7.

Figure 3.7. Collapse of masonry specimens: (a) specimen T1 and (b) specimen T7
