EVALUATION OF THE SEISMIC PERFORMANCE OF AN OLD MASONRY BUILDING IN LISBON

M.S. LOPES

Instituto Superior Técnico, Departamento de Engenharia Civil, Av. Rovisco Pais 1, 1000 Lisboa, Portugal

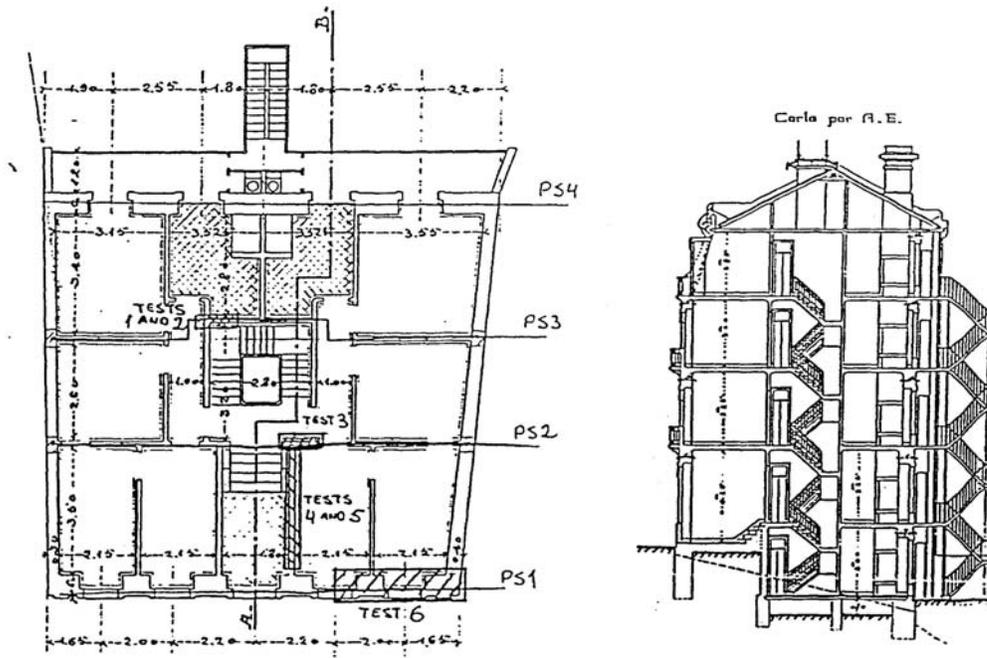
Fig. 1 Ground floor plan and vertical cut AB

The building comprised five floors, including the ground floor. There are two flats per floor with entrances to the stair landing. Figure 1 shows the ground floor plan of the building and a vertical cut. The materials used were:

levels and vertical wood members at the corners. These members are connected to the rest of the walls by steel dowels spaced approximately 40 cm. The dimensions of the bricks are $23 \times 11.5 \times 6.5 \text{ cm}^3$ with a 1.5 cm cover on either side.

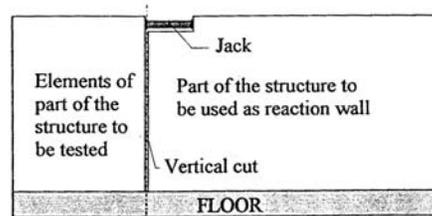
Fig. 2 Test arrangement

The tests had to be planned in such a way that the necessary set-up could be placed in position very quickly. Therefore it was not possible to use reaction walls or frames. Instead, parts of the building had to be used for that purpose. Thus, all the tests followed the organisation shown in fig. 2, with part of the existing structure used as reaction wall. The weight of the jacks was supported in general by the part of the structure used as reaction wall. The instrumentation comprised one load cell to measure the applied force and one or two sets of three transducers to measure horizontal displacements of the elements to be tested at three vertical levels. The transducers were fixed to a scaffold independent of the elements being tested, thus measuring absolute displacements.
