## VULNERABILITY ASSESSMENT IN EDUCATIONAL BUILDINGS – INFERENCE OF EARTHQUAKE RISK. A METHODOLOGY BASED ON SCHOOL DAMAGE IN THE JULY 9, 1998, FAIAL EARTHQUAKE IN THE AZORES

M.A. Ferreira<sup>1</sup>, J.M. Proença<sup>2</sup> and C.S. Oliveira<sup>3</sup>

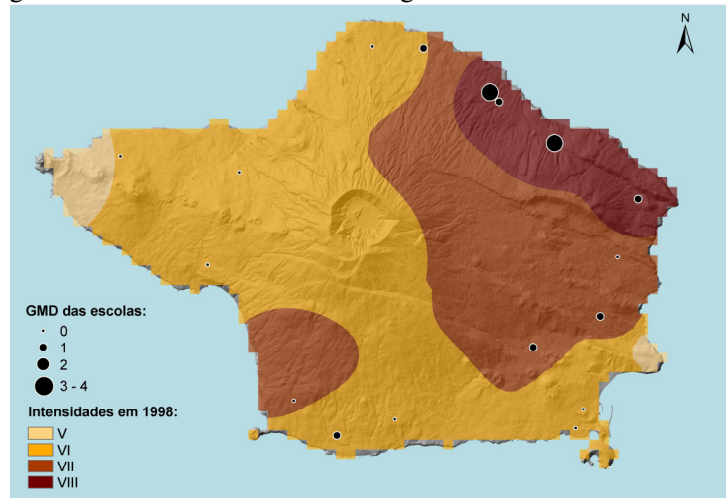
Figure 2 Isoseismal map of the 9 July 1998 Faial earthquake and mean damage grade

The detailed scenario illustrated in Figure 2 shows different levels of earthquake intensity obtained from Faial event. With this intensity values and knowing each vulnerable index was possible to obtain results similar of the referenced from post-earthquake inspection data; a mean damage grade,  $\mu_D=3$  and  $\mu_D=4$ , was obtained for the intensity VIII as observed after the earthquake. These two schools with mean damage grade equal to 3 and 4 consists in unreinforced masonry buildings with manufactured stone units and traditional constructions (rubble

stone), respectively, having little resistance to lateral loading which increases the chances of collapse.

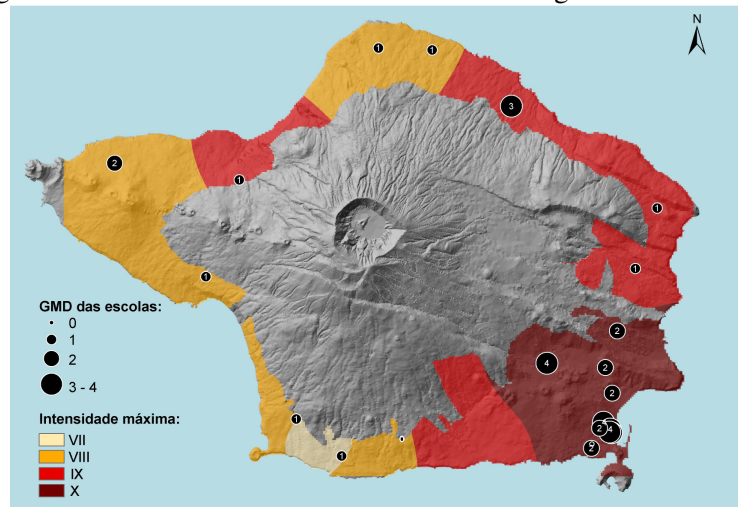
Figure 3 Mean damage grade assuming maximum intensities

Table 4 and Figure 3 refer the mean damage grade that could occur in each school building considering the maximum intensity for each locality.

The city of Horta and considering a maximum intensity X must be expected very heavy damages ( $\mu_D=4$ , heavy structural damage and very heavy non-structural damage) due to a high percentage of buildings of high

vulnerability. We conclude that both the variation in building types as well as local soil conditions significantly affect the mean damage grade and should be taken into account in damage scenario modelling.
