Characterization of Lisbon Old Buildings

A. Simões, M. Lopes, R. Bento & A. Gago

IST, Technical University of Lisbon, Portugal

This paper focuses on the characterization of old masonry buildings in Lisbon, where four typologies of buildings are typically recognized: buildings built before 1755, ‘Pombalino’ buildings built after the 1755 Earthquake, ‘Gaioleiro’ buildings built between 1870 and 1930 and ‘Placa’ buildings, a short-term structural solution which precedes the reinforced concrete buildings. One major concern for the engineering communities is the seismic susceptibility of this type of buildings and the potential life and property loss. The assessment existing buildings must be supported on their chronologic evolution, including the survey of structural modifications and causes of degradation. Given the cultural and economic value attached, structural interventions and retrofitting schemes may be fitted to the different typologies in order to maintain and emphasize, as much as possible, their original design.

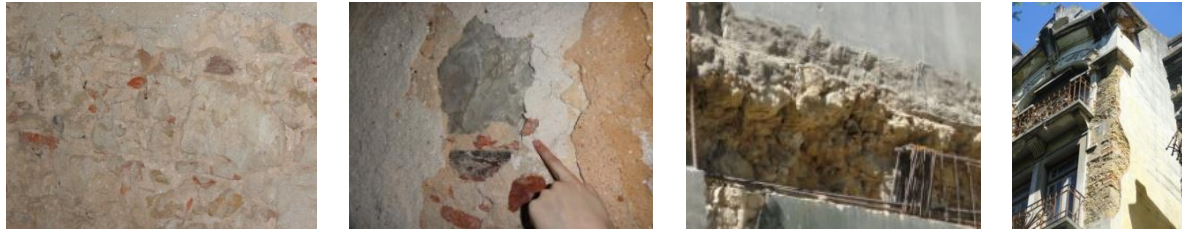
Figure 1. Rubble stone masonry walls.

Old masonry buildings are mainly composed by thick masonry walls arranged in perpendicular planes and relatively flexible wooden floor diaphragms. The irregularity of masonry stones (composition and shape), the quality of the mortar and the workmanship significantly affect the structural performance of the construction (Figure 1). The bearing capacity of masonry walls is mostly guaranteed by the internal compressive stresses and by the friction generated between the elements (cohesion). The mortar was usually made with good quality sand, from the Leiria pine forest, and air lime in a ratio of approximately one part to the double (1:2, 2:5, 5:9) or even stronger (3:5) (Appleton, 2005). The exterior masonry walls have a decreasing thickness from bottom to top; however, over the centuries the wall thickness was also reduced.

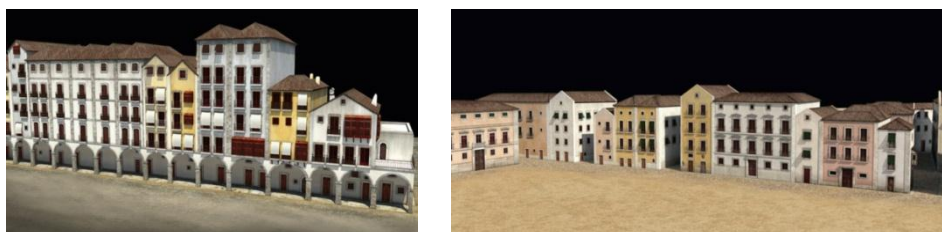
Figure 4. Reconstruction Model of the city in 1755 (Museu da Cidade, 2010).

The buildings that remain after the 1755 Earthquake belong to a very heterogeneous group. Actually, it is not possible to define a specific typology of buildings, as they emerged from several centuries of history without a proper urban planning. Though, at Castelo de São Jorge hill (Alfama, Mouraria and Castelo districts) and Bairro Alto, it is still possible to find original architectonic features. For instance, older buildings usually have a narrow front façade and pitched roofs to the side (Figure 4). Access to the upper floors is made next to the side masonry walls through one flight stairs.

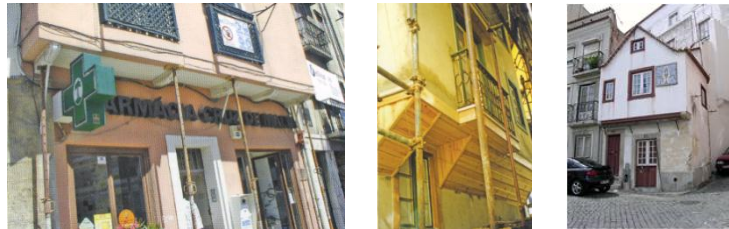
Figure 5. Buildings with rebounded ground floor (Museu da Cidade, 2010) (Lopes, 2008).

The interior walls are mainly composed by ‘tabique’ walls made of timber laths nailed to vertical joists, filled by rubble masonry and air lime mortar. Their structural role has to be individually assessed, regarding the conservation of the materials and the connection between elements. The floors and roof structure were made of rounded joists and reused wood elements, explaining the diversity of the solutions. Some buildings have a rebounded ground floor, as the upper floors stand out on the front façade wall increasing the interior space (Figure 5).

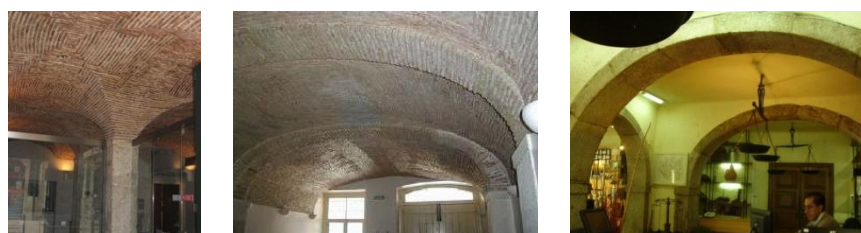
Figure 7. Masonry crossed vaults, barrel vaults (Appleton, 2003) and arches on the ground floor.

The buildings were supported on a timber grid laid on short timber piles intended to stiffen the alluvial soil and to create a working platform above the water level (Appleton, 2003). The general foundation system consisted in continuous masonry walls or caissons filled with rubble masonry covered by a group of arches. The building ground floor was entirely built in stone masonry. Vaults and arches support the first storey floor (Figure 7), while the upper floors were composed by timber beams usually placed perpendicular to the rubble stone masonry façade walls.

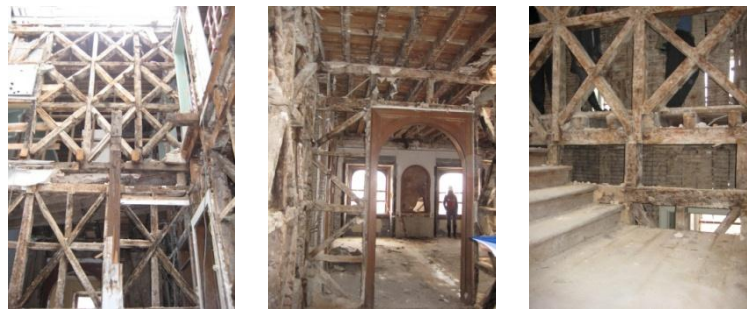
Figure 9. Structural variations of the ‘frontal’ walls on the building.

The ‘Pombalino’ reconstruction was extended for almost one century; hence structural variations are expected within the uniformity and regularity of the original designs. For instance, it has been reported the discontinuity of the timber structure of the ‘frontal’ walls between floors. From Figure 9 it is possible to realize that, on one hand, there is no connection between the vertical joists that would ensure the direct transition of loads and, on the other hand, the configuration of the truss structure changes between the floors. Moreover, above the doors’ frame, the timber structure is only composed by vertical joists, interrupting once more the truss structure.

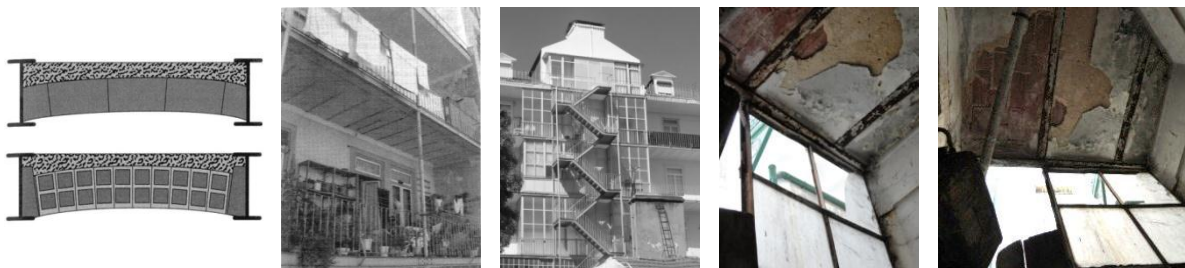
Figure 14. Metallic structures on the back façade wall (Appleton, 2005) and oxidation problems.

The back façade walls are recognized by the steel balconies or galleries and service staircases (Figure 14). The balconies were built with iron beams in shape of I or T profile (around 0.20 m height) and brick masonry disposed in vaults, interconnected by air lime mortar or cement. Nonetheless, the degradation of these structures is very common.

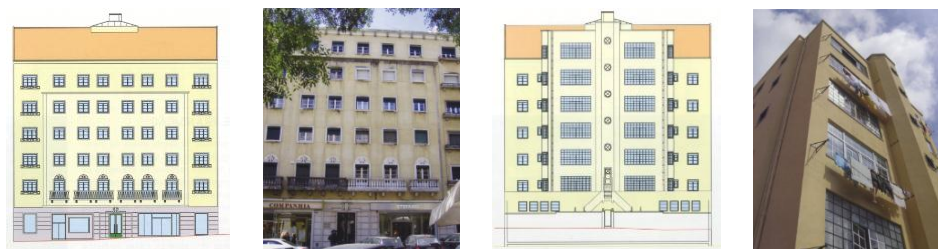
Figure 17. Front and back façade walls of a ‘Placa’ building in Guerra Junqueiro Avenue (Lopes, 2008).

The reinforced concrete frame structures started to appear at the ground floor of the buildings for commercial occupation where larger spans on the front wall and open spaces were needed. At this level the exterior walls were also built making use of hollow concrete blocks (Figure 17). The structural differences between the ground floor and the upper floors results in important stiffness variations on the buildings, leading to interruption of the interior walls on the first floor.

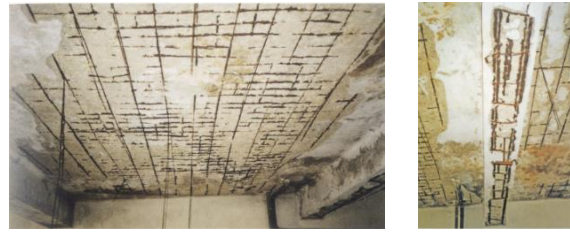
Figure 18. The corrosion of the steel is common and leads to the spalling of concrete cover (Lopes, 2008).

concrete used on the buildings has a low to moderate resistance class (C20/25 on the best cases) and was slight compact. There are, in addition, problems of excessive deformability of the slabs, and pathologies related with the corrosion of the reinforcement (Figure 18) and concrete carbonation.

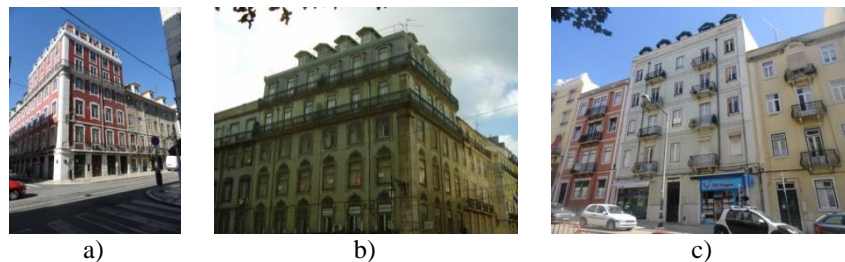
Figure 19. ‘Pombalino’ buildings: a) and b) increasing number of floors; and c) ‘Gaioleiro’ buildings with different heights in its original conception.

Ancient buildings have experienced several structural interventions mostly motivated by different uses and needs of occupation. Numerous ‘Pombalino’ buildings have now more stories than their original design (five storey height including attic) added at the end of the nineteenth century in reaction to the increasing population in the city (Figure 19 a and b). On the other hand, the ‘Gaioleiro’ compounds were originally design with no restrictions to the height of the buildings (Figure 19 c). This structural variation brings important irregularities within the group behaviour related with the increment of the plan eccentricity between mass and structural stiffness, which may originate major torsional effects during the action of an earthquake.

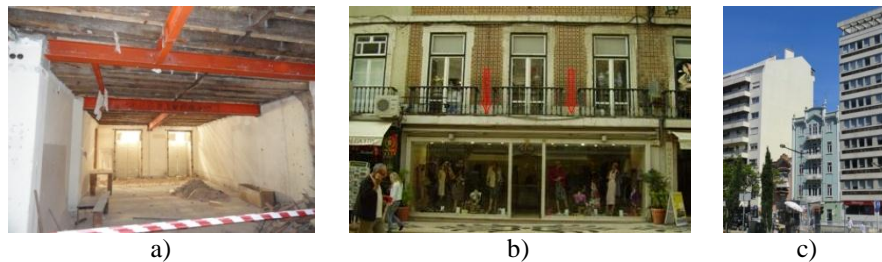
Figure 20. Example of structural modifications: a) elimination of interior walls replaced by steel beams; b) cut of the vertical façade elements on the ground floor; c) new reinforced concrete buildings within the old masonry compounds of buildings.

Other common modifications are related with the elimination of interior walls regarding the enlargement of the existing rooms (Figure 20 a) and the elimination of the masonry piers from the ground floor providing larger openings (Figure 20 b). Steel or reinforced concrete beams (pre-fabricated) are usually introduced in the place of the removed walls, supported in new columns (steel or reinforced concrete) or simply supported on the adjacent walls (interior or exterior). Nevertheless, the vertical discontinuous alignment of the walls might result on the excessive deformation of the overlying walls and floor that lose their original support system, and decrease the lateral support of the exterior masonry walls.

Currently, many old masonry buildings have been replaced by new reinforced concrete structures, coexisting in the same compound buildings with different structural conceptions (Figure 20 c). Even though, there are some cases where the old masonry façade walls are still part of the new building, the
