# Experimental investigations on wall-to-diaphragm connections

PhD student: Maria Pia Ciocci

ISISE, University of Minho, Portugal

# Pullout tests at EPFL

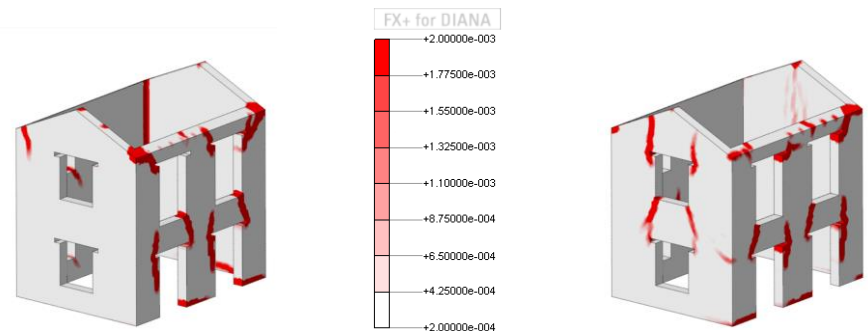
## Numerical model

Ciocchi et al. (2020)

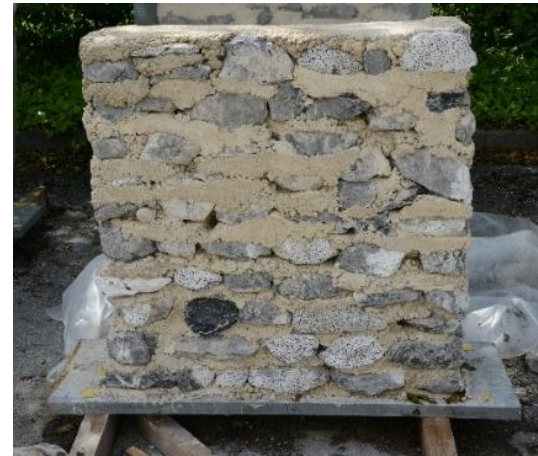
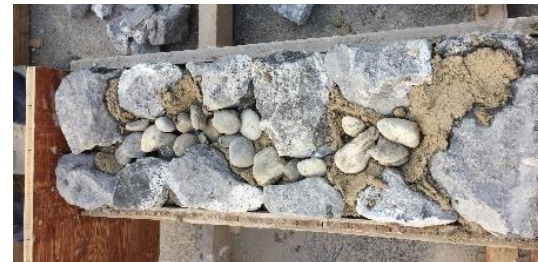
## Walls

- ☐ Double-leaf masonry
- ☐ 900 x 900 x 300 mm<sup>3</sup>

## Anchoring system

- ☐ 16 mm diameter bars embedded 250 mm
- ☐ Epoxy resin adhesive (Hilti HIT-RE 500)

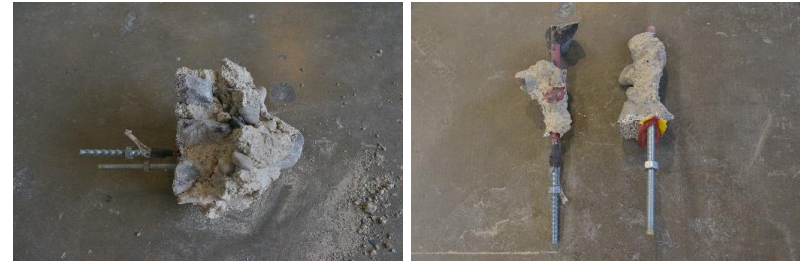
## Damage

- ❑ Combined cone-bond failure with higher participation of the cone breakout
- ❑ Cracking at interface mortar/stone, mortar and stones

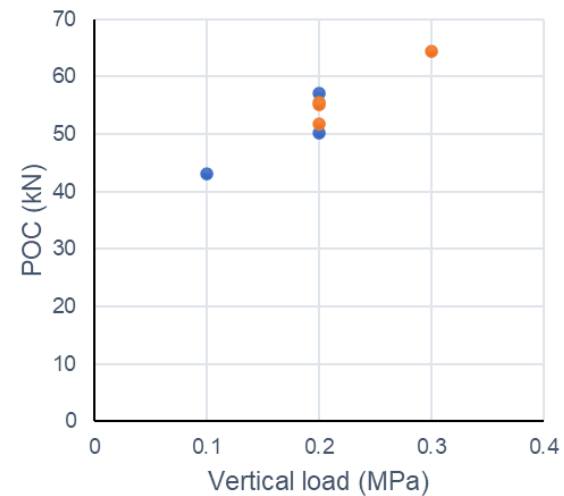
## Pullout capacity (POC)

- ❑ No significant difference under same vertical load
  - $\sigma_v = 0.20$  MPa
    - POC (parallel) =  $53.7 \pm 4.8$  (kN)
    - POC (inclined) =  $54.1 \pm 2.1$  (kN)

● Parallel anchors    ● Inclined anchors

- ❑ Influence of vertical loading
