DEVELOPMENT OF MULTI-HAZARD RISK INDICATORS FOR IMMOVABLE CULTURAL HERITAGE (Fire Vulnerability Assessment)

Ph.D. Student: Luis Gerardo Flores Salazar
University of Porto Faculty of Engineering

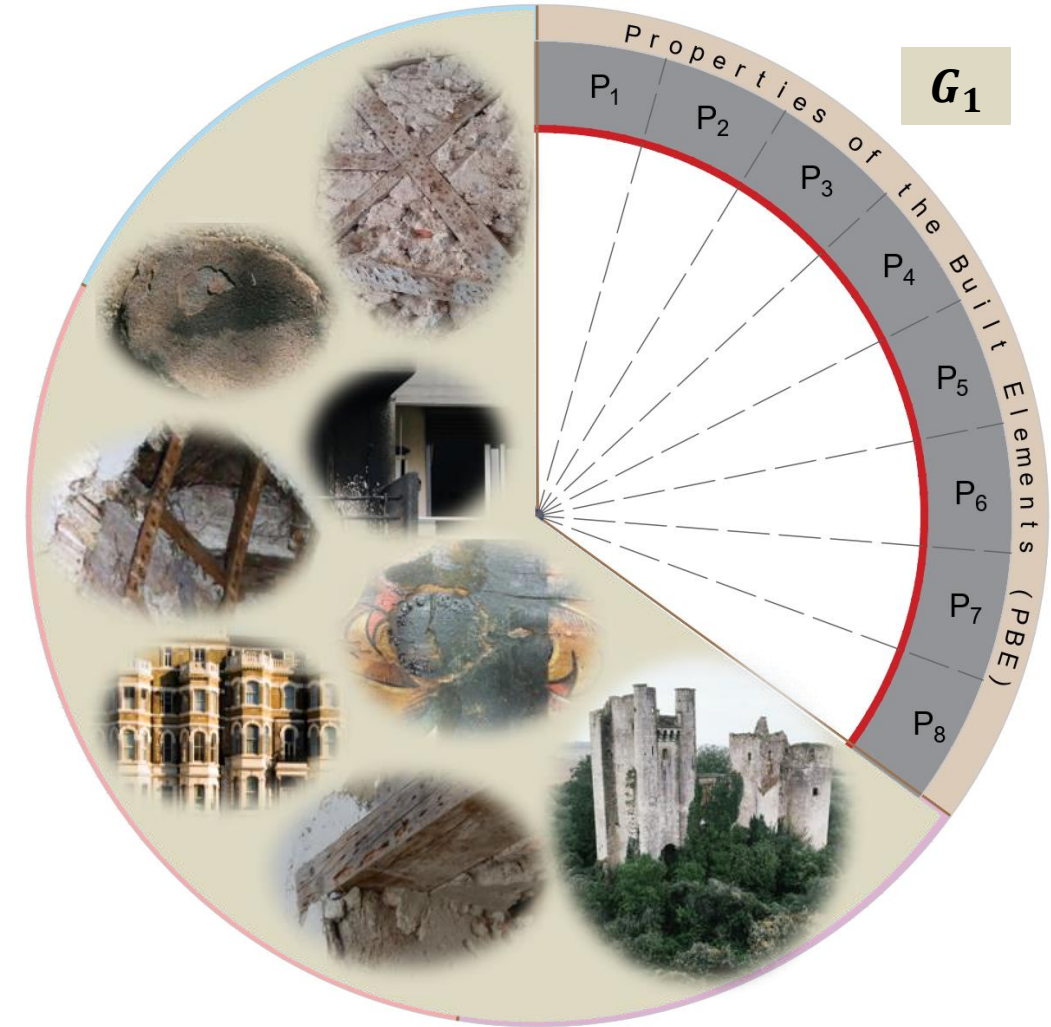
G₁ – Properties of the Built Elements (PBE)

The first category refers to indicators related to the physical properties of the building and immediate surroundings **that influence the impact of a fire to its cultural value.**

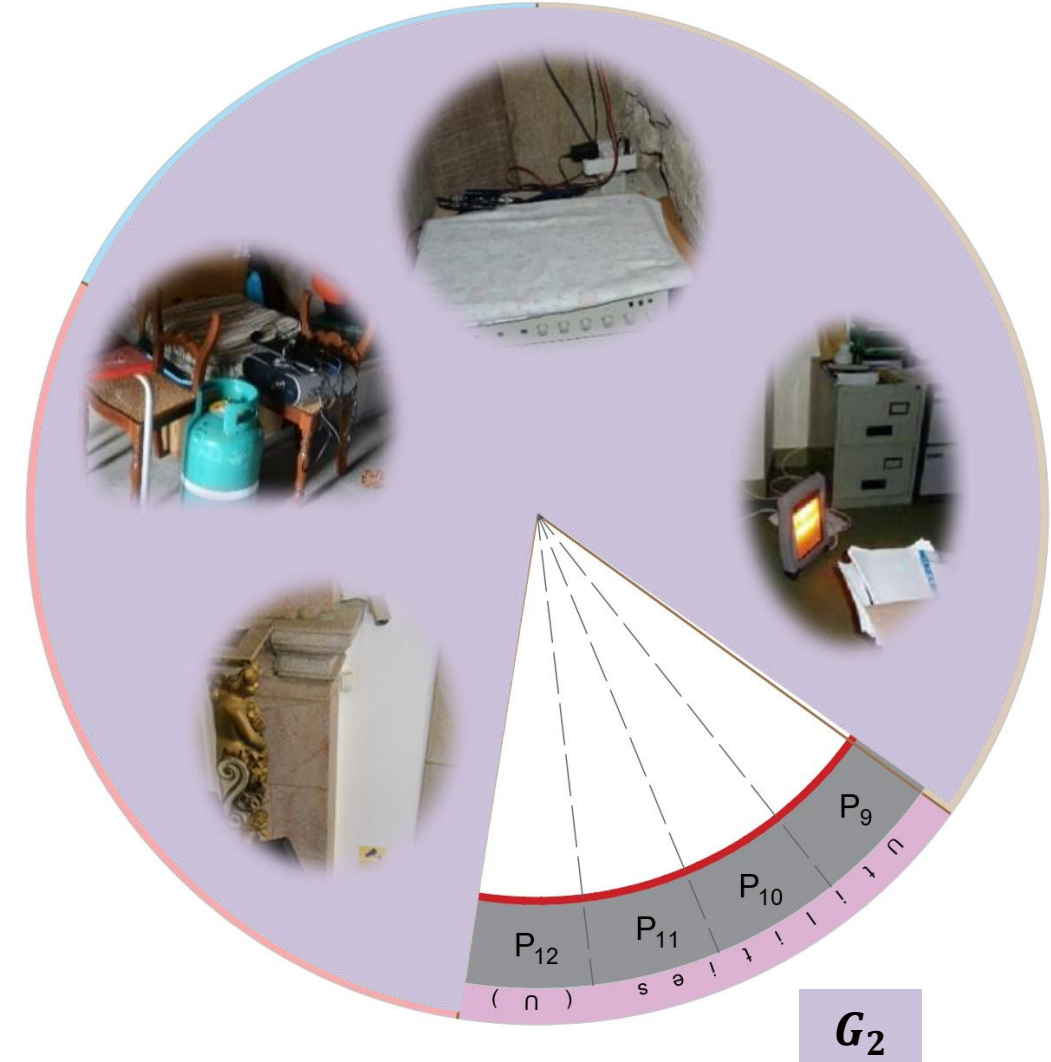
G₂ – Utilities (U)

The second group of indicators is based on the characteristics and components of the existing **utilities that can facilitate the occurrence or propagation of a fire due to their maintenance conditions, or contribute to increasing the overall fire safety.**

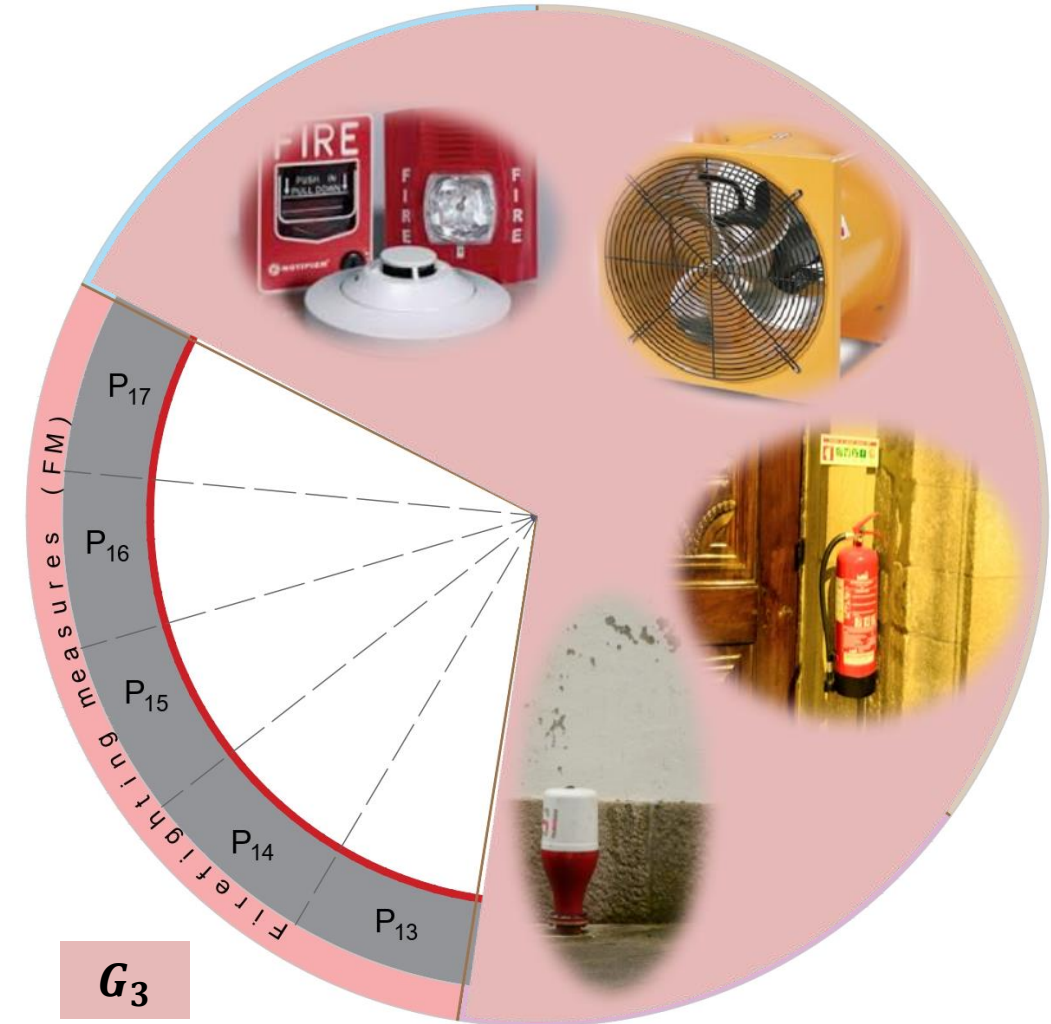
G₃ - Firefighting Measures (FM)

The third group involves indicators that account for **fire mitigation measures once it starts**.

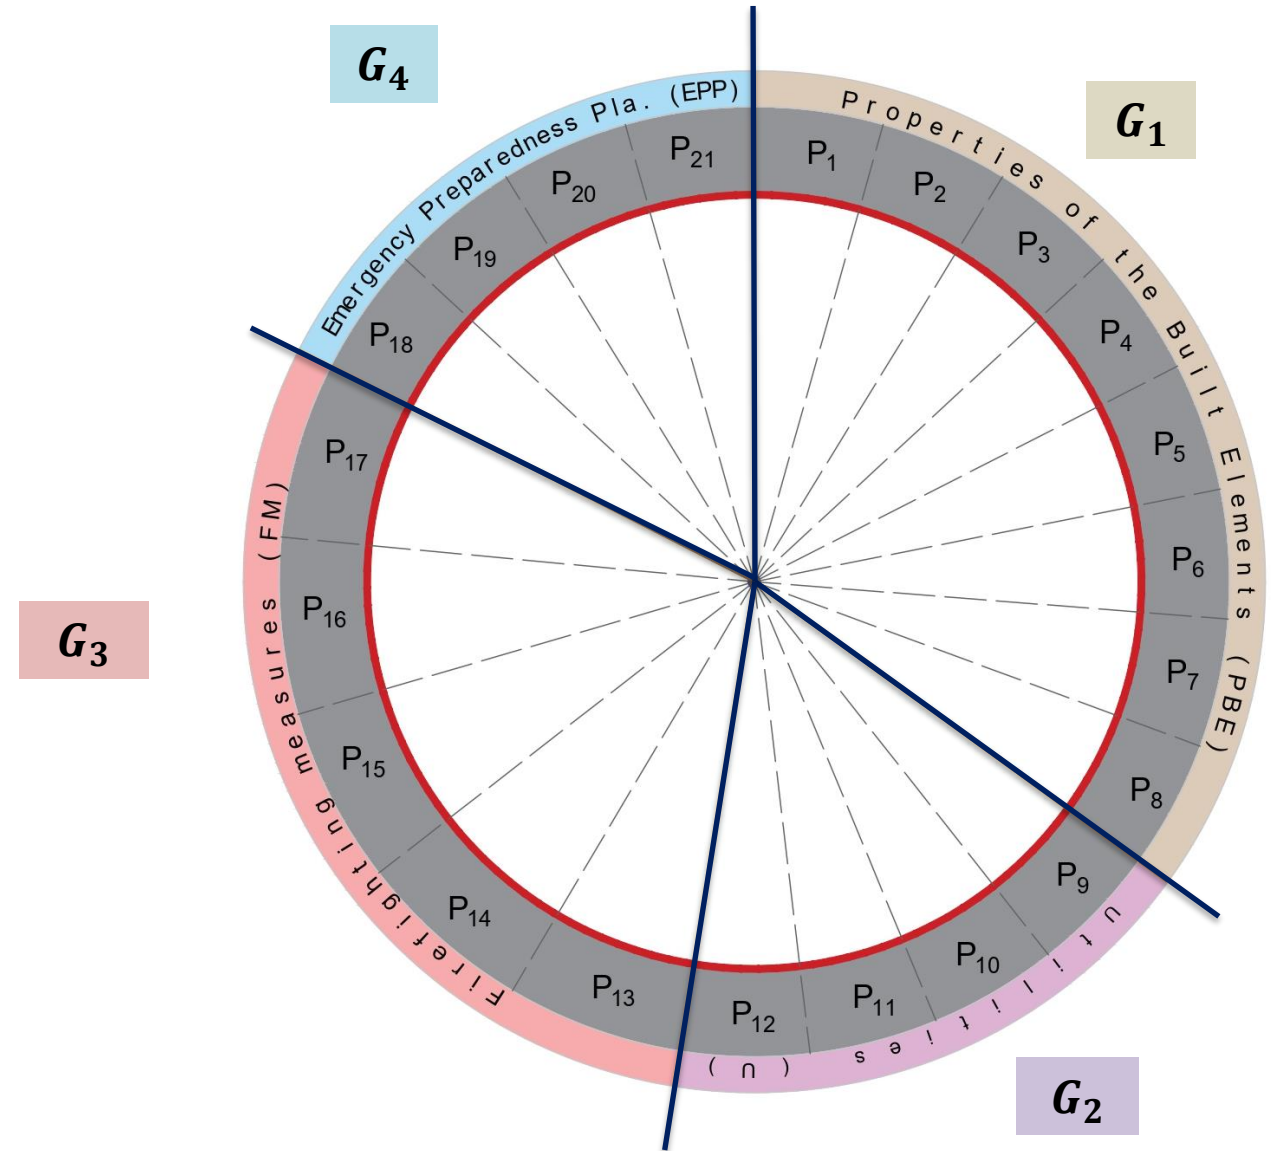
Level of Damage under fire effects

- The estimation of the level of damage under fire (D_f) considers the interconnectedness between dependent or similar fire vulnerability indicators through the sum of the product between the score of each category (G_i) and its corresponding weight (W_i) according to:

$$D_f = \sum_{i=1}^{n=4} G_i \times W_i$$

- The score of each category is obtained by the worst FVI performance, which is defined by the higher indicator score, (each indicator is scored among 5 Damage Potential Classes (DPC)).

$$G_i = [Max(P_{i,i})]$$

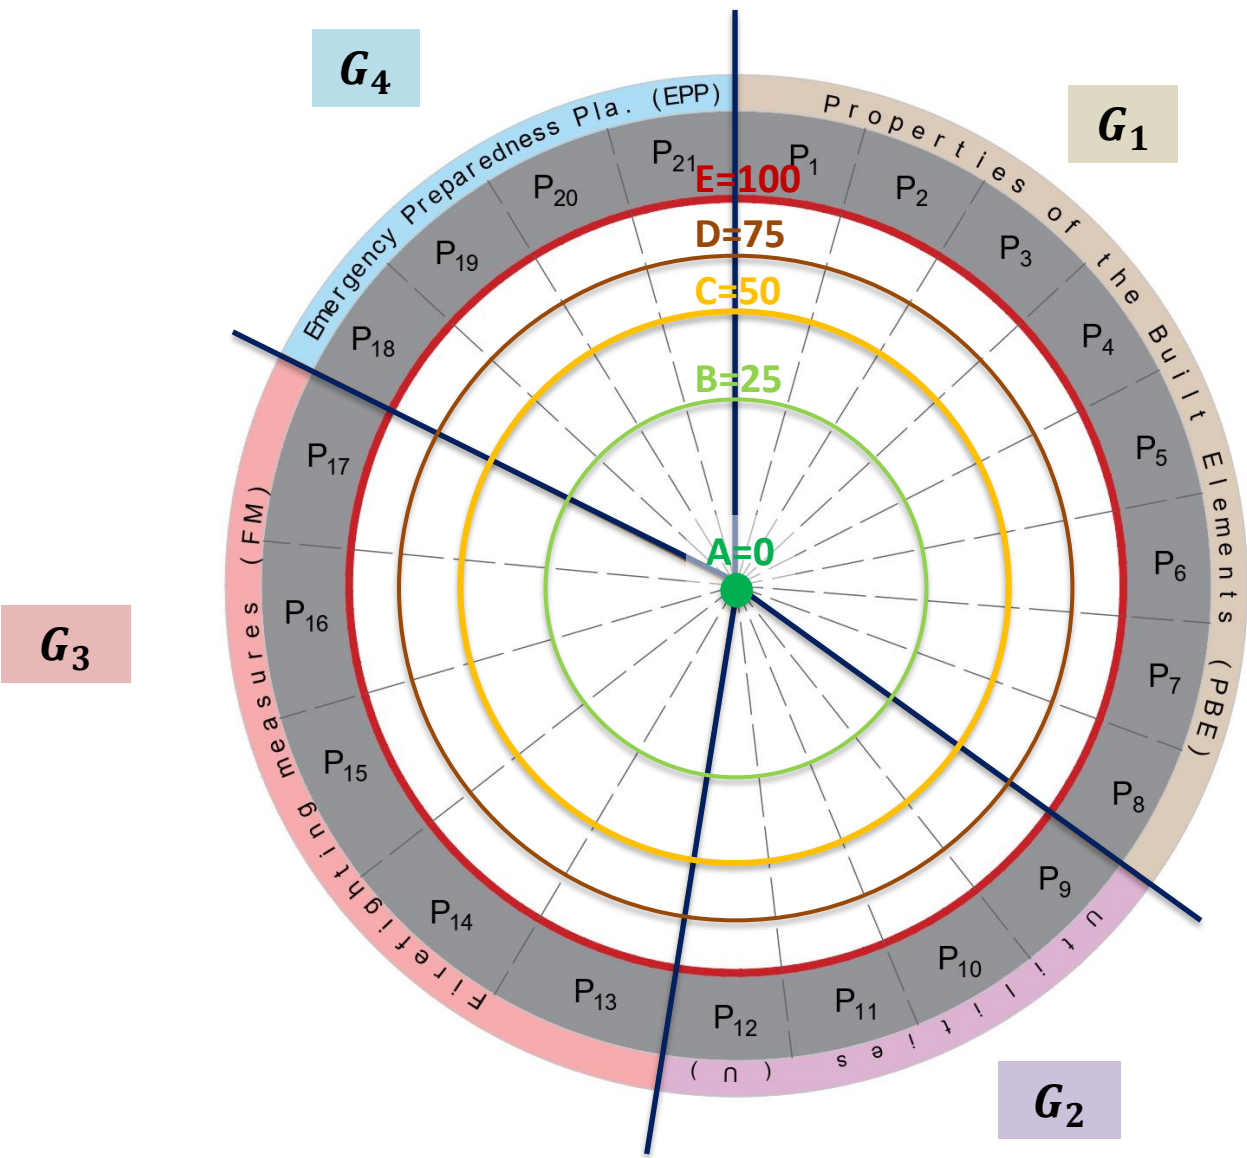
Damage Potential Class (DPC) code and corresponding value

Damage Potential Class

The Damage Potential Class (DPC) expresses the expected impact (from A to E) to the immovable asset under assessment, also accounting for some aspects that can contribute to the damage of movable assets by considering specificities that could increase the susceptibility in a fire.

A	B	C	D	E
0	25	50	75	100

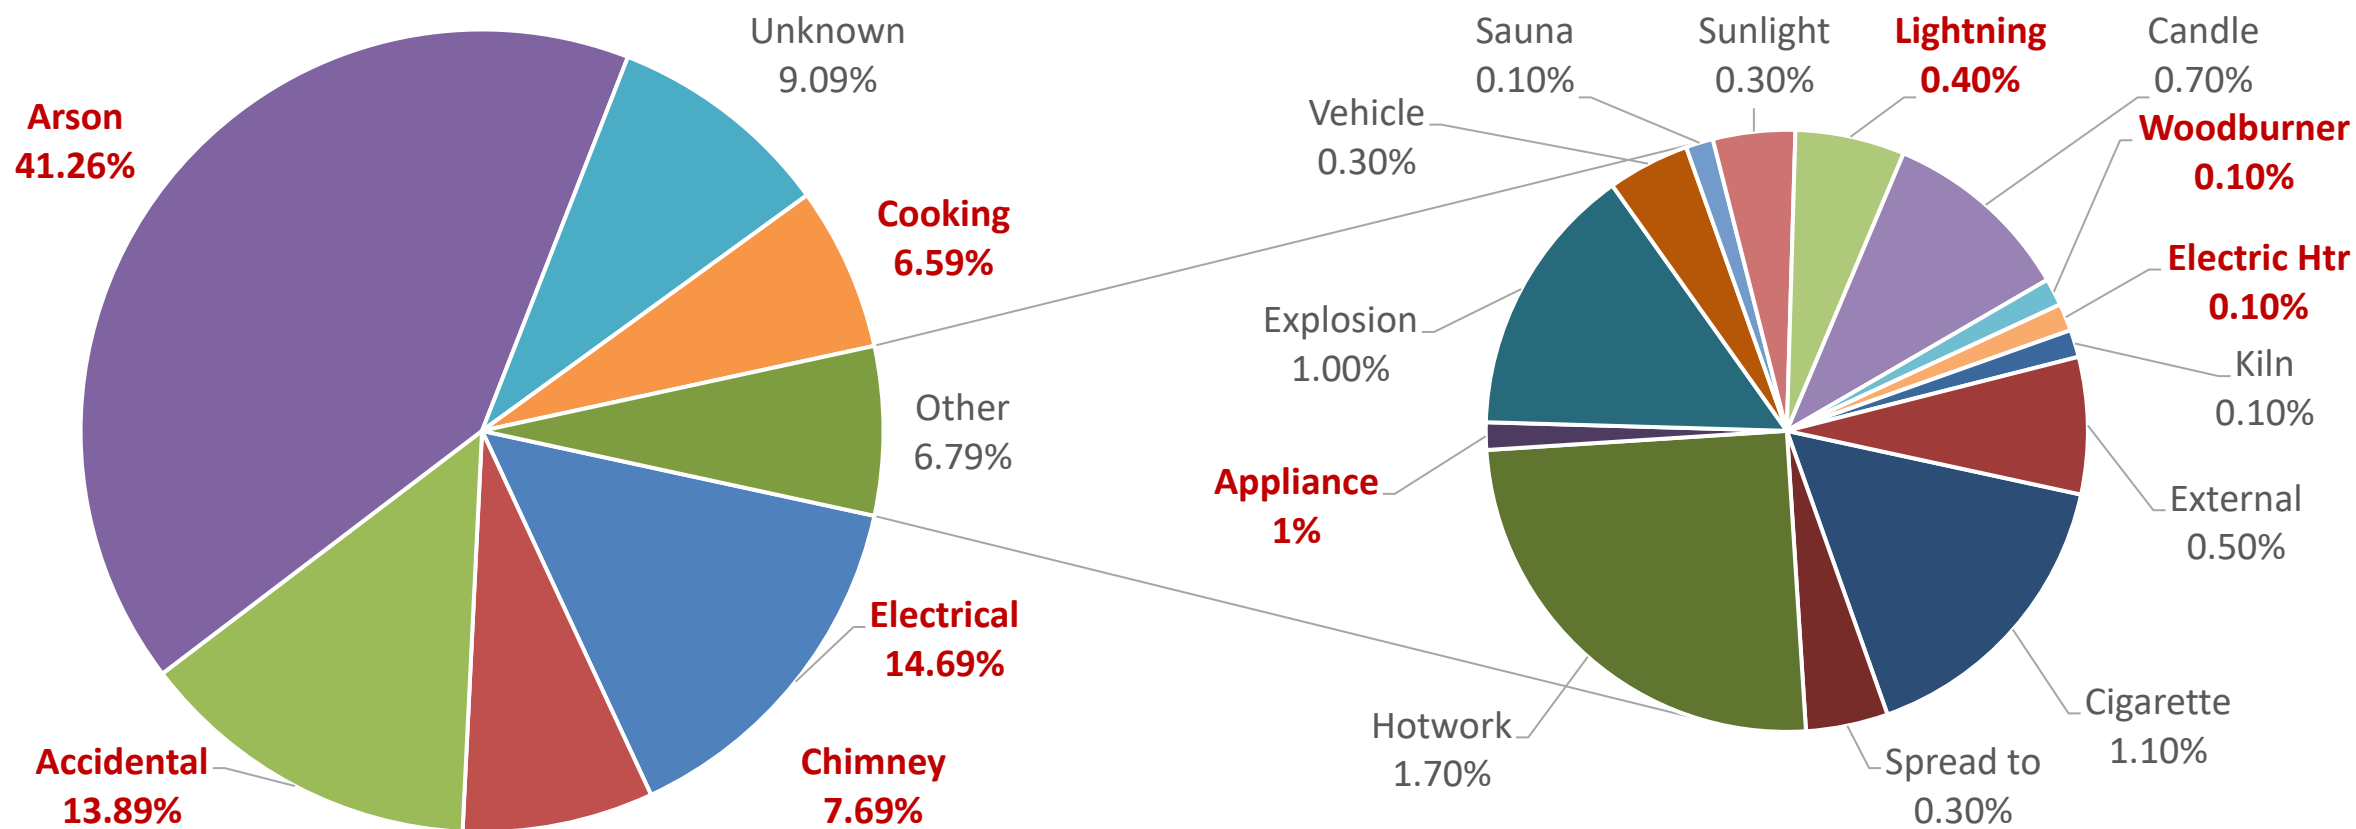
Database of Fire in Historic Buildings January 2017 – June 2020 (<https://www.fireprotect.me.uk/fires.html>)

Associated causes (in red) involved in group U (Utilities) ≈ 85%

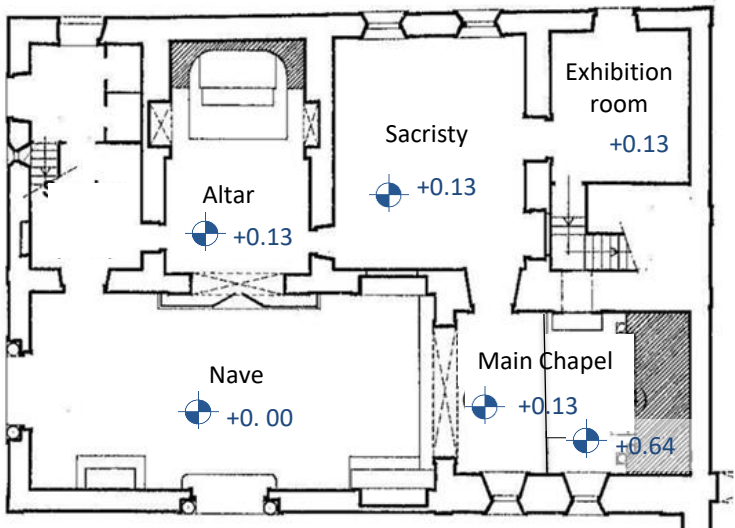
Ground Floor plan (m)

Case Study - Misericórdia de Esposende - Church

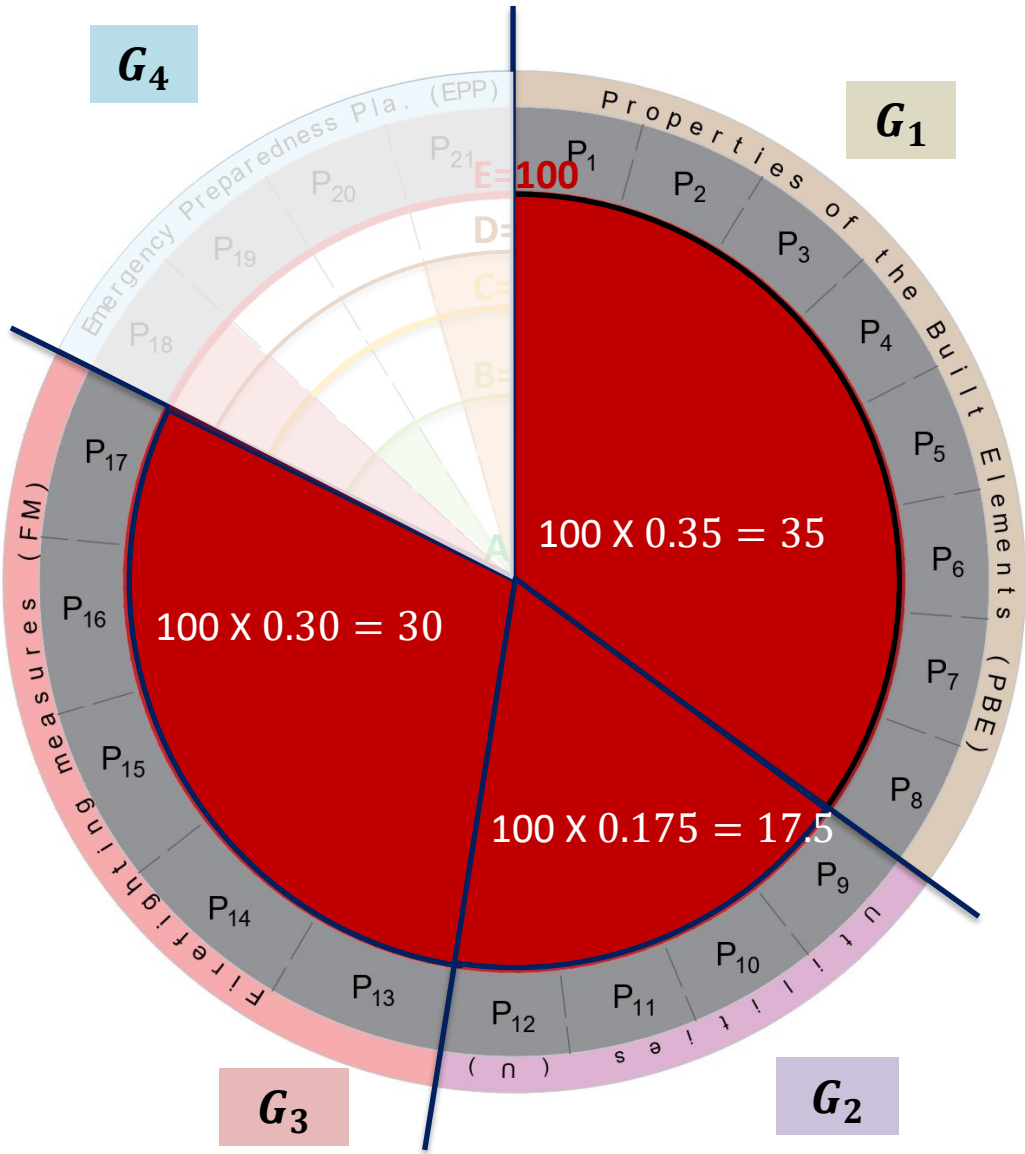
<i>P</i> ₁₈ -Emergency Planning	E	No emergency planning
--	---	-----------------------

Worst cases per category

G1 – Properties of the Built Elements (PBE)

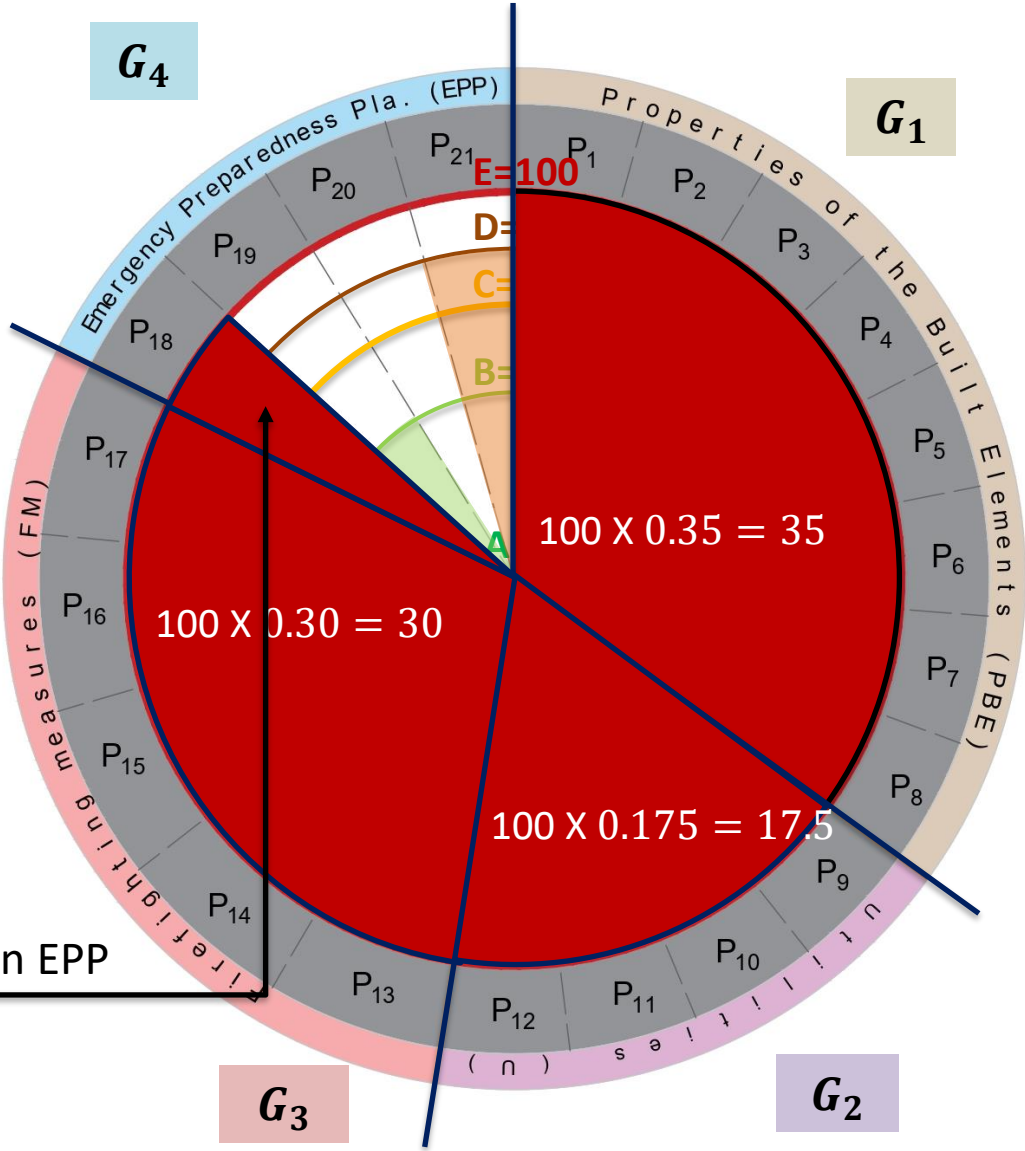
Worst case in EPP

<i>P</i> ₁₈ - Emergency Planning	E	No emergency planning
--	---	-----------------------

Worst cases per category

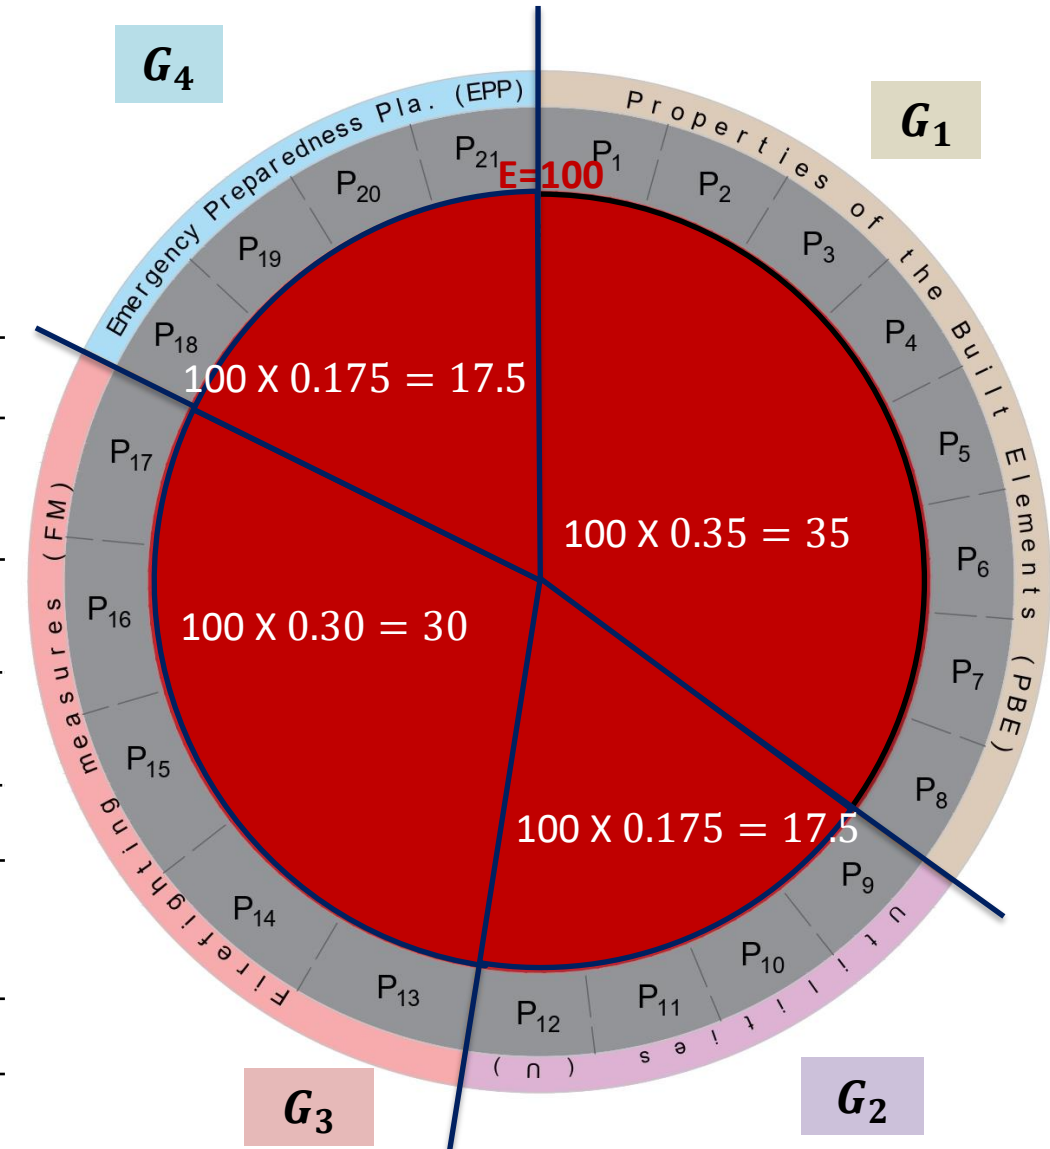
Sum of the scores to measure the expected Level of Damage

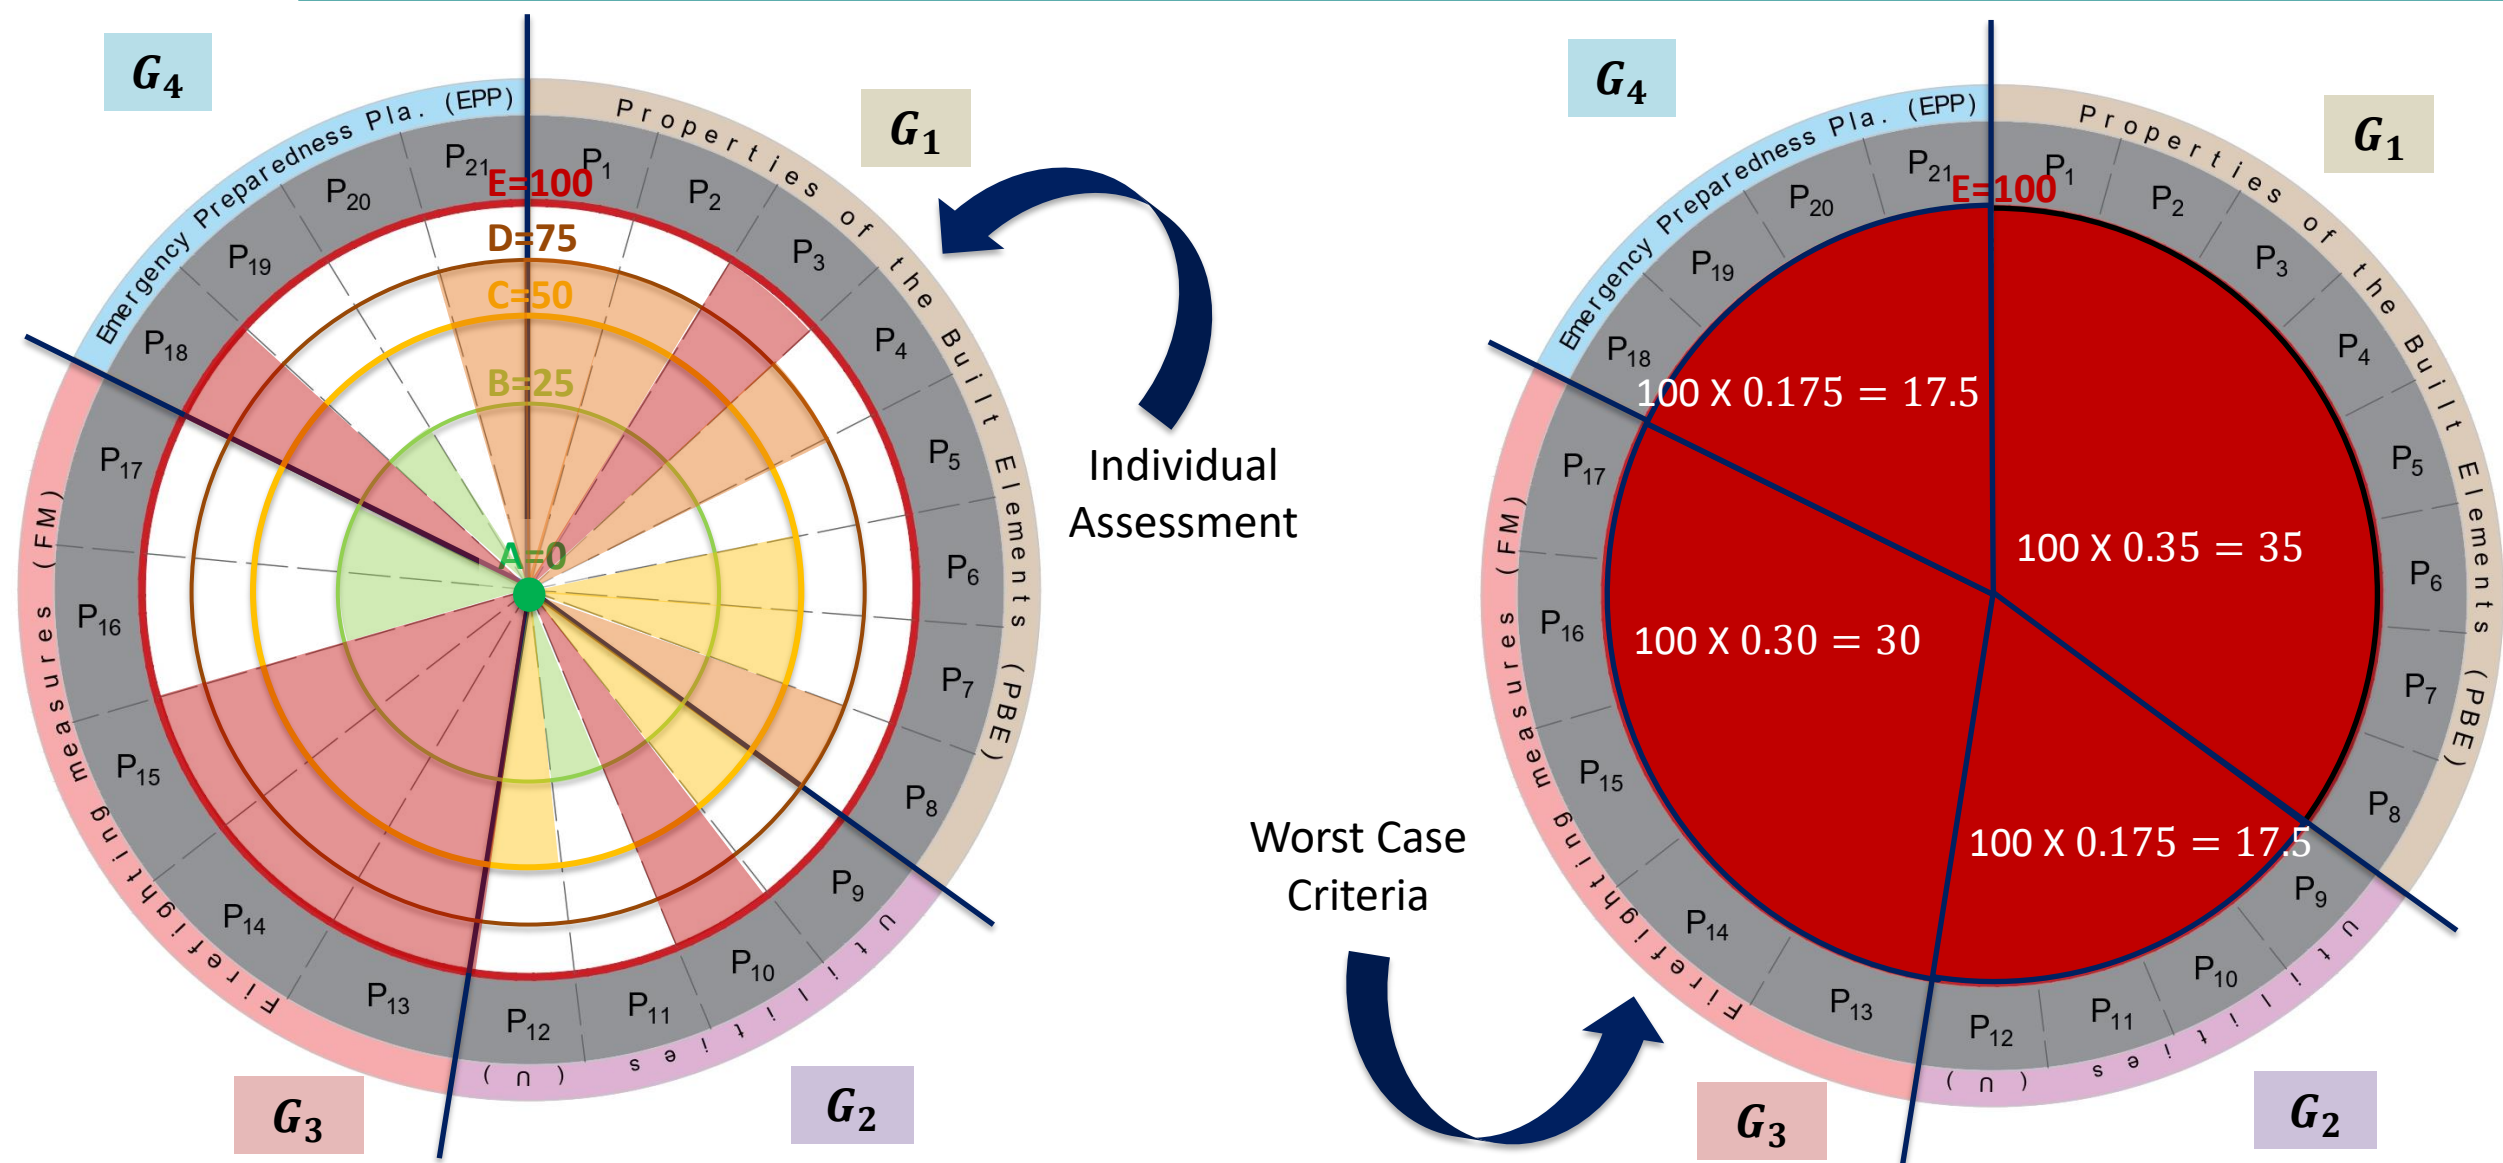
Sum of the scores to measure the expected Level of Damage

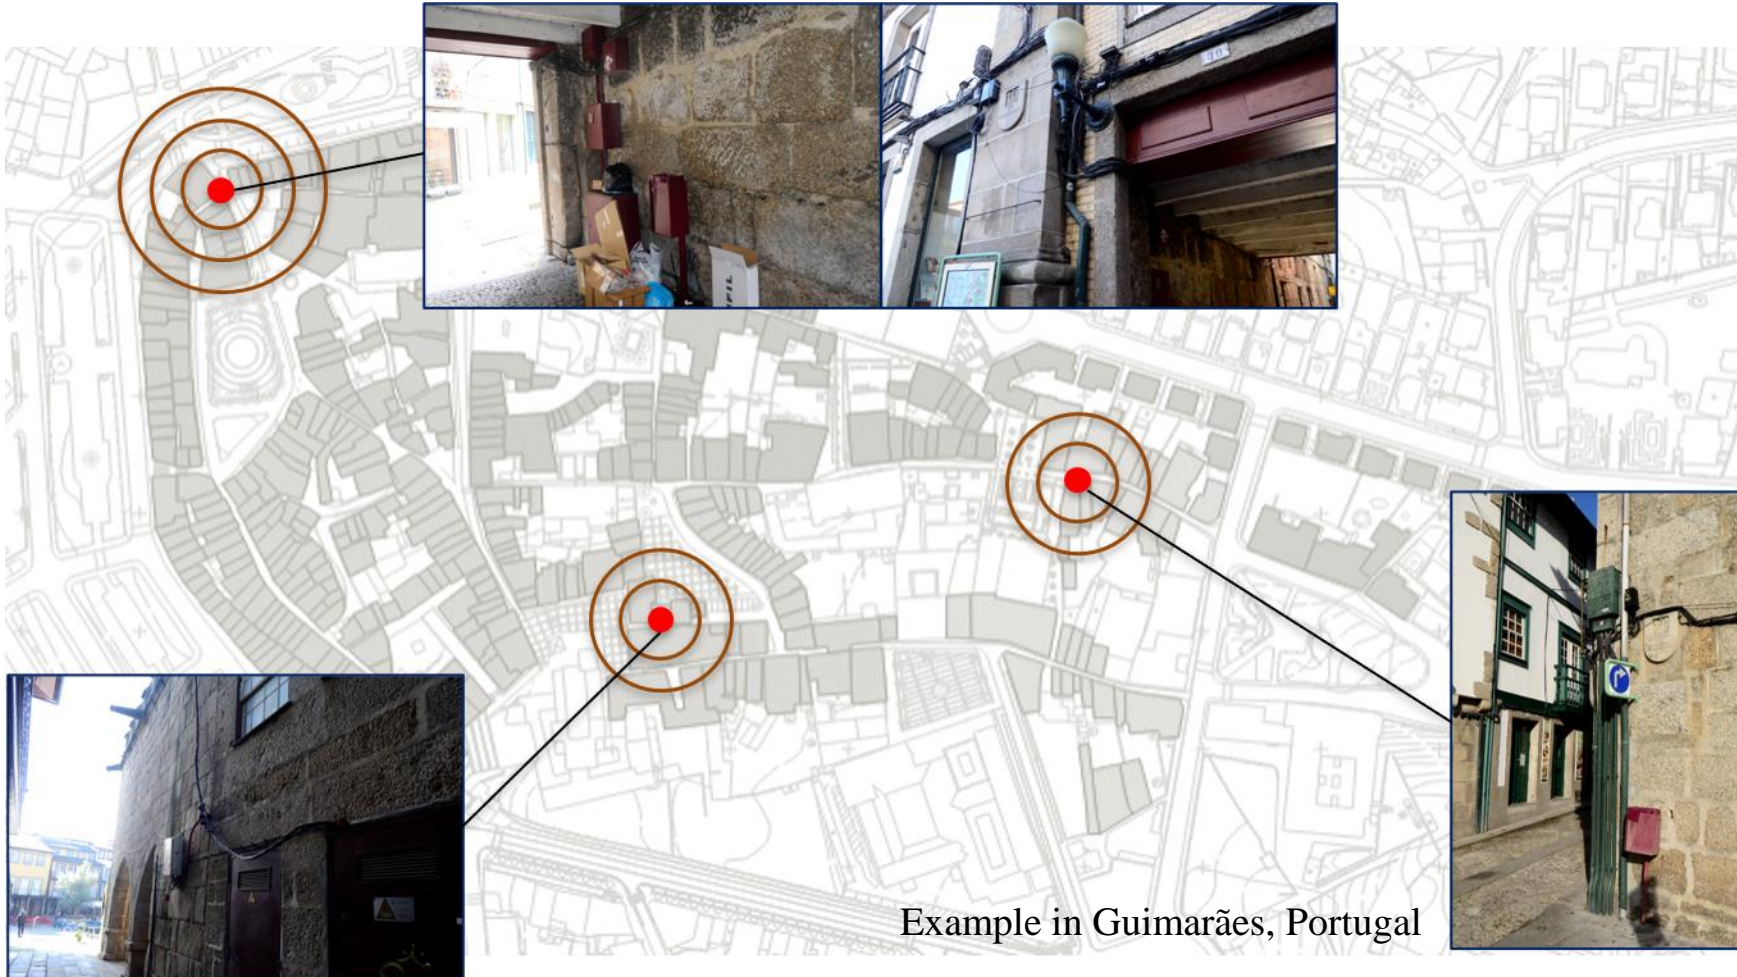
- **P9 - Electrical installations**
- **P12 - CCTV**
- **P18 - Emergency planning**
- **P20 - Evacuation Routes**
