EXPERIMENTAL CHARACTERIZATION OF THE FAILURE BY OVERTOPPING OF HOMOGENEOUS AND ZONED DAMS: HYDRODYNAMICS AND MORPHODYNAMICS

Supervisors: Rui Ferreira (IST), Teresa Viseu (LNEC)

PhD theme: Experimental characterization of the failure by overtopping of homogeneous and zoned dams: hydrodynamics and morphodynamics

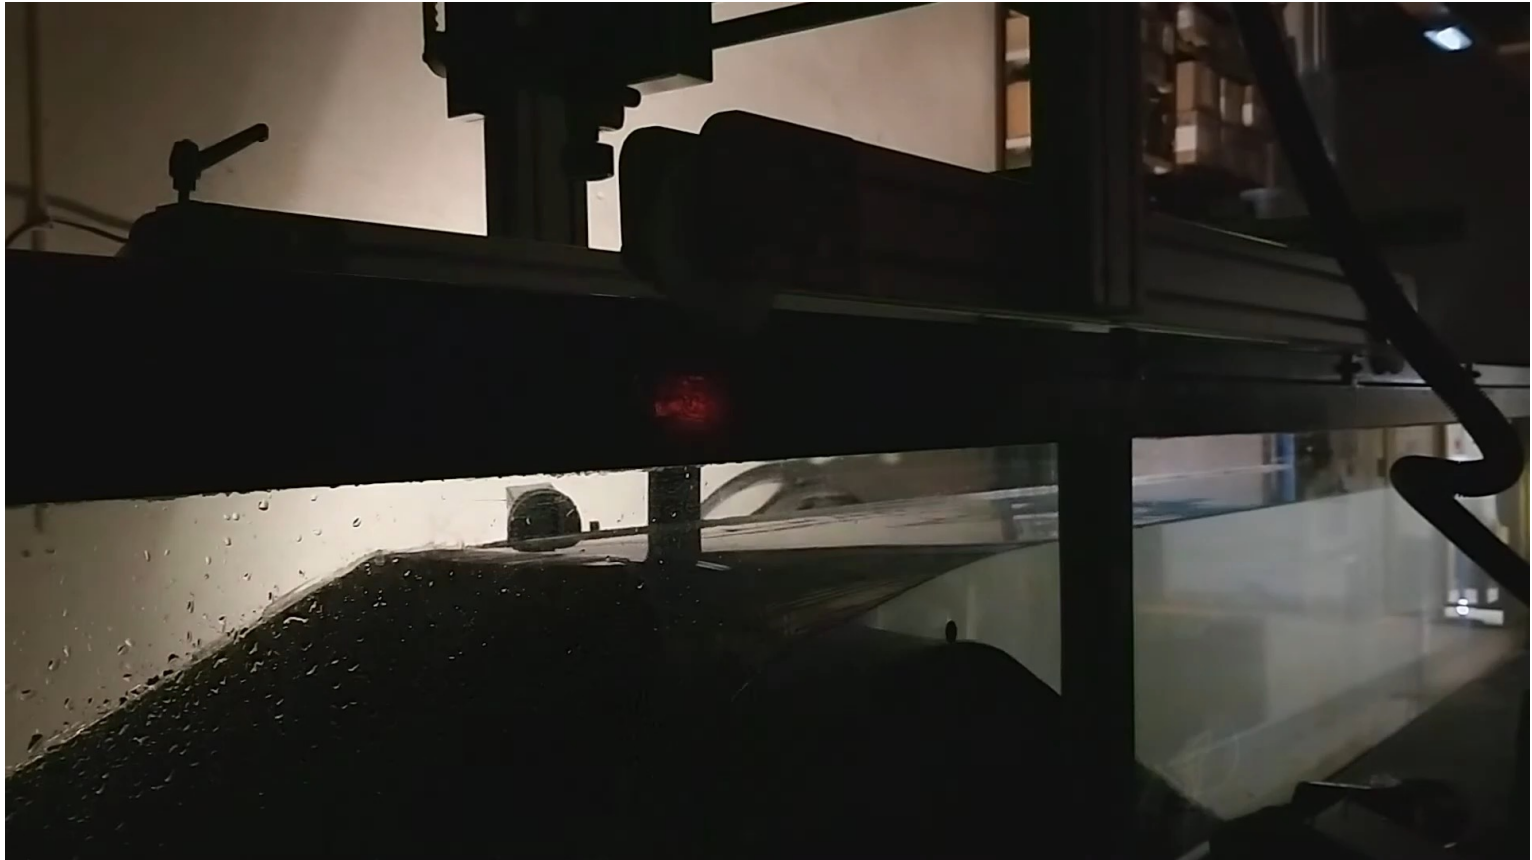
Solution: to STOP time

Freezing time allows for unlimited (sort of) time to study fluid flow with adequate non-intrusive instrumentation - PIV

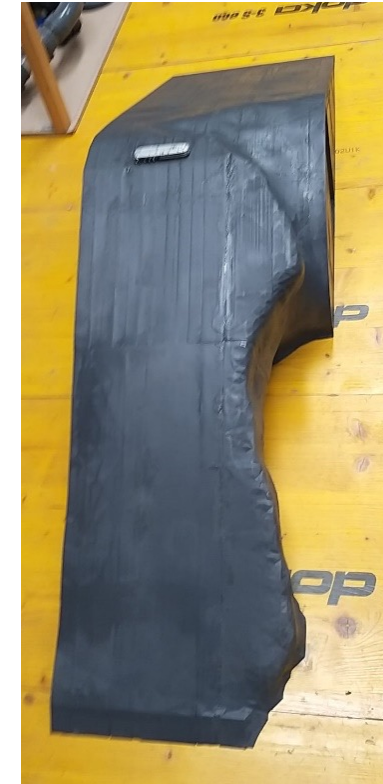
Print a 3D scaled model

Install it in the lab and test it

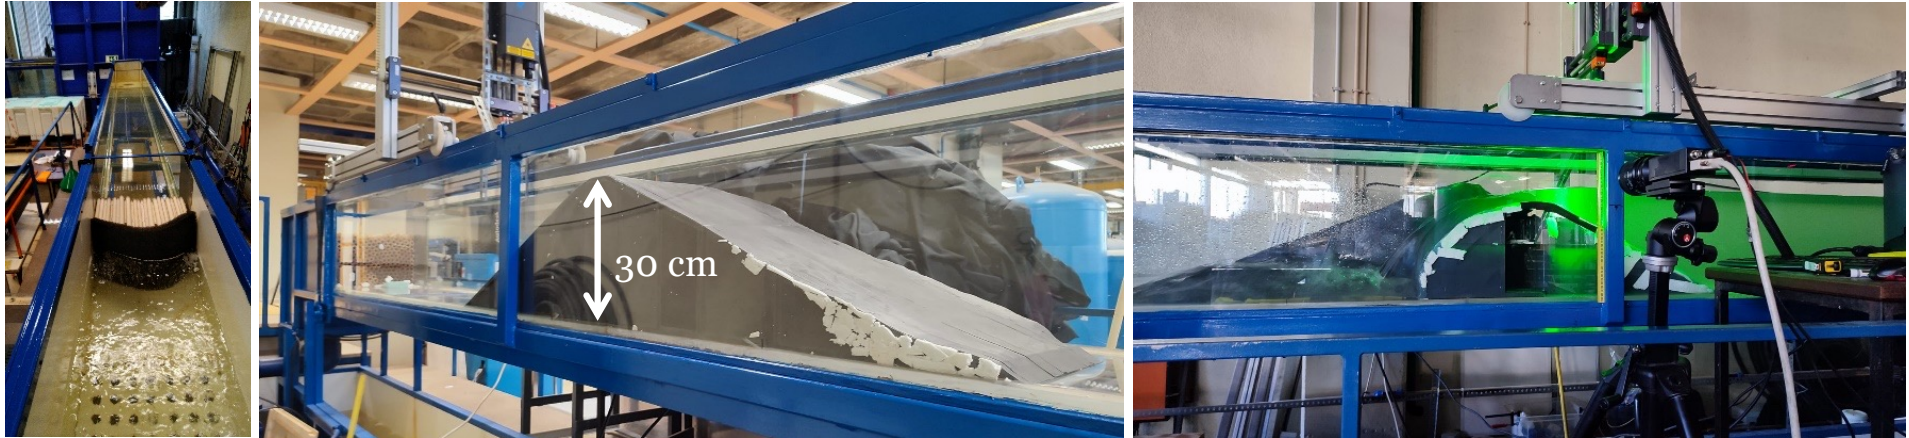
EXPERIMENTAL FACILITY

Legend:

- 1 – Inlet orifices
- 2 – Honeycomb structure
- 3 – Outlet orifices
- 4 – Dam breach model
- 5 – Laser light sheet
- 6 – Camera

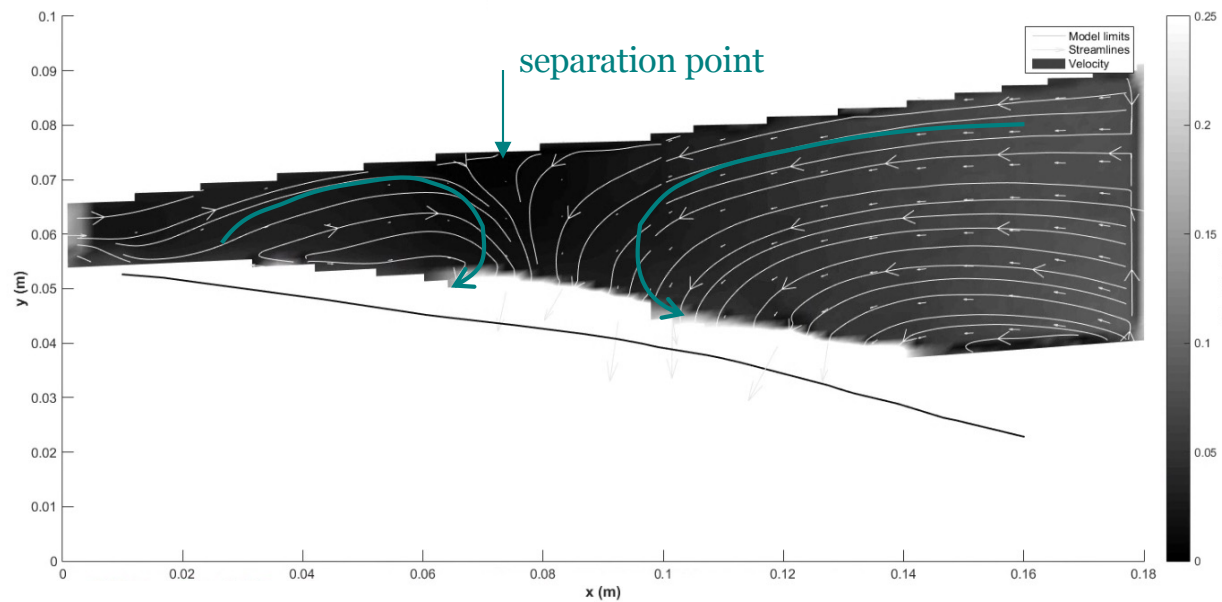
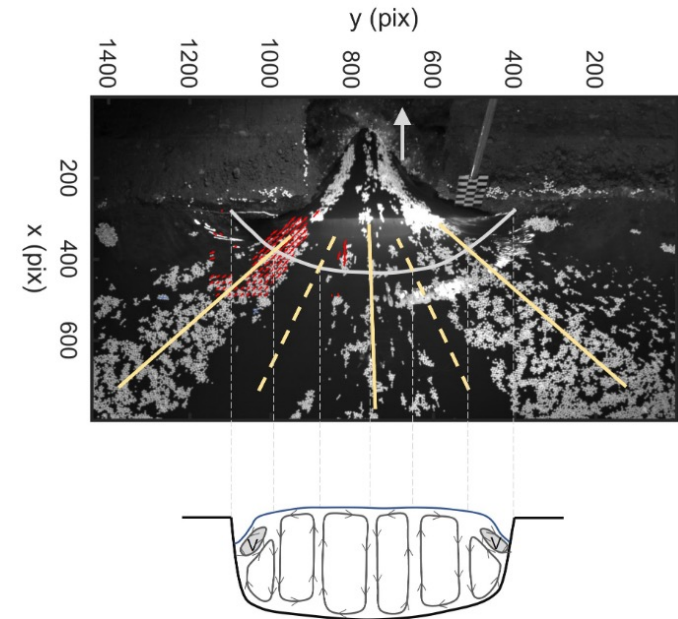
Flow over breach crest

Secondary currents – envisaged by the surface flow

Essentially generated by an inviscid mechanism

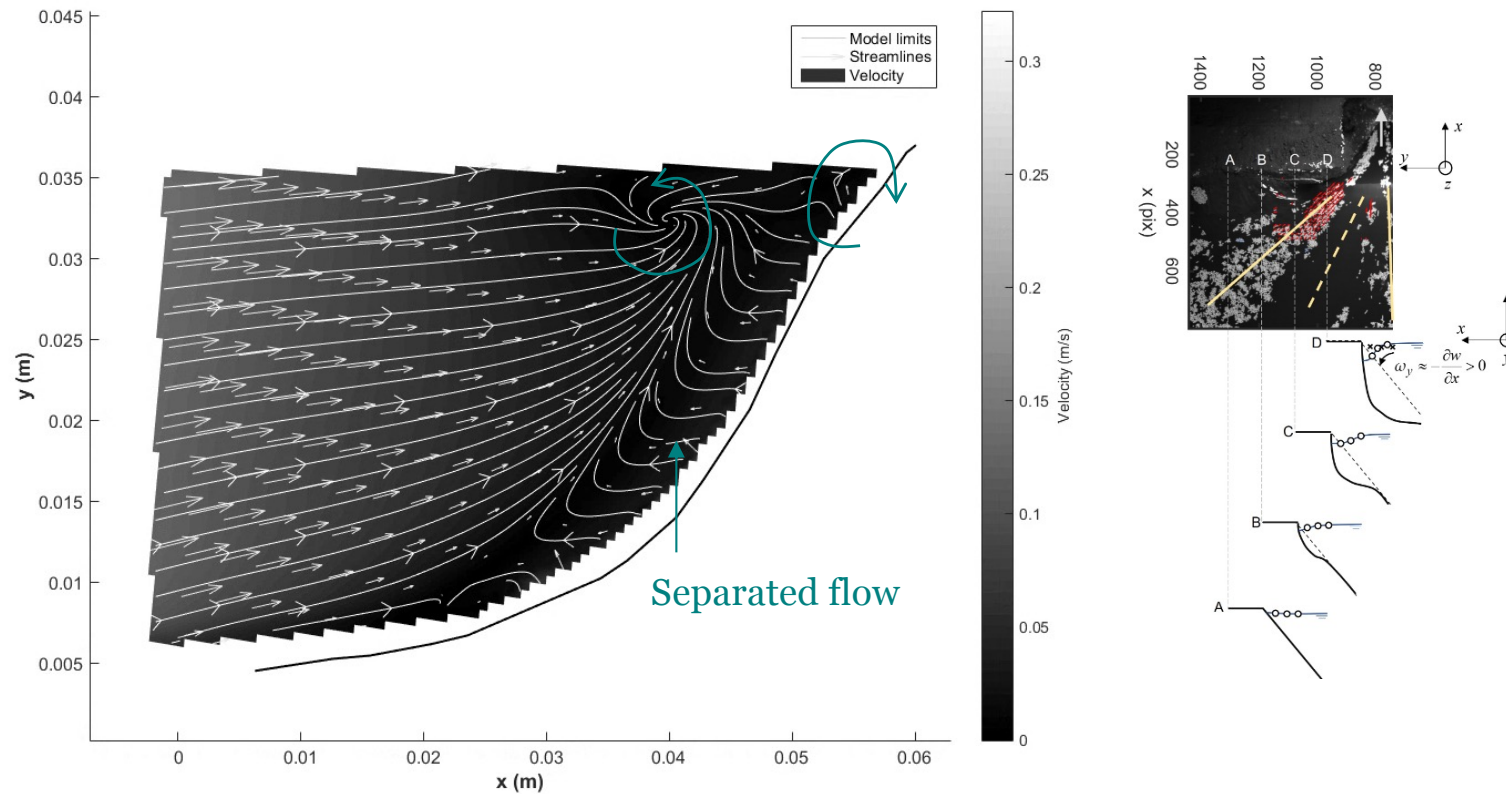
Flow along dam crest

Attached vortex along the crest – a kinematic effect of flow approaching the breach, essentially inviscid

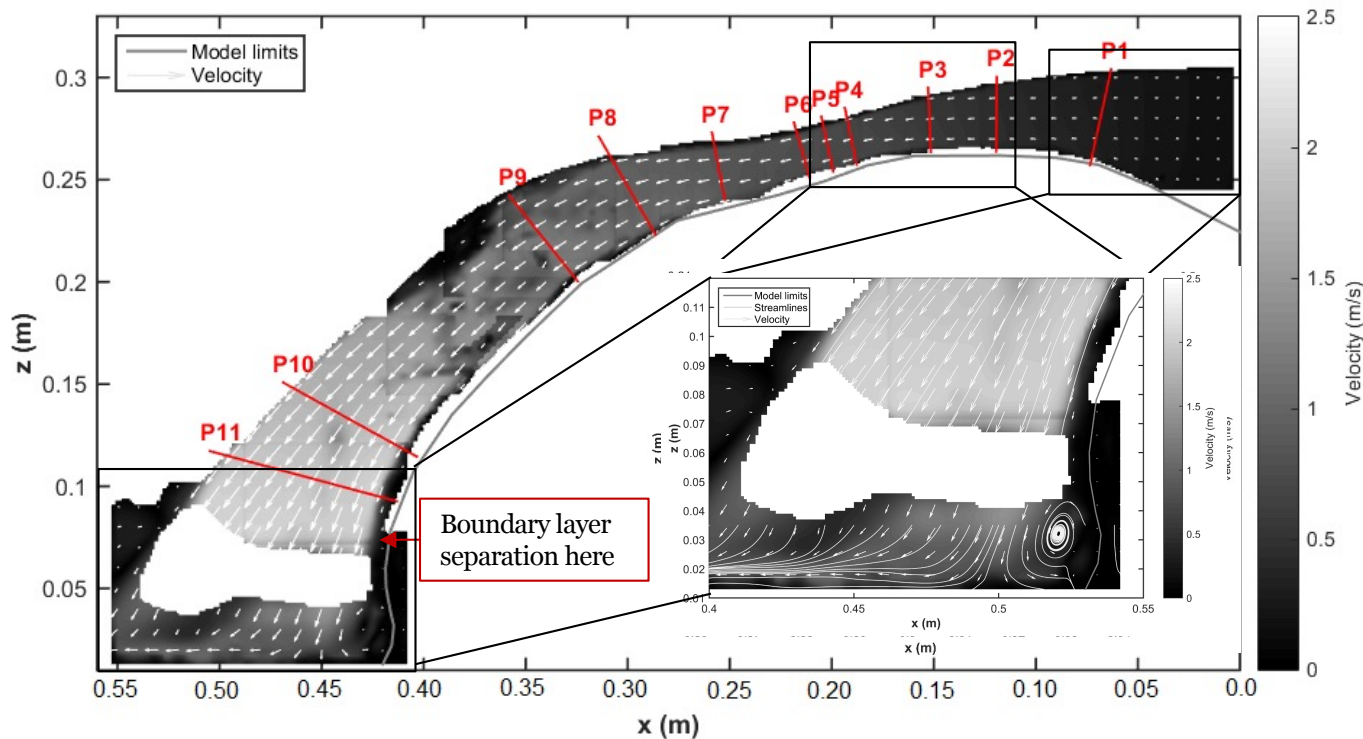
CONTRACTED FLOW OVER THE BREACH

Development of a boundary layer (viscosity and roughness are relevant).

Flow accelerates, contracts and forms a “blade” as it reaches the bottom.

Boundary layer separates before hitting the bottom.

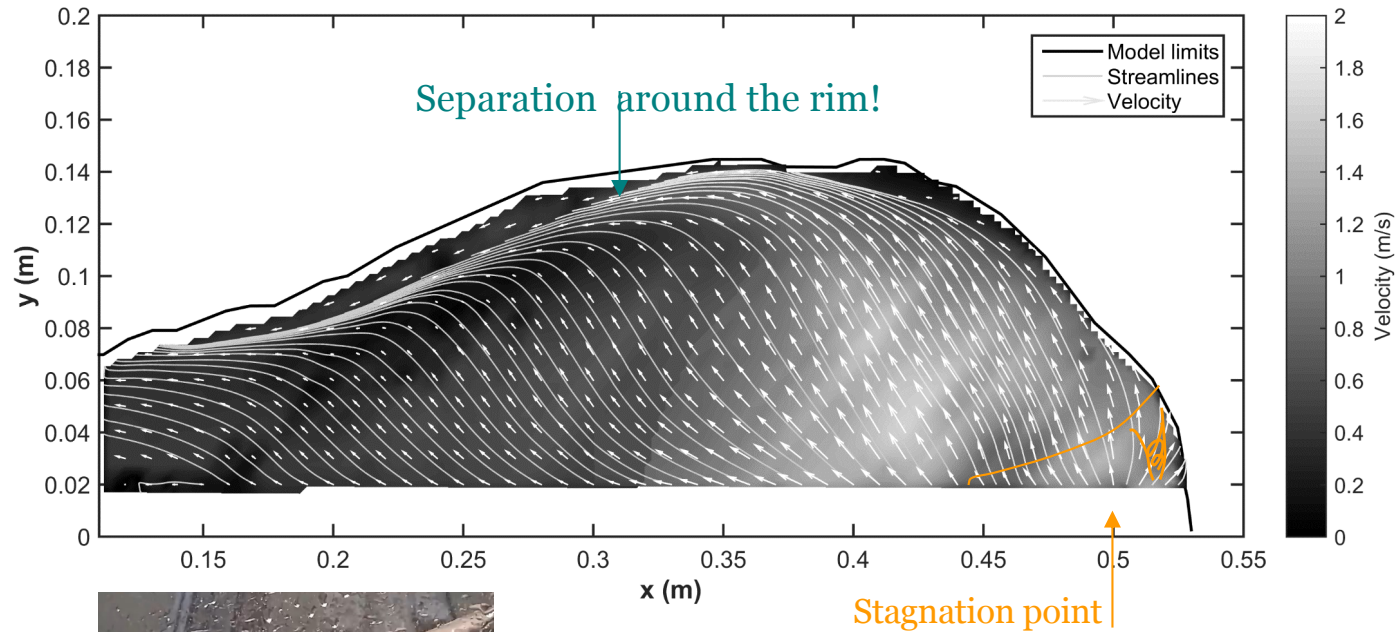
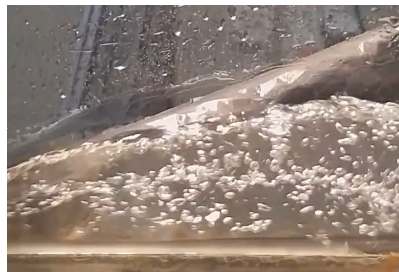
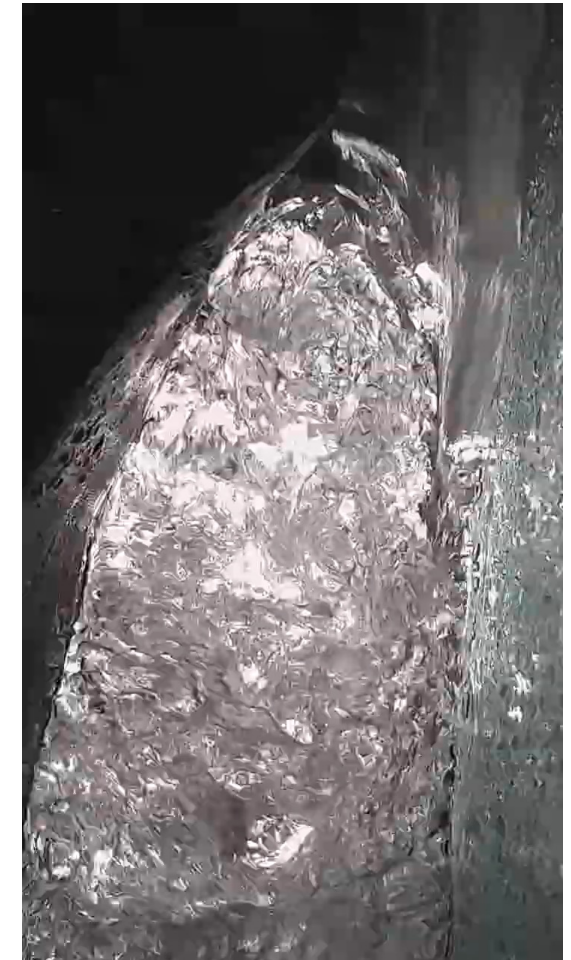
Flow in the horizontal plane – “out” from the plunging flow, turns at the inner walls, leaves as a vortex pair.

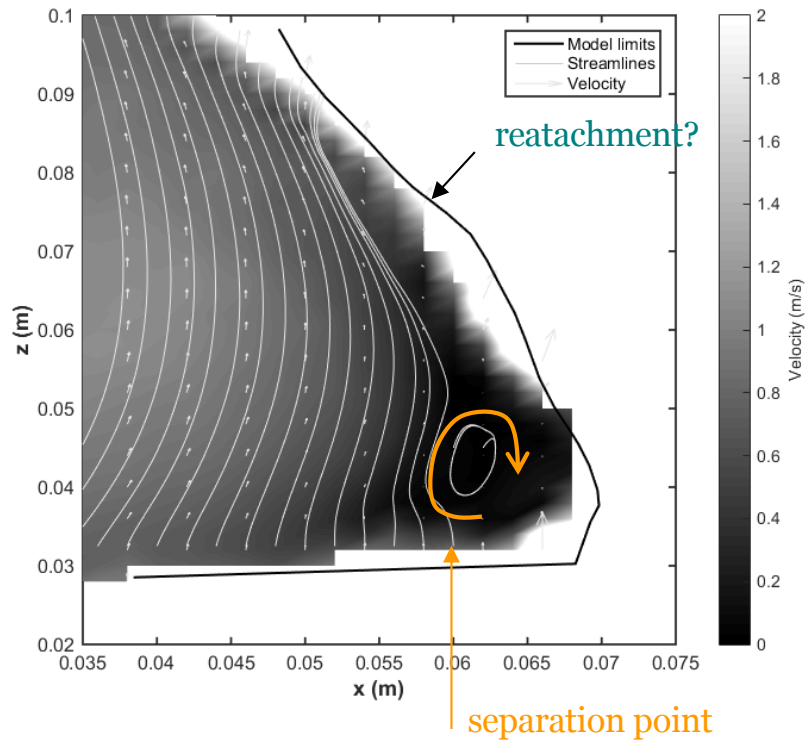
Flow around the rim of the dam inner cavity

A separation induced by an adverse pressure gradient as the flow approaches the inner walls of the cavity

Not the continuation of the separation of the BL

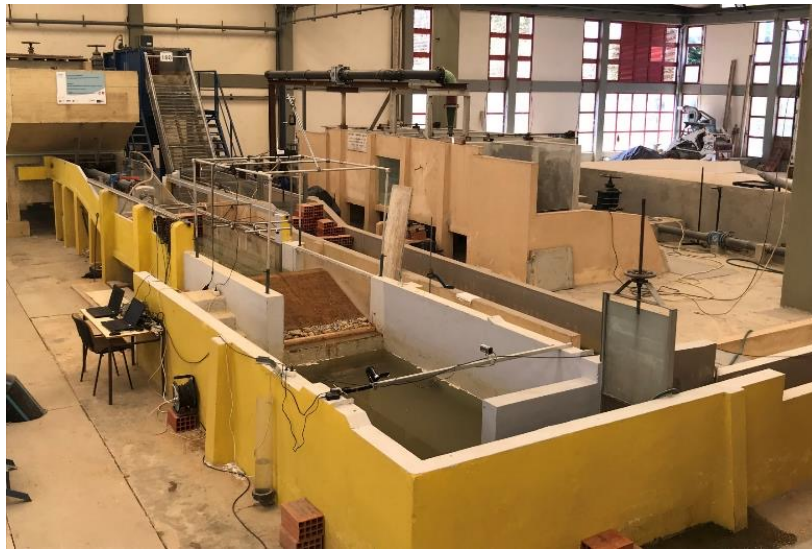
EXPERIMENTAL FACILITY

| 1 – Upstream reservoir | 7 – Glass wall | ● – Acoustic probe |
| 2 – Flowmeter | 8 – Dam site | ★ – Video camera |
| 3 – Flow control valve | 9 – Settling basin | ★ – Kinect sensor |
| 4 – Brick wall (for flow stabilization) | 10 – Outflow channel | |
| 5 – Dam reservoir | 11 – V-notch weir | |
| 6 – Bottom outlet | | |

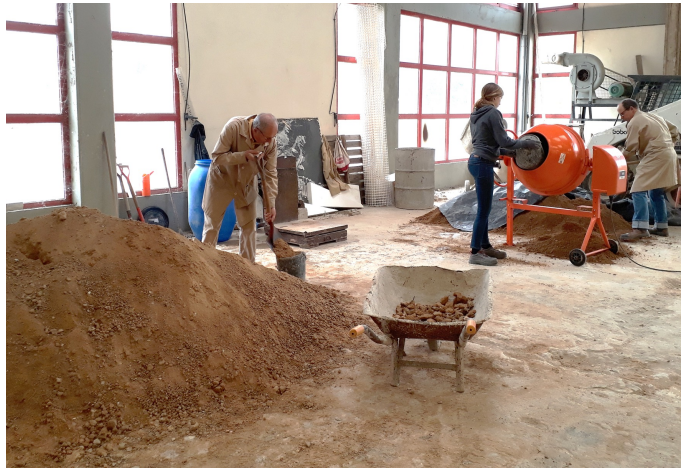
Soil homogenization and humidification

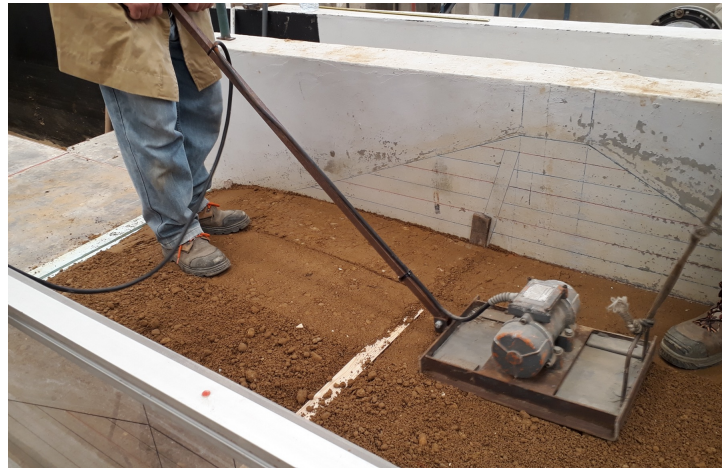
Embankment compaction (5 cm layers)

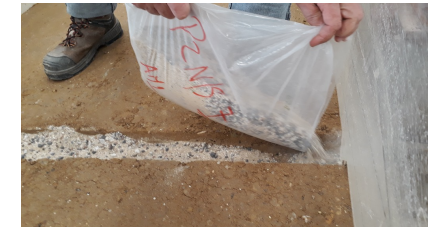
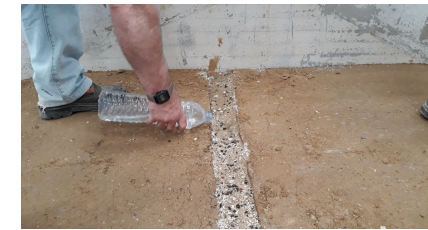
Chimney filter

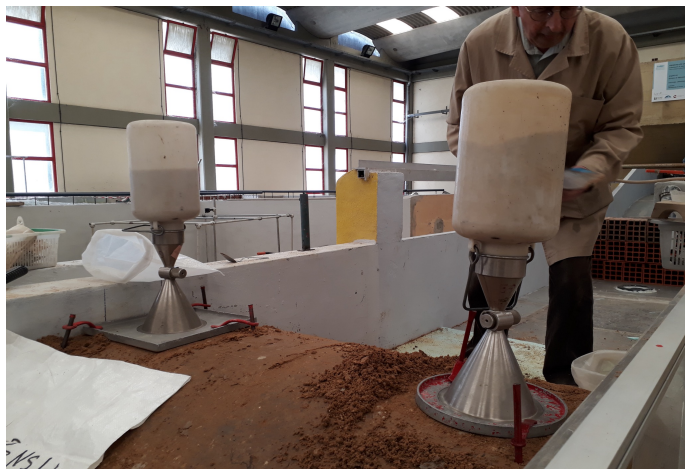
Sand replacement test

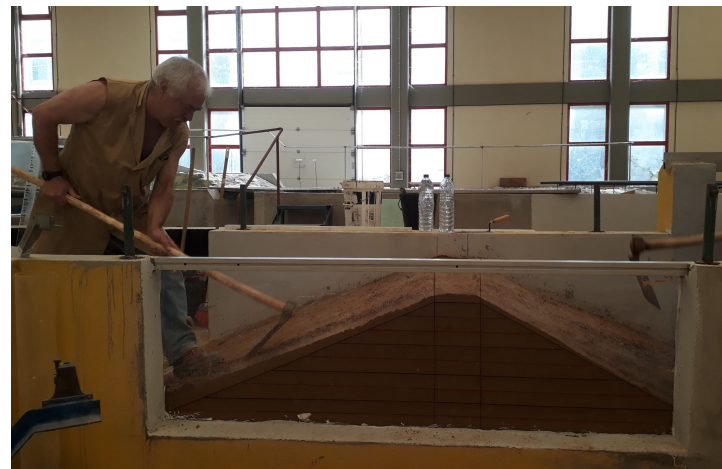
Embankment final cut

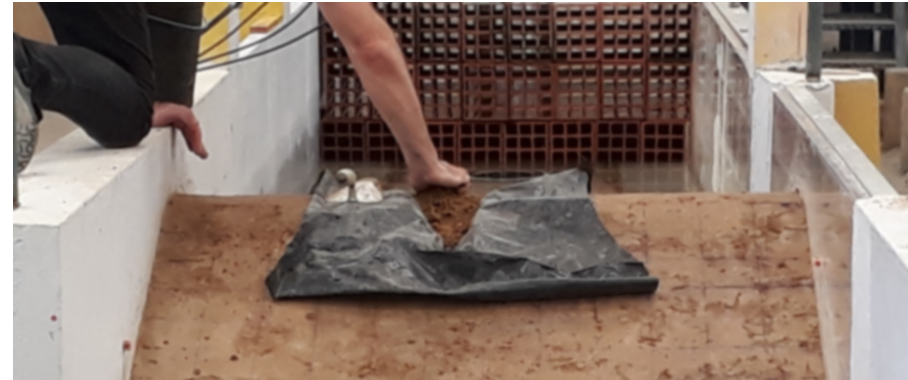
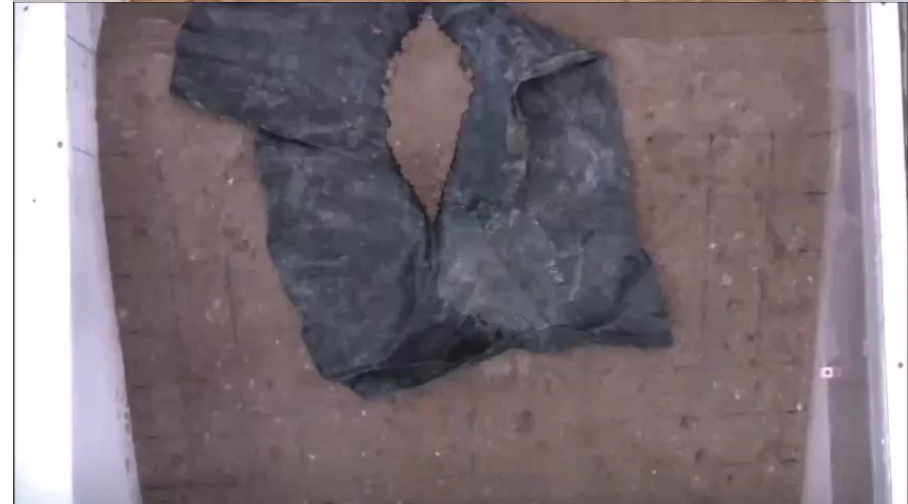
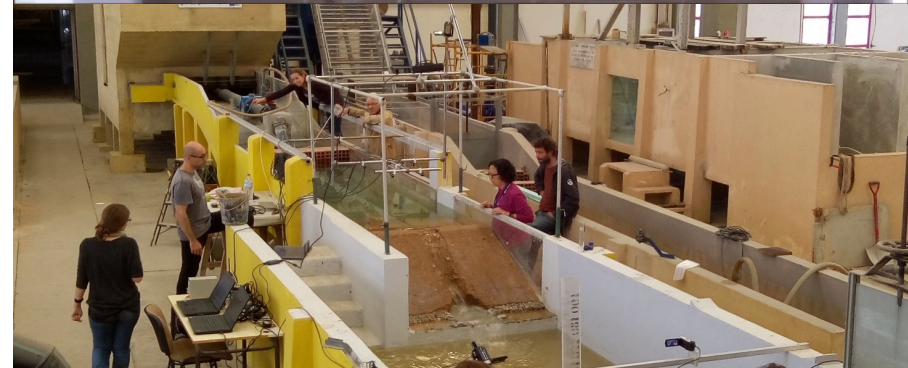
1. Approximately 24 h before the beginning of the test, the reservoir was filled up to 0.38 m;
2. The pilot channel was carved in the center of the crest and blocked, by a plate or soil;
3. The upstream water level was slowly raised up to the crest level (the upper 0.07 m);
4. The block of the pilot channel is instantly removed and the overtopping begins ($t = 0$ s);
5. The water level inside the reservoir was maintained reasonably constant and equal to the crest level, the inflow discharge was increased whenever the water level in the reservoir became lower than the crest level;
6. The tests were interrupted almost instantly for the breach characterization with the Kinect sensor. To halt the breaching process:
 - the inflow was cut-off, and simultaneously
 - the reservoir bottom valve is opened

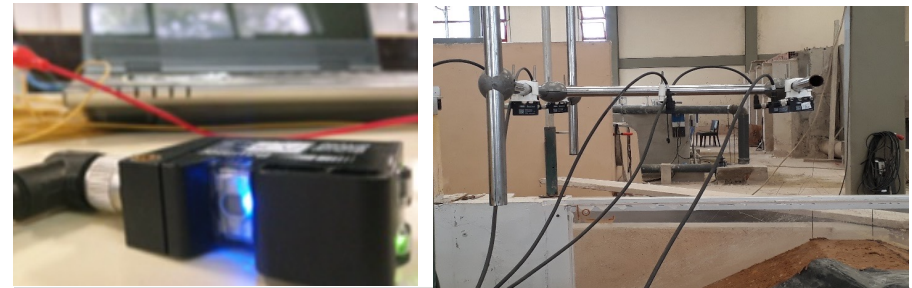
Acoustic probes

1. Reservoir inflow
⇒ digital flowmeter
2. Reservoir water level
⇒ 6 acoustic probes
3. Channel outflow, using water level measurements in the channel
⇒ 1 acoustic probe
4. Breach morphologic evolution
⇒ 2 HD video cameras
(above the crest & downstream of the dam)
5. 3D breach morphology
⇒ 2 KINECT sensors
(above the crest & mobile)

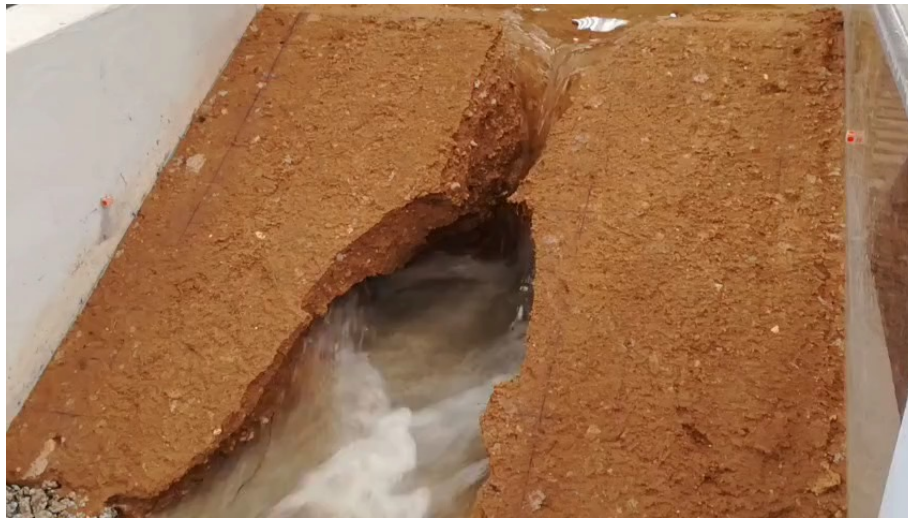
Main Erosion Mechanisms:

homogeneous dams without filter

On the experimental tests, it was possible to fully reproduce the main breaching mechanisms:

- Hydraulic erosion
- Headcut erosion
- Underscouring

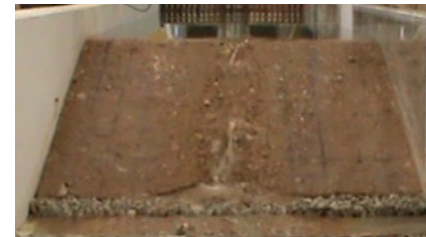
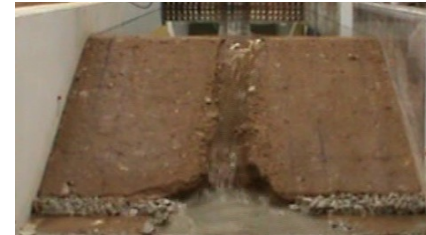
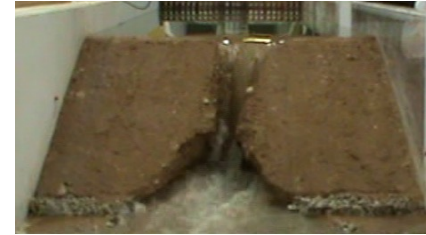
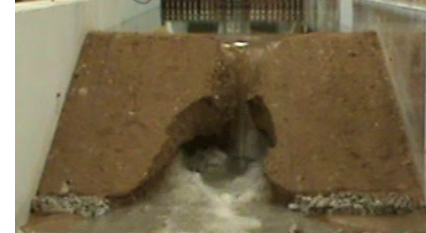
Test 1: Homogeneous dam with toe drain

Test 1 – small pilot channel

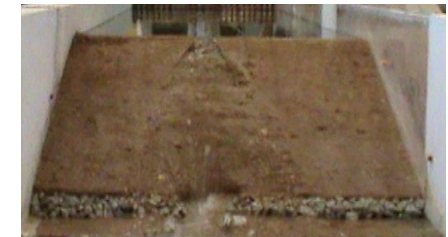
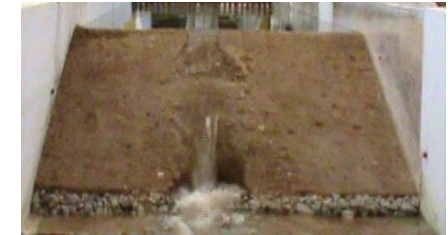
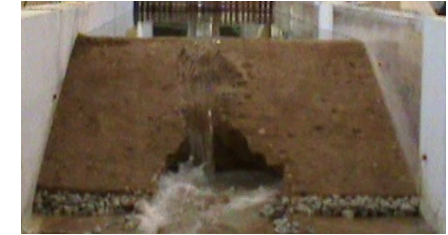
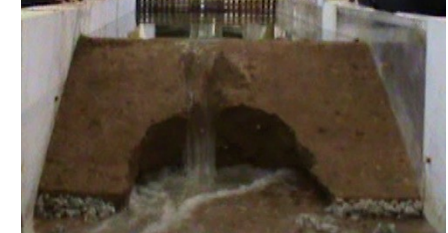
Test 3 – large pilot channel
