**Characterization of 'Placa'  
Buildings**

M. Monteiro; R. Bento  
- Maio de 2012 -

**Relatório ICIST  
DTC nº 02/2012**

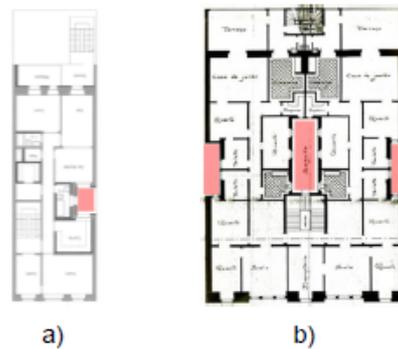
Figure 6 – Plant of ‘Gaioleiro’ buildings (Branco, 2007): a) type 1 b) type 3

At this period the plane draw of the buildings tend to be less depth and the light –shafts, characteristic of the ‘gaioleiro’ buildings (Figure 6), which provide natural light and ventilation to the interior rooms, were no longer introduced regarding the rules imposed by RGPU.

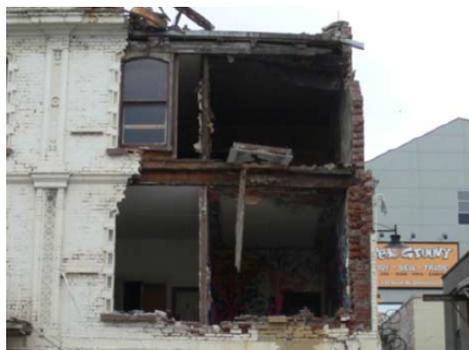
Figure 18 – Representative example of the possible damage of the 'placa' buildings during an earthquake (Ingham, 2012).

Moreover, the resistant masonry walls should not have enough resistance capacity of deformation for the actions perpendicular to its plane, so it is possible that occurs the out-of-plane collapse due to the higher values of inertia forces caused by the reinforced concrete rigid floor (Figure 18).
