Characterization and Classification of Lisbon Old Masonry Buildings

A. Simões; R. Bento
- Março de 2012 -

**Relatório ICIST
DTC nº 01/2012**

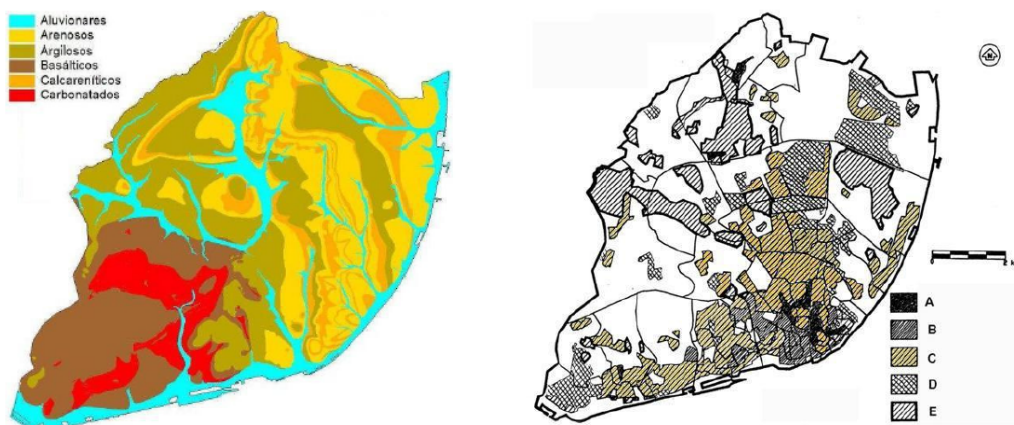
Figure 1 – Soil type in Lisbon County (CML, 2010) and dominant location of each type of building (Mendes-Victor *et al.*, 1993): A – Masonry Buildings (<1755); B – ‘Pombalino’ buildings (1755-1880); C – ‘Gaioleiro’ buildings (1880-1940); D – ‘Placa’ buildings (1940-1960); E – Reinforced Concrete buildings (>1960).

In Lisbon County there is a range of geological formations, diverging from very soft soils, such as the alluvial formation, to soils with a high resistance, such as carbonated or calcareous-sandstone formations. Figure 1 gives a comparative look between the type of soil and the dominant location of each type of building in the city.

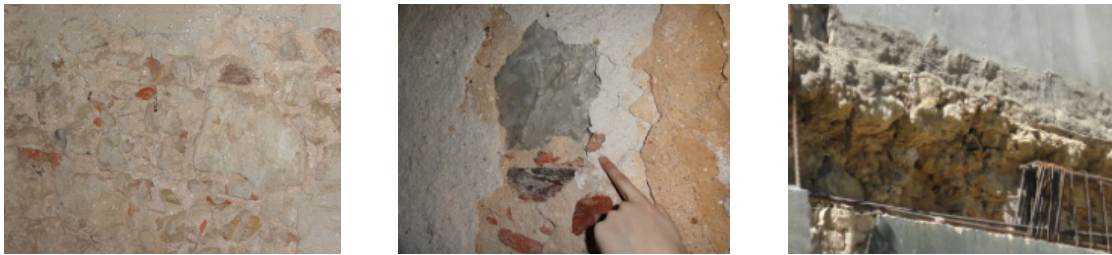
Figure 3 - Rubble stone masonry walls.

Old masonry walls were generally composed by rubble limestone masonry with grit (red aggregate) or fragments of ceramic bricks bounded by mortar (Figure 3) or composed by a multi-leaf structure made of larger stones on the exterior and a rubble core (Figure 4). On the better quality constructions, the ground façade walls were made of regular limestone blocks, which were also used to reinforce the corner of the buildings along the height (Figure 5).

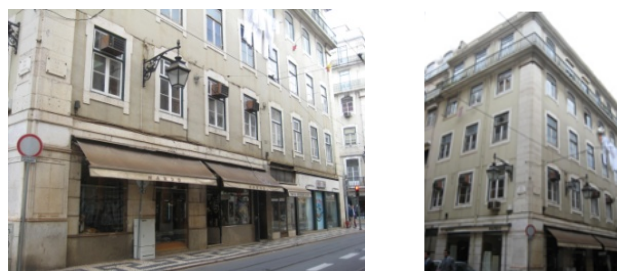
Figure 5 – Limestone blocks on the ground floor façade wall and on the corner of a 'pombalino' building.

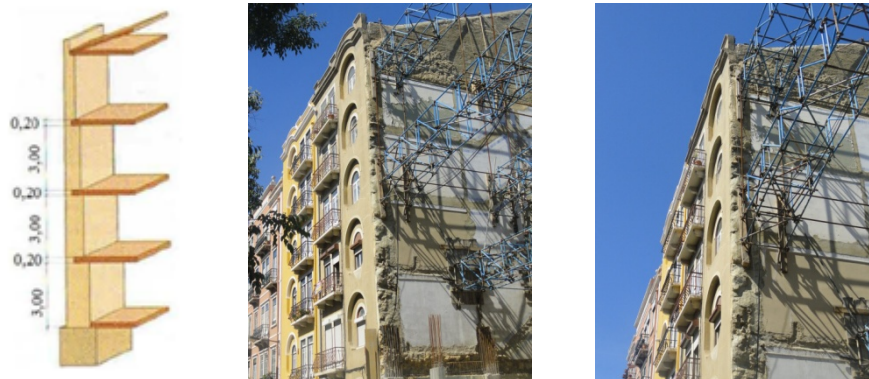
Figure 6 – Reduction of the wall thickness along the height of the building (Appleton, 2003).

These walls have a decreasing thickness from bottom to top, regarding the reduction of the loads on the lower levels, the rationalization of the materials and it also allowed a better support for the floor structure (Figure 6). Nevertheless, the construction of the exterior masonry walls suffered few variations over the centuries which lead to the progressive reduction of its thickness.

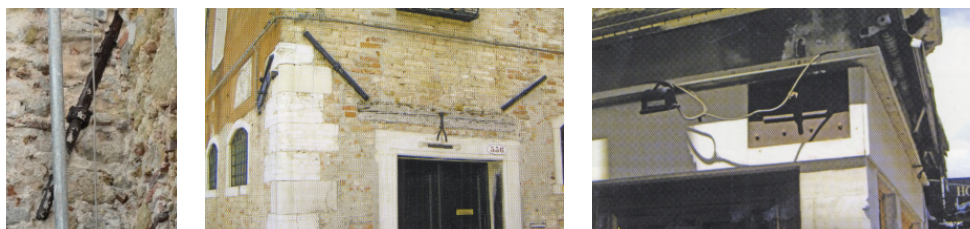
Figure 7 – Iron ties in the connection between orthogonal masonry walls and between parallel masonry walls at the floors level (Lopes *et al.*, 2008).

Iron ties were commonly used to strength the connection between perpendicular masonry walls and parallel masonry walls at the floor level (Figure 7). The tie rods worked as passive reinforcements, only mobilized after changes on the structure balance, for example, connected with thermal variations, foundation settlements or horizontal forces due to the action of earthquakes.

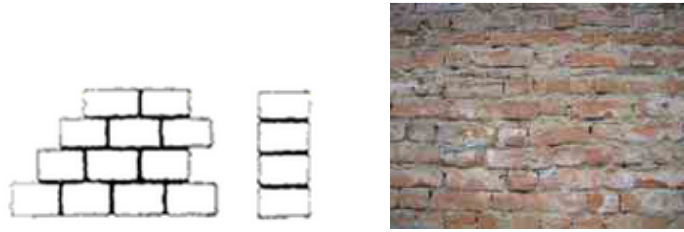
Figure 10 – Brick masonry walls characteristic of a 'gaioleiro' building (Jones, 2002 and Carvalho, 2008).

Composed by vertical, horizontal and diagonal joists, these structural elements (frontal walls) were connected by assemblies and nailing fixation and filled afterwards by rubble masonry (Figure 9). By the end of the nineteenth century, the timber structure started to be simplified and the rubble masonry infill replaced by industrial masonry bricks (Figure 10).

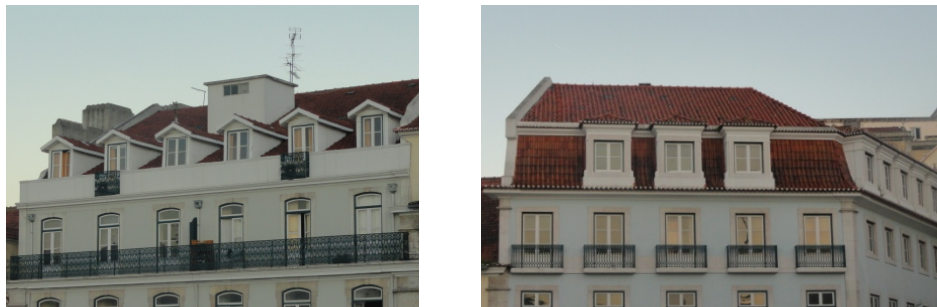
Figure 13 – Dormer and mansard windows.

The buildings were then covered by pitched roofs, with a timber frame structure and ceramic tile coating. Depending on the location of the building and the type of use of the attic, the roofs include dormer or mansard windows (Figure 13).

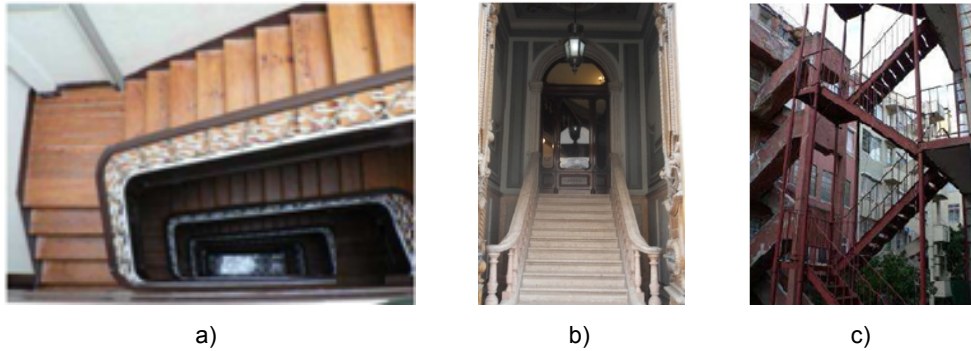
Figure 15 – Different types of stairs (Andrade, 2011): a) Interior timber staircase; b) Ground floor masonry staircase; c) Steel staircase from a 'gaioleiro' building.

There is also an evolution on the staircase structure (Figure 15). On older buildings, the stairs only had one flight between floors and were located along the side walls. During the eighteenth century, the increasing ceiling height of the floors and the need of comfortable accessibilities brought the use of two-flight stairs separated by a half-landing or even three-flight stairs. The stairs were also moved to the centre supporting larger buildings with two houses per floor.

Stone masonry stairs were used on the ground floor level preventing humidity problems to the upper timber structure of the buildings. At the end of the nineteenth century, steel staircases were used on the back façade of the buildings for fire prevention. These structures were made by circular columns, I or T profile beams and grid steel plates on the stairs.

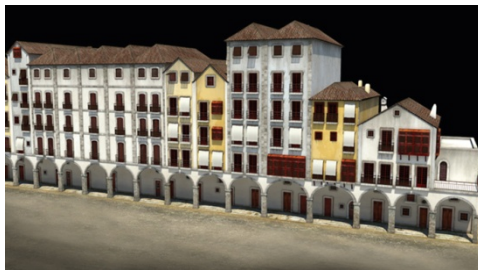
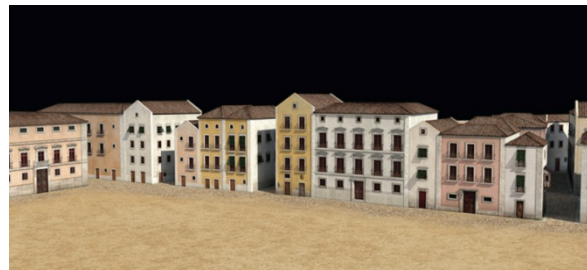
Figure 18 – Reconstruction Model of the city in 1755⁴ (Museu da Cidade, 2010): a) Nova dos Ferros Street; b) Rossio Square.

At Castelo de São Jorge hill (Alfama, Mouraria and Castelo districts) and Bairro Alto, it is still possible to find original architectonic features of the second group of buildings. For instance, older buildings usually have a narrow front façade and pitched roofs to the side (Figure 18). Access to the upper floors is made next to the side masonry walls through one flight stairs with less than one meter width. These stairs are much leaned and uncomfortable (the risers could have 0.20 m), though only possible regarding the reduced ceiling height of the floors.

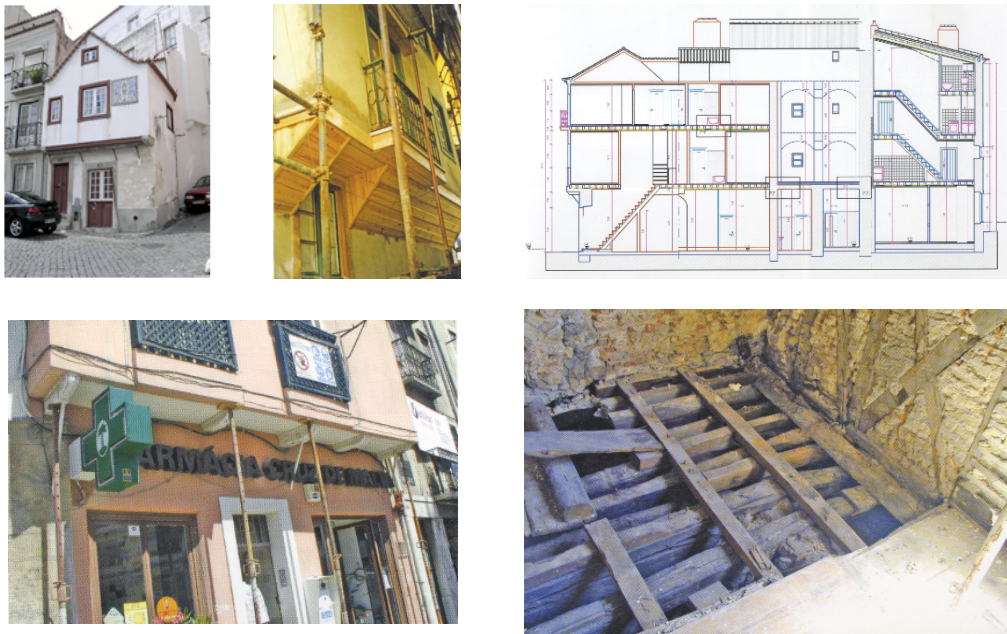
Figure 20 – Buildings from the XVI century with floor ledge and an interior view of the floor with the density of timber beams (Museu da Cidade, 2010 and Lopes *et al.*, 2008).

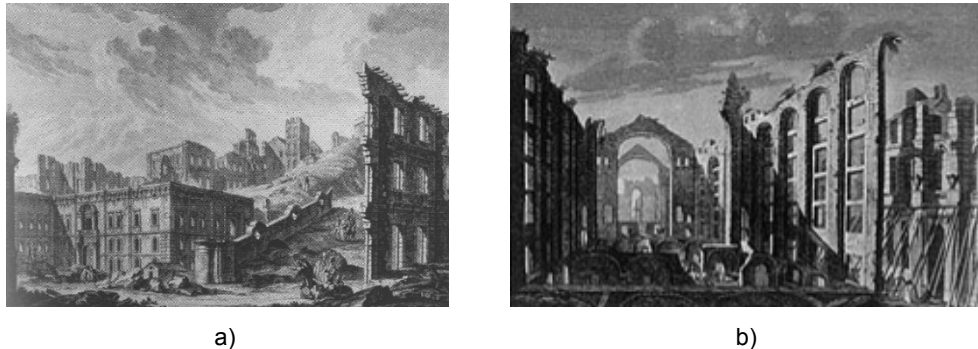
Figure 21 - Lisbon after the 1755 Earthquake: a) On the right the ruins from Patriarcal Church (what is now the City Hall) and on the left (back) the ruins from São Francisco Convent (what is now Belas Artes College) (Lopes *et al.*, 2008); b) Damage caused on the Opera House or Ribeira Theatre. On the right, the score of a building façade wall (Museu da Cidade, 2007).

Portugal was hit by a severe earthquake⁵ followed by a tsunami that caused great damage in Lisbon on November 1st, 1755 (Figure 21). Consequence of the earthquake and destruction, several fires spread through the city lasting for days. This catastrophe was considered as one of the most deadly in history, leaving the city of Lisbon almost completely destroyed. It was estimated that about 75% of the buildings collapsed or became uninhabitable (LNEC, 2005).

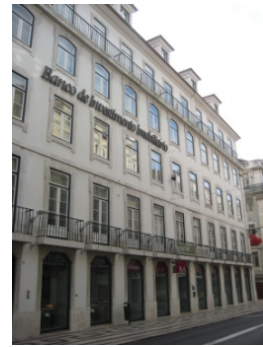
Figure 23 - The windows were aligned both vertically and horizontally in order to maintain the balance of forces (Mascarenhas, 1996).

The façade walls were composed by large doors to the exterior on the ground floor; French windows with a stone balcony on the first floor; sash windows on the higher floors and dormer windows on the roof (Figure 23). Some buildings have also an extra floor between the ground floor and the residential floors, used as storage for the shops. These lower floors intended to ensure a constant high within the compound of buildings on sloped areas (Figure 24).

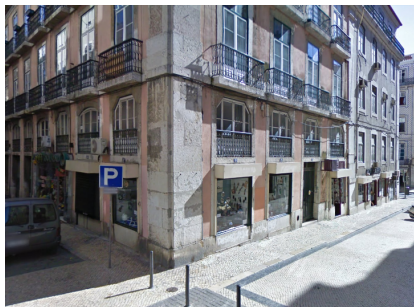
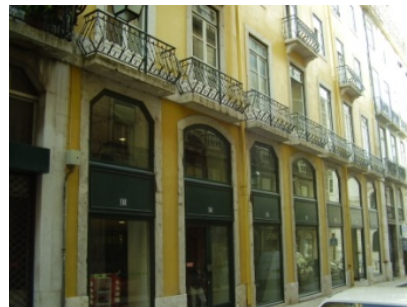
Figure 24 – Lower floor above the ground shops.

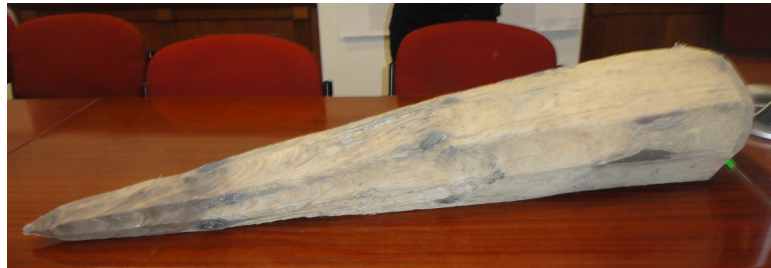
Figure 26 – Timber pile from a 'pombalino' building: experience has demonstrated that these timber piles are closer to 1 m length rather than 6 m.

The downtown soil is very soft and of alluvial nature, while the upper layers are composed by the rubble from the previous buildings. The 'pombalino' buildings were supported on a timber grid laid on short timber piles with no more than 0.15 m diameter and 1 to 6 m length (Figure 26), which hardly achieved the resistant soil. This support system intended to stiffen the alluvial soil and to create a working platform above the water level (Appleton, 2003). The general foundation system consisted in continuous masonry walls or caissons filled with rubble masonry covered by a group of arches (Figure 27).

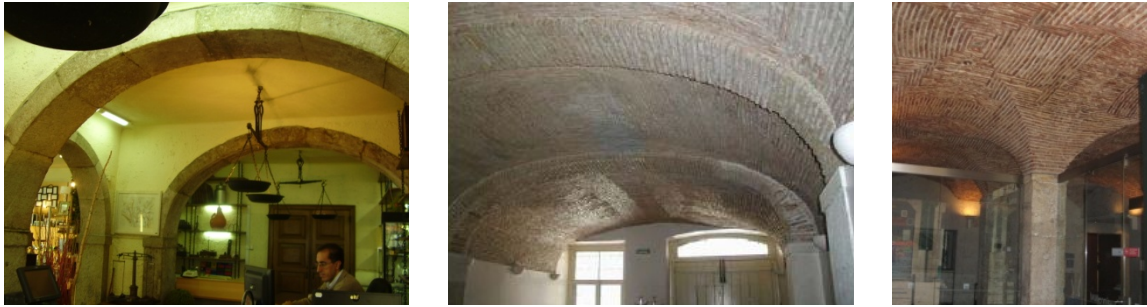
Figure 28 – Example of arches barrel vaults and arches (Appleton, 2003) and crossed vaults.

The ground floor was entirely built in stone masonry, preventing the rising humidity from the ground soil or fire propagation from the warehouses. The ceiling was usually covered by barrel vaults and arches or crossed vaults made in stone or brick masonry (Figure 28). These structures were supported by thick walls or squared columns providing a large stiffness to the structure in its base. Above the masonry vaults and arches the flooring was supported on a timber frame structure (Figure 29.a) or debris infill (sand or loose soil) covered afterwards by a layer of mortar (Figure 29.b). On the better quality solutions, the ground façade walls were

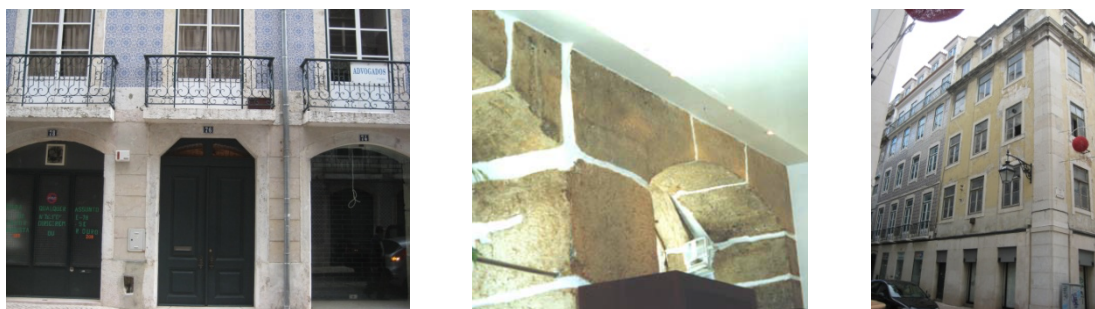
Figure 30 – Ground floor façade wall made of regular limestone blocks.

made of regular limestone blocks, which were also used to reinforce the corner of the buildings along the height (Figure 30).

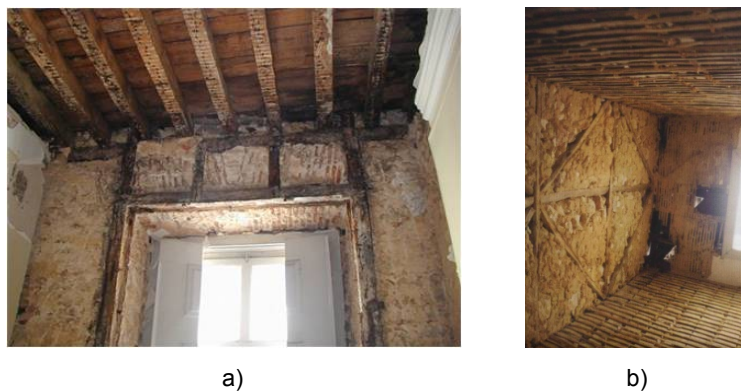
Figure 32 – 'Pombalino' cage (Appleton, 2008): a) Timber frame on the façade walls and relieving arch lintel above the window; and b) Interior timber-masonry walls ('frontal' and timber floors).

façade walls, stiffening the masonry structure around the window openings (Figure 31). The interior structure was composed by timber-masonry walls, timber floors and roof (Figure 32), linked to the exterior walls by timber connectors, partially embedded on the masonry (0.25 to 0.30 m) and reinforced by metal straps.

The main beams were frequently spliced over the interior walls, though in better quality constructions those beams were continuous between perimeter walls. The floors were also connected to the timber frame disposed on the façade walls (Figure 32.a). On the corner

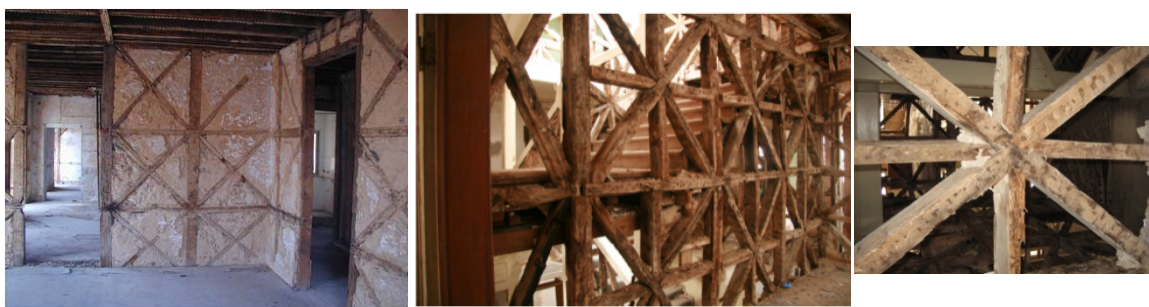
Figure 33 - Example of 'frontal' wall with (Appleton, 2008) and without masonry infill (Lopes, 2010). Despite the regularity that defines the 'pombalino' buildings, there is a great variability in shape and connection of the timber joists.

'Frontal' walls were composed by vertical, horizontal and diagonal elements connected between assemblies and nailing fixation. The position of the joists is based on the empirical principle that is difficult to deform a triangle, without changing the length of its sides (Figure 33). In that case, 'frontal' walls, while requested by vertical and horizontal actions in the plan, respond by the axial strength of the timber elements and connections (Figure 33 and Figure 34).

The truss structure was then filled by rubble stone masonry restraining the deformation of the joist. These walls were placed in orthogonal directions sharing timber elements between, providing strength to the actions in any direction.

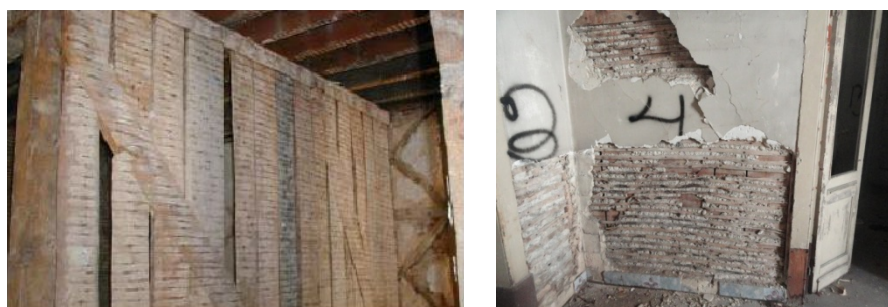
Figure 35 – Example of 'tabique' walls (Pena, 2008).

The 'tabique' walls have a lighter structure made of timber laths nailed to vertical joists, filled afterwards by masonry and air lime mortar (Figure 35). Both 'frontal' and 'tabique' walls were plastered on both sides, but can be easily distinguished by its thickness. Usually, 'frontal' walls were 0.15 to 0.20 m thick, while 'tabique' walls were slightly thinner, around 0.10 to 0.12 m, and mostly used for compartments division (Silva, 2007).

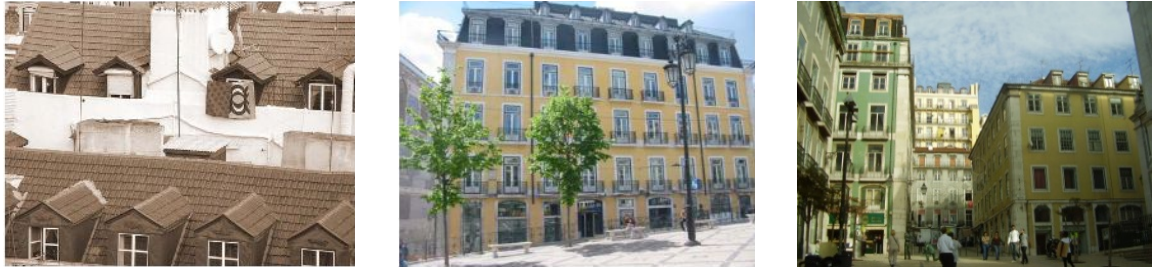
Figure 39 – Example of typical dormer windows and mansard roofs (Appleton, 2008).

The buildings were then covered by dual-pitched roofs, originally with dormer windows and after with mansard windows (Figure 39). The interior space was divided by a timber truss structure, support for the ceramic tiles and connected to the interior 'gaiola' structure.

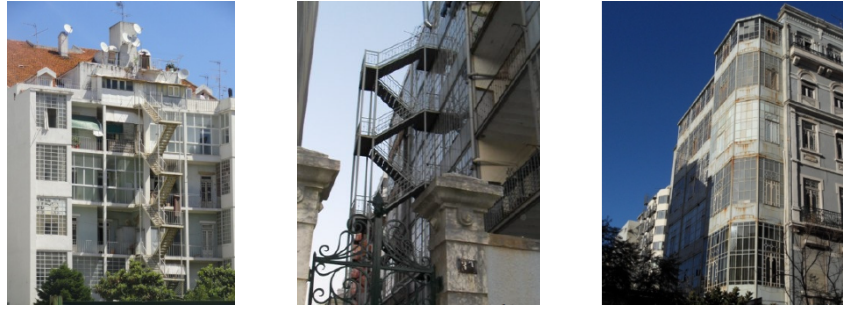
Figure 46 – Steel service stairs and galleries on 'gaioleiro' buildings (Andrade, 2011).

The back façade walls are recognized by the steel balconies or galleries and service staircases to access the interior area of the block, which were actually imposed by the fire-fighters and influenced by the contemporary Iron Architecture (Figure 46).

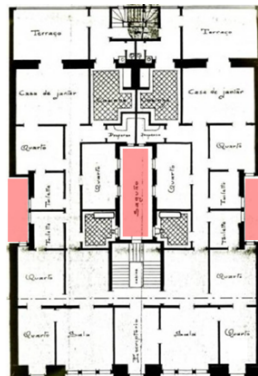
Figure 47 – Plan of 'gaioleiro' buildings: a) Example of Type 1 (Andrade, 2011); b) Example of Type 3 (Branco, 2007); c) Example of Type 4 (Andrade, 2011).

Generally, the quarters have a rectangular shape, though there are also trapezoidal shape quarters conditioned by the slope of the uptown land, originating corner buildings with irregular dimensions. The buildings are usually longer into the backyard and tighter into the façade walls, originally with two houses per storey or only one, resulting from the division of a larger fraction. According to Appleton (2005) the 'Gaioleiro' buildings might be divided into four different types (Figure 47 and Figure 48).

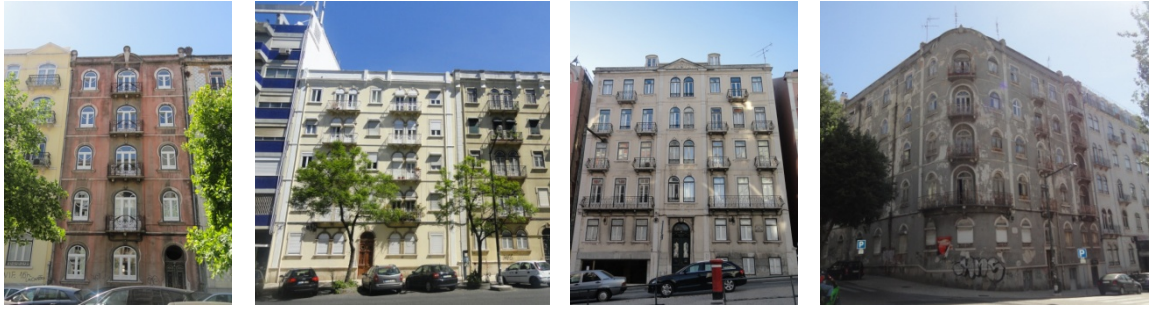
Figure 48 – ‘Gaioleiro’ buildings with different size and shape.

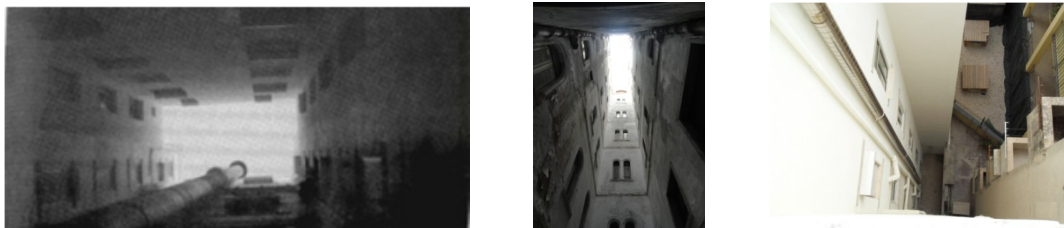
Figure 49 - Example of light-shafts (Appleton, 2005 and Andrade, 2011).

The side walls, frequently shared by adjacent buildings, are interrupted by light-shafts, which provide natural light and ventilation to the interior rooms (Figure 49). Ventilated masonry boxes on the ground floor prevented the rising moisture from the soil and the rotten of the interior wooden structures. These elements can be identified outside by steel or masonry grids on the façade walls or on the entrance hall of the buildings with a first flight of masonry stairs that makes the connection to the interior timber staircase (Figure 50).

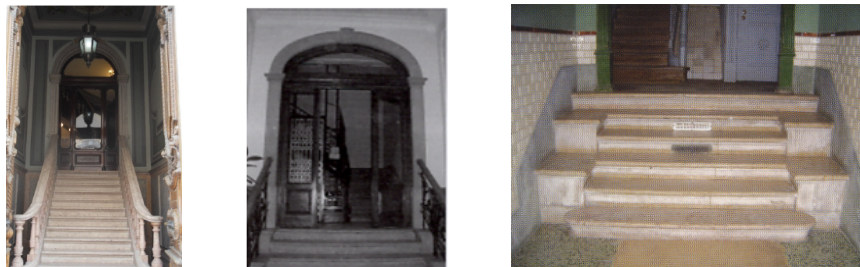
Figure 50 – First flight of masonry staircase gives access to an elevated ground floor with ventilated box underneath (Andrade, 2011 and Appleton, 2005).

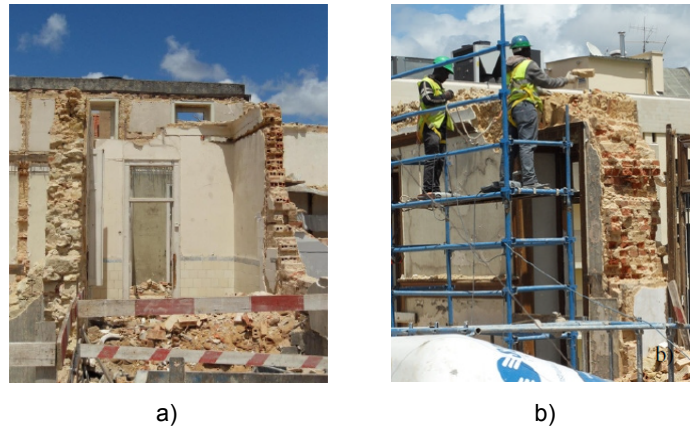
Figure 53 – Brick masonry walls (Andrade, 2011): a) Example of a light-shaft with rubble stone masonry wall (on the left) and solid brick masonry wall (on the right); b) Hollow brick masonry wall.

By the end of the century, new industrial materials were introduced allowing different construction solutions. Therefore, the light-shaft and side walls, originally built in rubble stone masonry, started to be replaced by bricks masonry walls (Figure 53).

The wall thickness varies from 0.40 to 0.50 m in the case of the masonry walls or 0.30 to 0.15 m with brick masonry walls, but often constant in height (Appleton, 2005). Nevertheless, the light-shaft walls are usually thinner than the side walls.

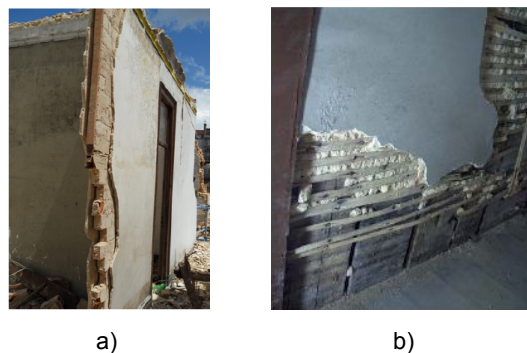
Figure 54 – Interior structure characteristic of ‘gaioleiro’ buildings: a) Solid ceramic brick wall (Andrade, 2011); and b) ‘Tabique’ walls (Pena, 2008).

During the nineteenth century, the cage structure characteristic of the ‘pombalino’ buildings was progressively simplified. The diagonal elements from the ‘frontal’ walls started to be removed, conditioning the bracing of the timber structure. The rubble infill was then replaced by brick masonry, solid on the lower floors and hollow on the upper, or by ‘tabique’ walls, originally used on ‘pombalino’ buildings for compartments division (Figure 54).

Brick masonry walls were occasionally reinforced by an orthogonal grid of joist; horizontal elements at the floors level and at the middle height of the storeys and vertical elements around the door openings. The thickness of the brick masonry walls decreases along the height of the building by changing the position of the bricks (Figure 55). Nevertheless, this variation is also related with the transition between solid masonry bricks on the lower floors and hollow bricks on the upper floors or the replacement of the brick masonry walls by ‘tabique’ walls.

The ‘tabique’ walls were made of vertical timber strips with approximately 0.15 m large and horizontal timber square strips (0.02 to 0.03 m wide) filled on the breaks by rubble masonry, resulting in walls with 0.10 to 0.12 m thickness. There are some cases where these walls were placed perpendicular to the main beams or used as part of the staircase structure. In these cases, the ‘tabique’ walls were reinforced by inclined timber strips (15° with the vertical direction).

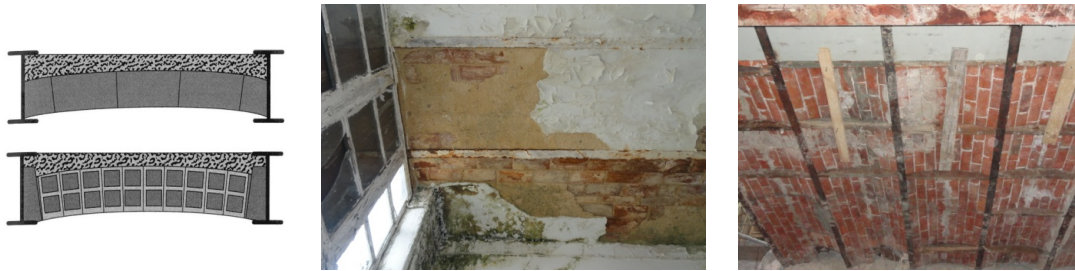
Figure 57 - Floors made of steel beams and ceramic bricks interconnected by mortar or cement (Appleton, 2005).

The balconies and galleries from the back façade walls were built with iron beams in shape of I or T profile (around 0.20 m height) and brick masonry disposed in vaults, interconnected by air lime mortar or cement (Figure 57). The floors were restrained by the side and back masonry walls and supported on border beams and slender circular columns (Figure 58.a). Occasionally, there are diagonal tie rods connecting the border beams to the façade walls, supporting balconies which can reach 2.5 m depth.

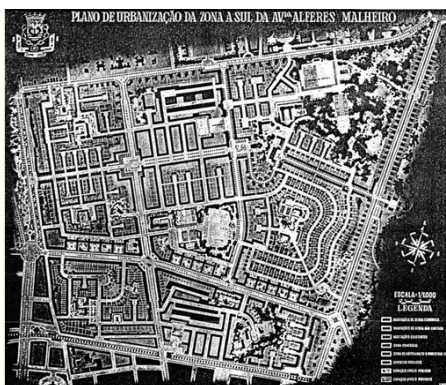
Figure 61 – Urbanization of Bairro de Alvalade (AMFL): a) Urbanization Plan of the south area of Alferes Malheiro Avenue developed by the architect Faria da Costa in 1945; and b) Division of the compound in eight cells.

Bairro de Alvalade developed by the architect Faria da Costa, was intended for 45,000 inhabitants (Figure 61). The district provided the integration of different social groups and activities organized in eight central residential compounds (or cells). The area was limited by Alferes Malheiro Avenue (what is now Brasil Avenue) on the north side, Aeroporto Avenue (what is now Gago Coutinho Avenue) on the east, Campo Grande on the west and by the railway line crossing Roma Avenue on the south, occupying an area of 230 ha (Figure 62).

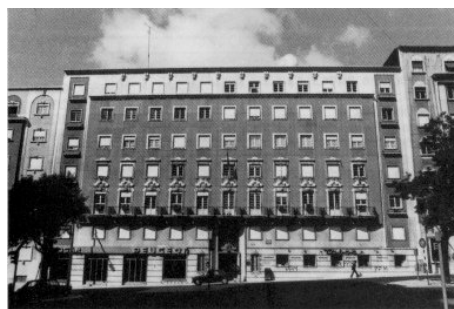
Figure 64 – Building designed by the engineer Duarte Pacheco (1940) in an attempt of defining the Portuguese Architecture model for the rest of the country (Pereira and Buarque, 1995). The building is located at António Augusto de Aguiar Avenue. The floors are still made of timber beams.

The design of the front was dominated by large smooth surfaces covered in marble and by the complete absence of decorative details (Figure 64). Apart from the exterior modification, the buildings structure continues to be made of rubble stone masonry walls and timber floors. Nevertheless, the use of reinforced concrete elements (prefabricated) started to appear on the façade balconies and interior staircases.

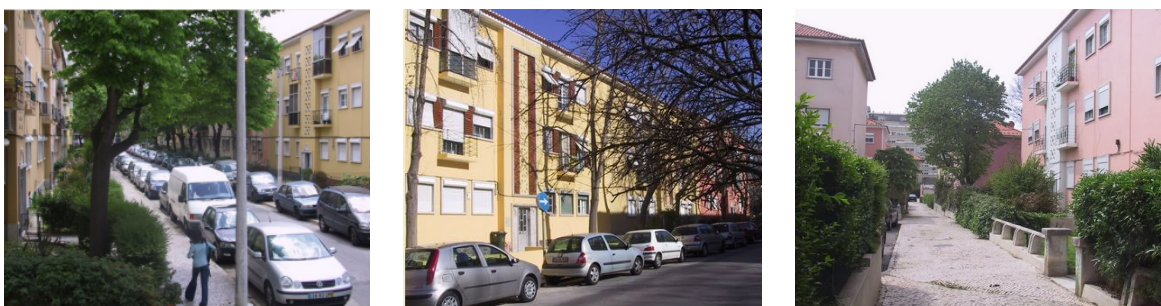
Figure 69 – The front façade walls were disposed along the grid of secondary streets or interior sidewalks (Coelho, 2006).

The construction of cells I and II was developed between 1947 and 1950, and in the same year, began the construction of Houses of Economic Rent on cells V and VI. These buildings, with no more than four floors, were grouped in bands with interior backyards guaranteeing the natural light and ventilation (Figure 69). The exterior design of the buildings had few architectonic details in accordance with the picture of traditional village (Figure 70). The front façade wall had a symmetric design with balanced balconies aligned along the height of the building. The main entrance was located on the centre of the building accessing a two flight staircase separated by a half-landing, guaranteeing two houses per floor.

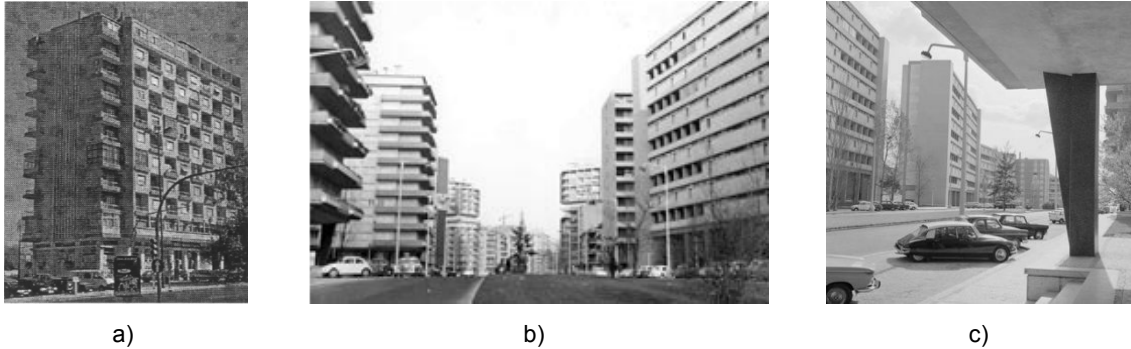
Figure 74 – Buildings from the VIII cell: a) Tower at the intersection between Estados Unidos da América Avenue and Gago Coutinho Avenue (Costa, 1997); b) and c) Overview of Estados Unidos da América Avenue (AFML).

The earliest buildings in height built on Bairro de Alvalade appeared at the intersection between Estados Unidos da América Avenue and Gago Coutinho Avenue through the construction of two towers with ten storeys (Figure 74.a). It was the beginning of the reinforced concrete period as the main structural solution, perceptible by the construction of Bairro das Estacas (meaning piles) designed by Formosinho Sanchez and Rui d'Athouguia, which received several national and international awards (Figure 74).

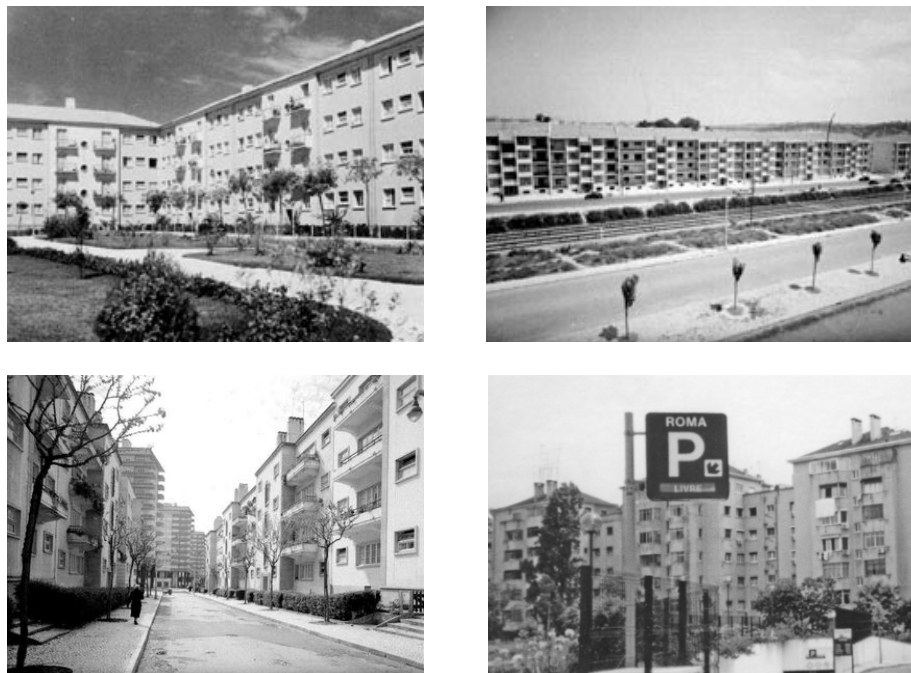
Figure 75 – Transition from 'placa' buildings to reinforced concrete buildings with increasing number of storeys (AFML and Lopes *et al.*, 2008).

The 'placa' buildings sign the abandonment of the traditional techniques and materials and the progressive adaptation to effective structural solutions of construction. This period is well acknowledged on the urbanization of Bairro de Alvalade (Figure 75).

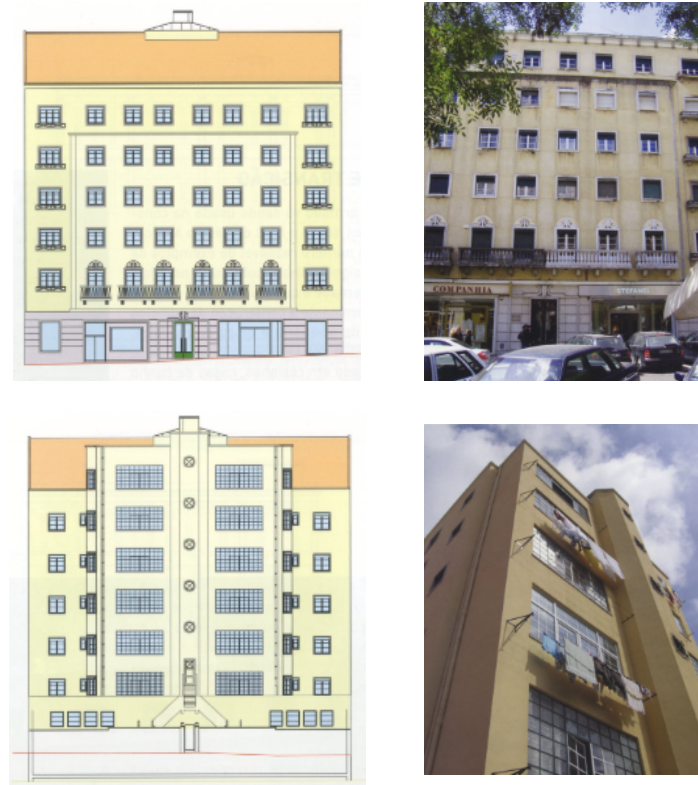
Figure 77 – Front and back façade walls of a 'placa' building in Guerra Junqueiro Avenue (Lopes *et al.*, 2008). The concrete elements on the façade walls allow larger spans on the ground floor.

The reinforced concrete frame structure started to appear at the ground floor of the buildings meant for commercial occupation. The need of larger spans on the front wall and open spaces was overcome by the use of reinforced concrete beams supported on reinforced concrete columns. At this level the exterior walls were also built making use of hollow concrete blocks (Figure 77). Nevertheless, the structural differences between the ground floor and the upper floors results in important stiffness variations on the buildings, leading to significant structural irregularities and the interruption of the interior walls on the first floor.

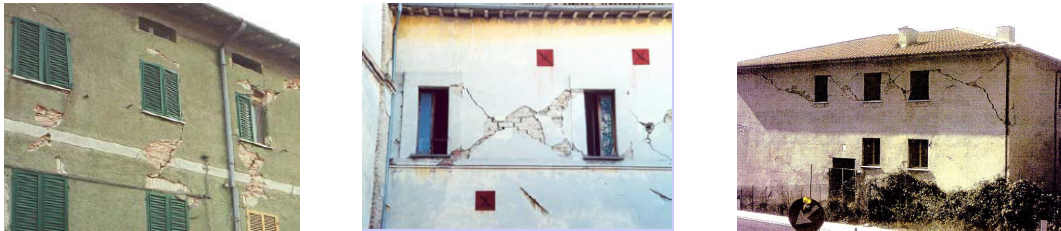
Figure 87 - Damage on a masonry wall around the openings (Logormasino, 2007).

The presence of openings in the walls influences the way the horizontal forces from the upper floors are transferred to the base of the floor¹⁸. The openings decrease the resistance and stiffness of the panels and affect the in-plane cracking pattern on the façade walls, depending on the number, size and position of the openings. Figure 87 shows a series of damage on masonry buildings resultant, illustrating the effect of an earthquake.

The cracking pattern is characterized by large crossed diagonal cracks on the piers or on the spandrels, consequence of the bi-directional ground acceleration. It is also possible to conclude that the openings should be symmetrically distributed on the panel, should have similar dimensions and should be aligned on the vertical and horizontal direction. On the other hand, the openings should be uniform between the walls of the building, preventing additional stiffness variations. Located failures of the structure might also have serious consequences to the integrity of the building, particularly on the connections between the roof structure to the masonry walls and between the floors and the masonry walls (Figure 88).

The inclination of the timber floors or lintels above the doors and windows also gives the indication of the settlement direction. Though, the opening of new cracks on the walls suggests that the settlements are still happening and, therefore strengthening measures should be taken on the structure and foundations. The presence of diagonal cracks in both directions (cross cracks at 45 degrees) on the masonry walls are usually connected with the effect of a seismic action, resulting from bi-directional ground acceleration (see Figure 87).

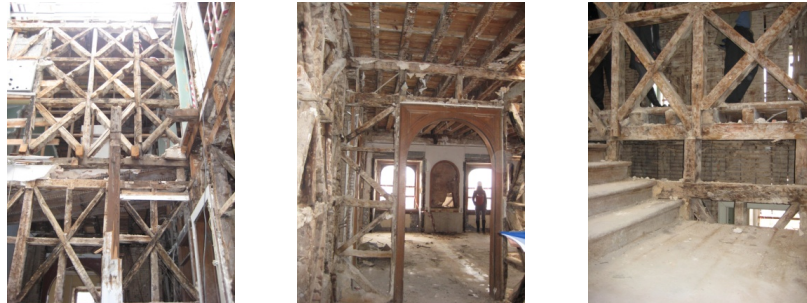
Figure 97 – Structural variations of the 'frontal' walls on the building.

From Figure 97 it is possible to realize that, in one hand, there is no connection between the vertical joists that would ensure the direct transition of loads and, on the other hand, the configuration of the truss structure changes between the floors. Moreover, above the doors' frame, the timber structure is only composed by vertical joists, interrupting once more the truss structure.

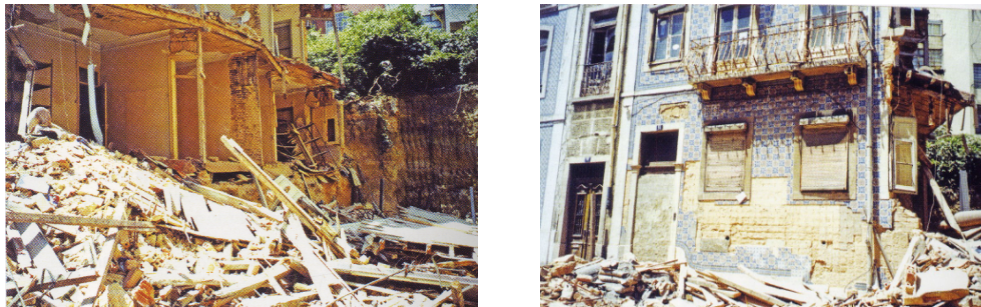
Figure 98 – Collapse of ‘gaioleiro’ buildings (Lopes *et al.*, 2008).

'Gaioleiro' buildings have been a major concern justified by the structural ambiguity that characterises these buildings. The connections between walls and between walls and floors are probably one of the main weaknesses of these buildings when subjected to seismic actions. Actually, there is the record of the collapse of several buildings as shown in Figure 98, though the collapse may also be related to their poor state of conservation.

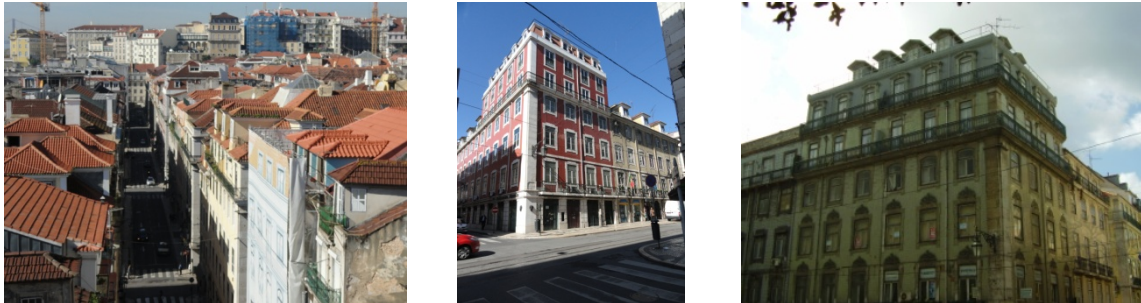
Figure 99 – The ‘pombalino’ buildings were supposed to have five stories height, though a brief view of the ‘pombalino’ downtown gives a different perception.

According to Mascarenhas (1996), the structural regularity of the 'pombalino' buildings provided a similar performance of the construction within the block, which besides reinforcing the composition effect also gave them superior structural stability. Nowadays, several 'pombalino' buildings have more stories than the original buildings (five storey height including the attic) added at the end of the nineteenth century in response to an increasing population (Figure 99).

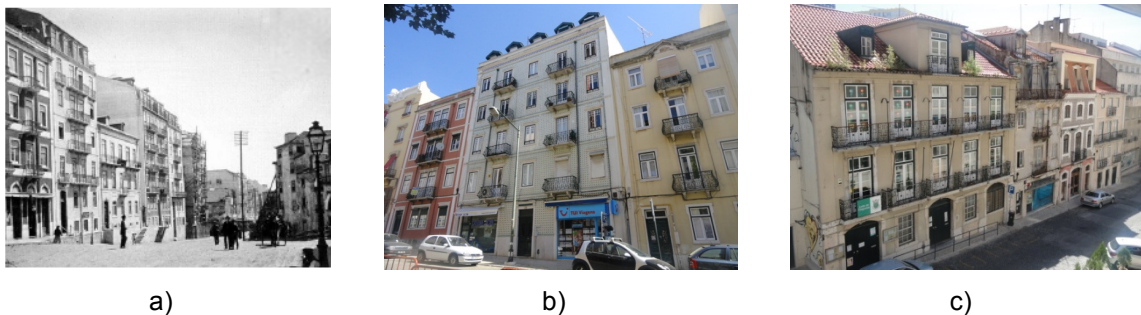
Figure 100 - 'Gaioleiro' buildings with different heights in its original conception: a) Rainha Amélia Avenue (now Almirante Reis Avenue) in 1908 (AFL); b) Tomás Ribeiro Street; c) São Sebastião da Pedreira Street.

On the conception of the ‘gaioleiro’ compounds of buildings, there were no restrictions with the buildings height generating quarters of buildings with several structural variations and an unpredictable global dynamic behaviour (Figure 100). This type of interventions brings important structural irregularities within the group behaviour related with the increment of the plan eccentricity between mass and stiffness.

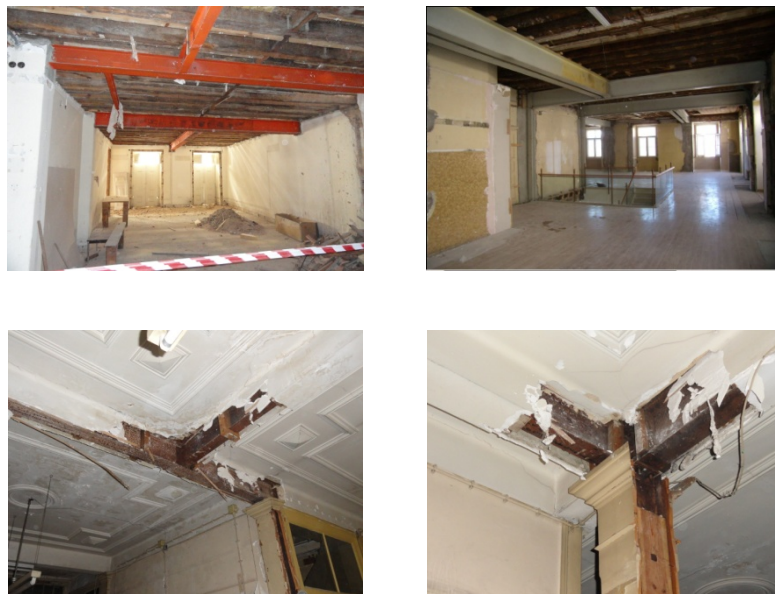
Figure 101 - Removal of interior walls which were replaced by steel beams and columns.

The most common modifications are related with the removal of structural walls regarding the enlargement of the existing rooms or the adaption to a different use (Figure 101). The

It is common the introduction of steel or reinforced concrete beams (pre-fabricated) in the place of the removed walls, supported on columns (steel or reinforced concrete) or simply supported on the adjacent walls (interior or exterior). Depending on the orientation of the wall, the actual bracing to the masonry façade walls might be compromised.

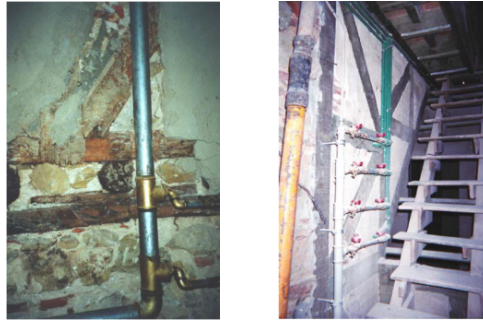
Figure 102 – Cut of a timber joist for the introduction of a pipe, which might compromise the purpose of the ‘pombalino’ cage (Lopes *et al.*, 2008).

The existence of supply networks is recent in ancient buildings and sometimes these networks are introduced without any structural concerns. From time to time, the insertion of pipes ends up with the slash of the timber joists of the ‘frontal’ walls (Figure 102). As referred before, these walls are important for the support of the horizontal inertia forces, contribute to the energy dissipation capacity of the system and are fundamental to brace the masonry façade walls.

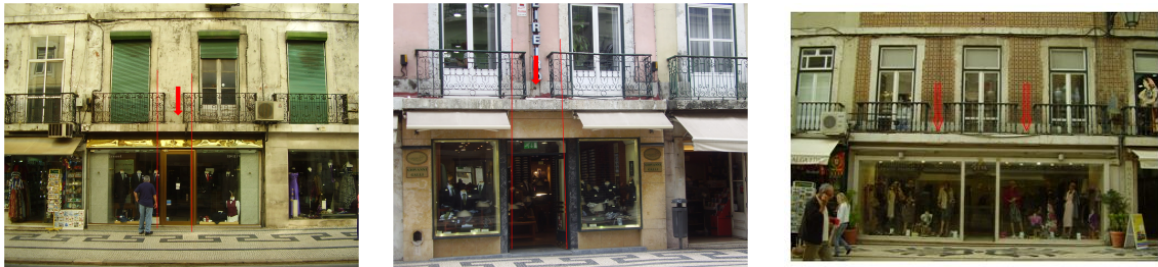
Figure 103 - Example of the interruption of the vertical façade elements.

The commercial occupation of the ground floor usually takes advantage of enlarged façade openings (Figure 103) through the cut of the vertical façade elements (piers). These actions generate artificial soft-stories which result on the support of a rigid element (upper floors) over weaker and flexible elements.

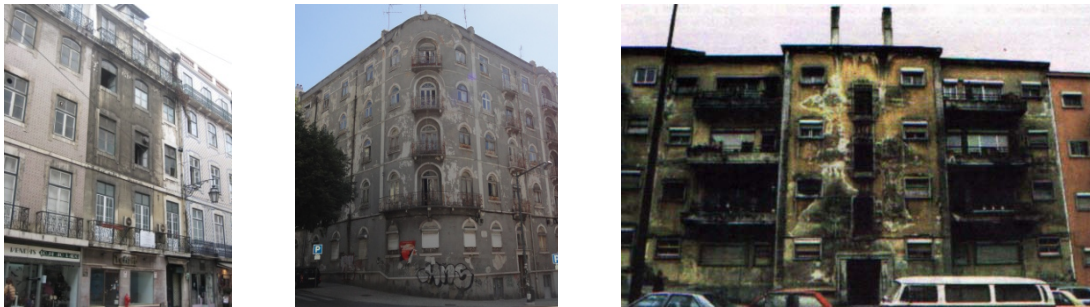
Figure 108 - Degradation of the façade wall of old masonry buildings.

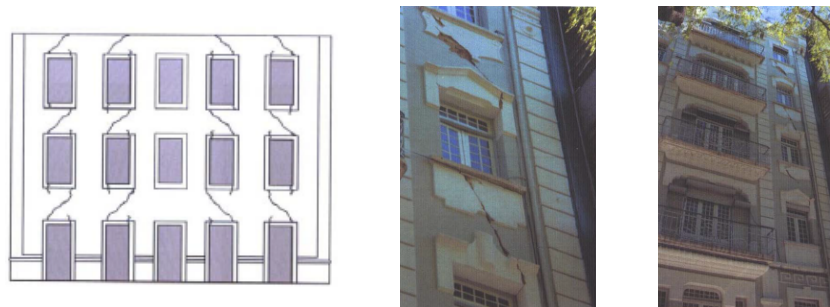
Figure 110 – Diagonal cracking due to differential settlements (Branco *et al.*, 2011).

Cracking, crush and disintegration of the masonry elements are usually related with the material low tensile strength and cohesion, structural modifications linked with the removal of interior walls without a proper support system or related with differential settlements of the foundation system. These factors can generate different displacements inside the wall, leading to the opening of diagonal cracks pointing to the settlement direction (Figure 110); or different displacements between walls leading to vertical cracks on the connection between perpendicular walls.

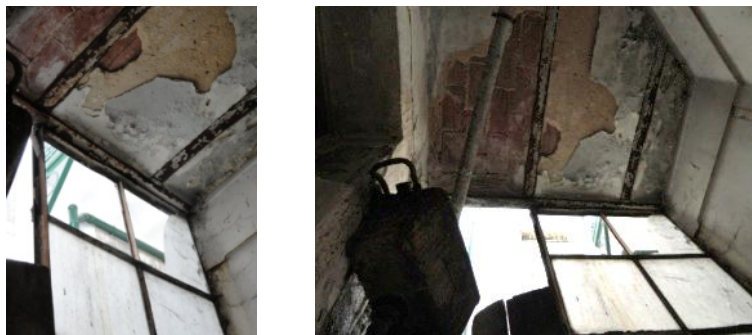
Figure 113 – Oxidation of the steel structure.

The degradation of the steel balconies and stairs from the 'gaioleiro' buildings is very common (Figure 113). The oxidation of the metal structures is actually related with the initial treatment of the iron (reduced thickness of the protection) and with the lack of maintenance actions, due to the costs involved or due to the reduced visibility of these structures. Nevertheless, the current state of oxidation can cause failure by forcing apart adjacent elements or sections, invalidating the use of these equipments. In the worst possible scenario, these balconies can drag the back façade wall of the buildings into a global collapse.

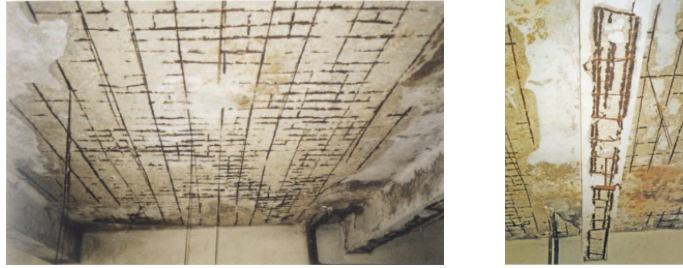
Figure 114 – Reinforced concrete slabs and beams slightly compact concrete with a thin layer covering the reinforcement. The corrosion of the steel is common and leads to the spalling of concrete cover (Lopes *et al.*, 2008).

On the 'placa' buildings, the reinforced concrete elements used were very slender and poorly reinforced. In addition to that, the covering concrete layer was very thin leaving the

reinforcement vulnerable to the oxidation and corrosion. The expansion of the steel material results on the spalling of the concrete cover exposing the reinforcement (Figure 114).
